NATIONAL PROGRAM FOR INSPECTION OF NON-FEDERAL DAMS
GARNISS POND DAM (CT.) (U) CORPS OF ENGINEERS WALTHAM MA
NEW ENGLAND DIV NOV 79

GARNISS POND DAM
CT-00114

4. TITLE (and Subtitle) East Haven, Conn. Garniss Pond Dam NATIONAL PROGRAM FOR INSPECTION OF NON-FEDERAL DAMS		5. TYPE OF REPORT & PERIOD COVERED INSPECTION REPORT

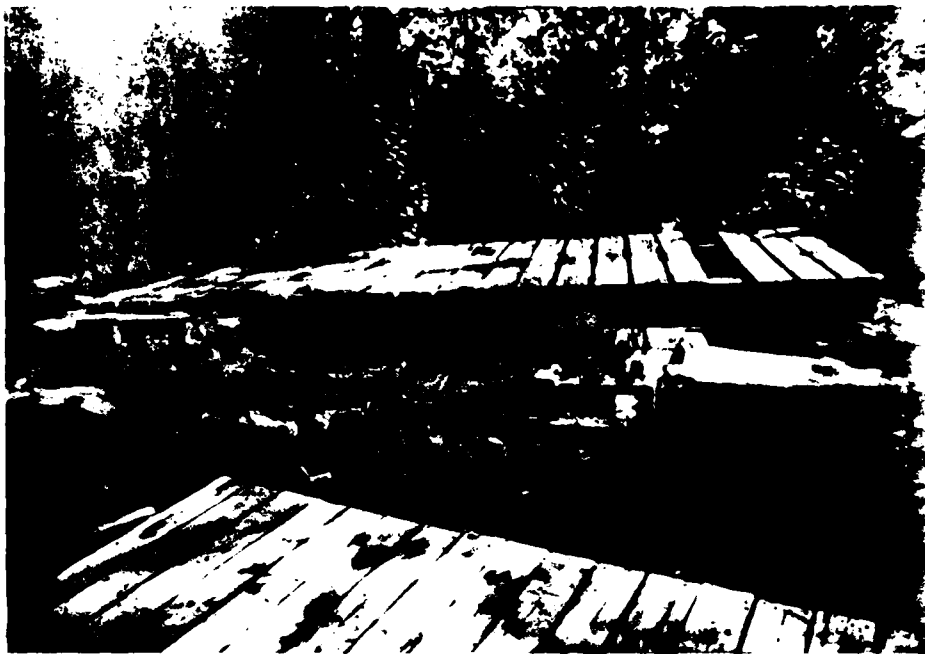
The findings of our visual inspection revealed that the condition of the dam is poor. The upstream weir is deteriorated and has fallen to a state of disrepair (Photo Page 3). The downstream weir has several areas of seepage at the downstream side (photo 5 and 6). The crest and slopes are overgrown with trees and brush (photos 1 and 2).

Photo 3 - Upstream weir and spillway channel. Downstream weir in background.
