**PRITCHARDS POND DAM
CT 00033**

**NAUGATUCK RIVER BASIN
WATERBURY, CONNECTICUT**

**PHASE I INSPECTION REPORT
NATIONAL DAM INSPECTION REPORT**

Name of Dam : Pritchards Pond Dam
Identification Number : CT 00033
Town : Waterbury
County and State : New Haven County, Connecticut
Stream : Hopeville Pond Brook
Owner : Risdon Manufacturing Company, 2100 South Main Street,
Waterbury, Connecticut
Date of Inspection : December 3, 1980

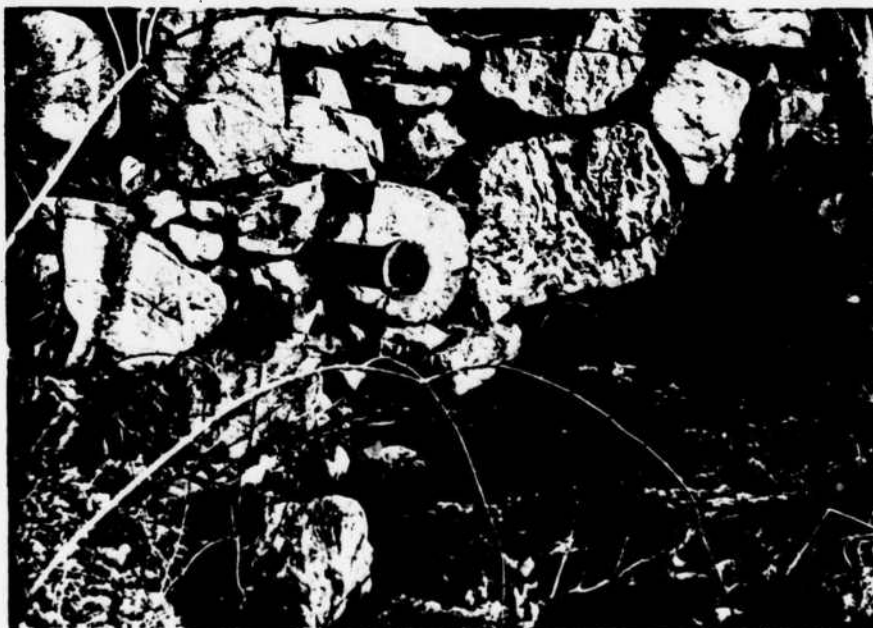
6. Spillway and outlet discharge pipes.
