NATIONAL PROGRAM FOR INSPECTION OF NON-FEDERAL DAMS  
PAPER GOODS POND DAM. (U) CORPS OF ENGINEERS WALTHAM MA  
NEW ENGLAND DIV MAR 81

| REPORT DOCUMENTATION PAGE | | READ INSTRUCTIONS<br>BEFORE COMPLETING FORM |
|---|---|---|
| 4. TITLE (and Subtitle)<br>Paper Goods Pond Dam | | 5. TYPE OF REPORT & PERIOD COVERED<br>INSPECTION REPORT |

# **NATIONAL DAM INSPECTION PROGRAM**

## **PHASE I - INSPECTION REPORT**

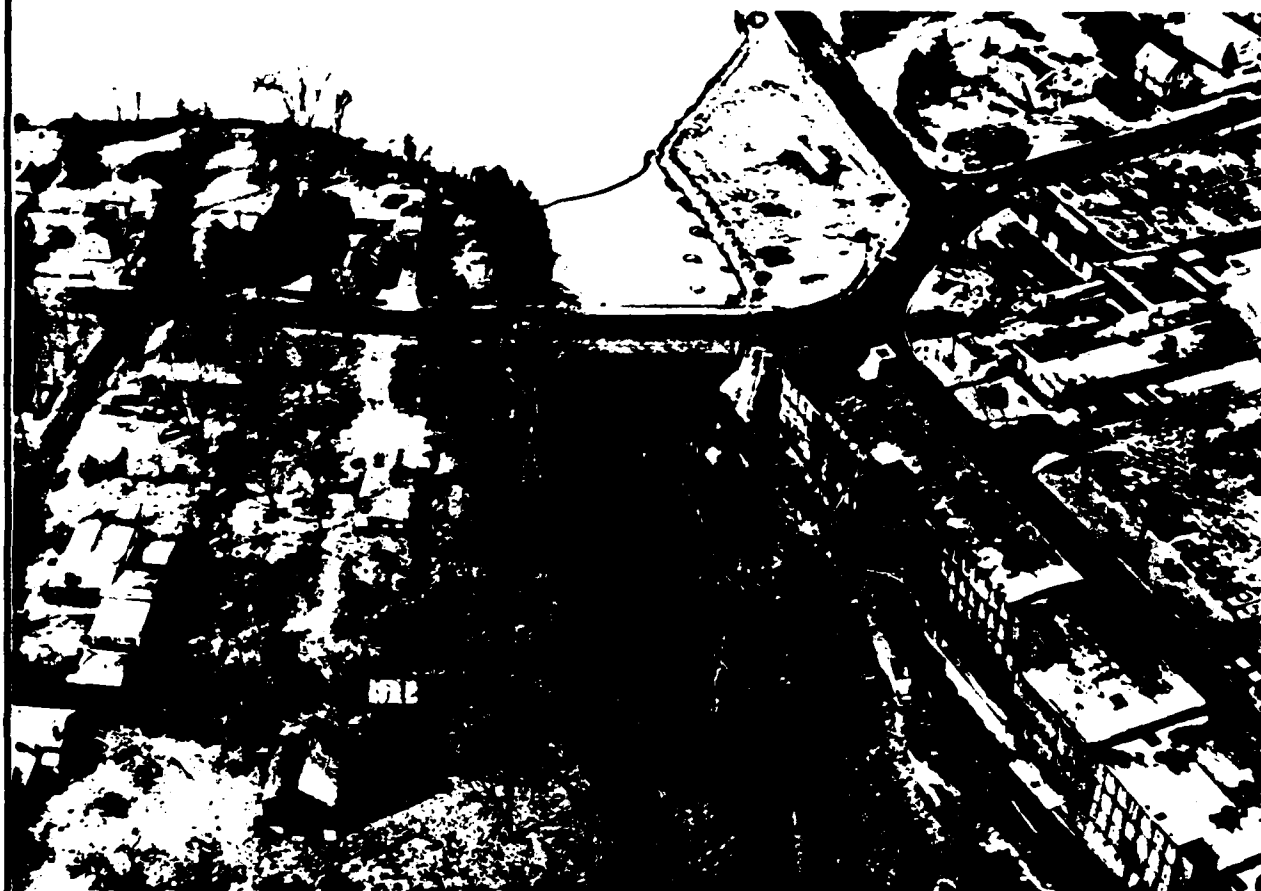
OVERVIEW PHOTO - PAPER GOODS POND DAM

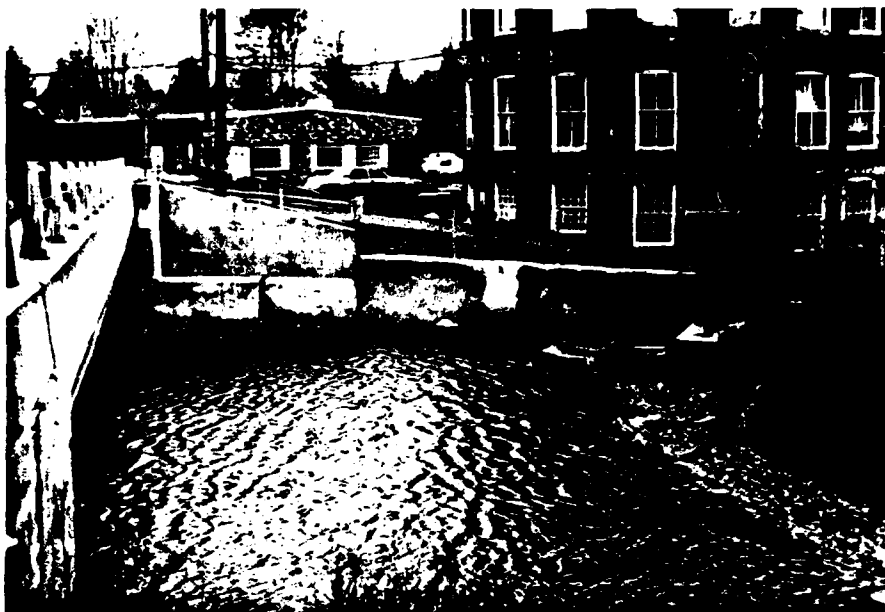
The other two valves on the dam controls discharge into the pipe. An attempt was made to open the valve in 1974 at which time several gear teeth were broken. It is believed this valve is inoperable.

C-3 NORTHEAST END OF SPILLWAY SHOWING  
OUTLET WORK CONTROLS
