NAUGATUCK RIVER BASIN  
NAUGATUCK, CONNECTICUT

**THURSTON POND DAM  
CT 00129**

**PHASE I INSPECTION REPORT  
NATIONAL DAM INSPECTION PROGRAM**

DECEMBER 1980

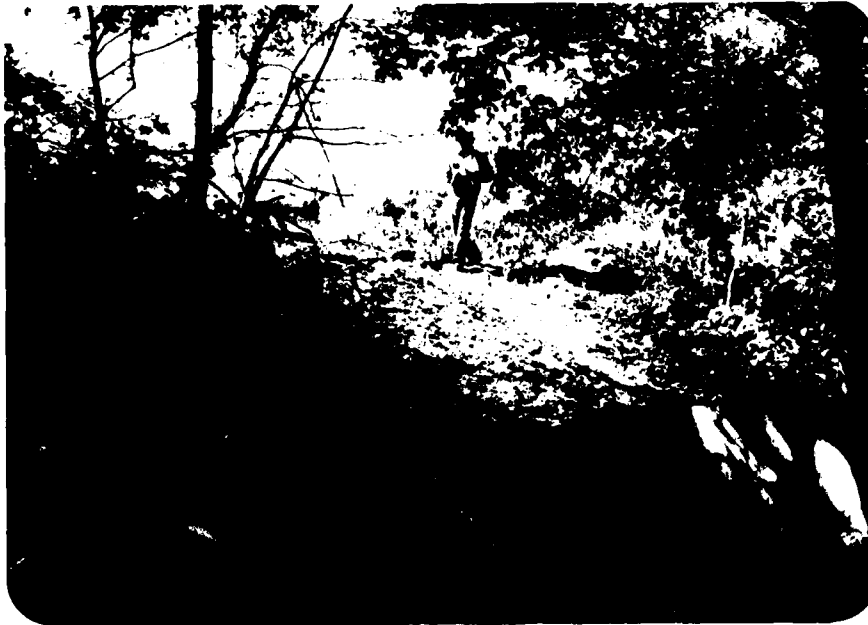
PHOTO NO. 4

EROSION PATH ON DOWNSTREAM SLOPE.

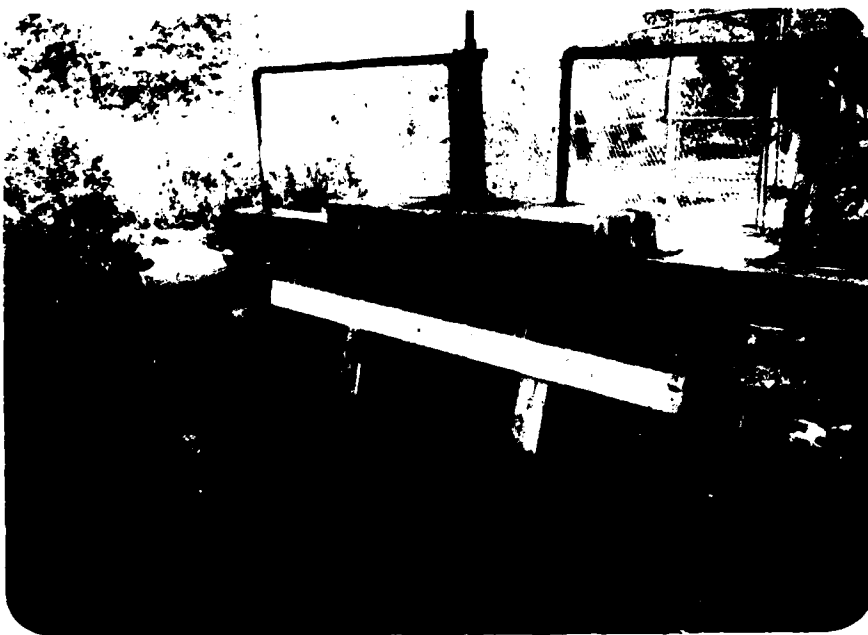
The outlet works consist of a concrete intake structure located at the right abutment. The exposed part of the concrete structure appears to be in good condition, Photos 10 and 11. The intake sluice gate is in good condition and is reported to be operable. A wooden trash rack in front of the sluice gate is rotted at the water line. The intake sluice gate controls the flow into the structure and into a pipeline which supplies water to downstream locations where it is used for industrial purposes. An 18-inch concrete pipe discharges through the upper part of the right spillway training wall, Photo 9. The flow through this pipe is controlled by a sluice gate located outside the intake structure, Photo 11. The gate was reported to be operable. The intake structure and gate serve as the low level outlet for the dam. There is an overflow for the intake structure which discharges over the right spillway training wall. There are indications of erosion in front of the training wall, probably resulting from the discharge of the overflow and the 18-inch pipe.

PHOTO NO. 10  
OVERFLOW AND OUTLET  
GATE AT INTAKE  
STRUCTURE.

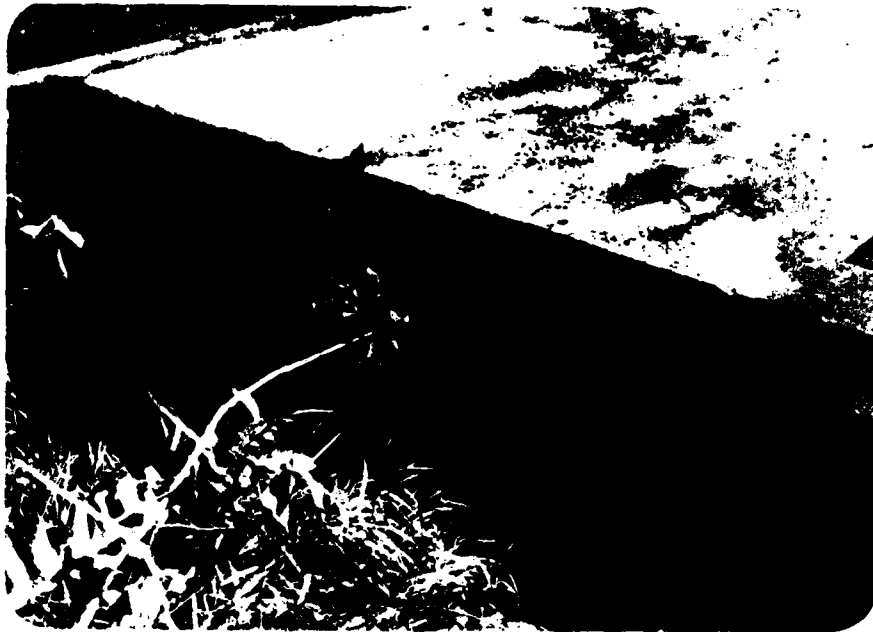
PHOTO NO. 11

INTAKE STRUCTURE AT  
RIGHT ABUTMENT

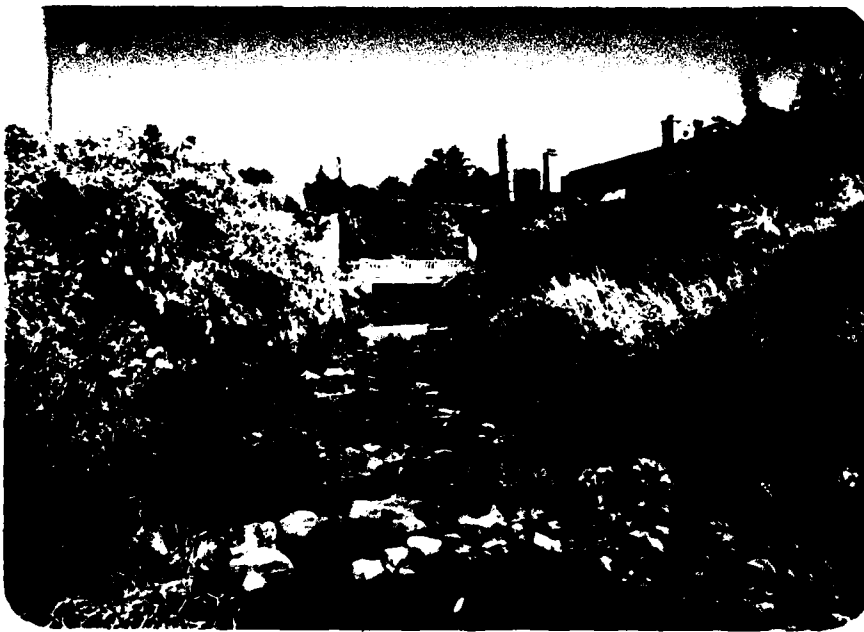
PHOTO NO. 12

DOWNSTREAM CHANNEL
