NAUGATUCK RIVER BASIN  
WATERTOWN, CONNECTICUT

**PIN SHOP POND DAM  
CT 00127**

**PHASE I INSPECTION REPORT  
NATIONAL DAM INSPECTION PROGRAM**

JANUARY 1981

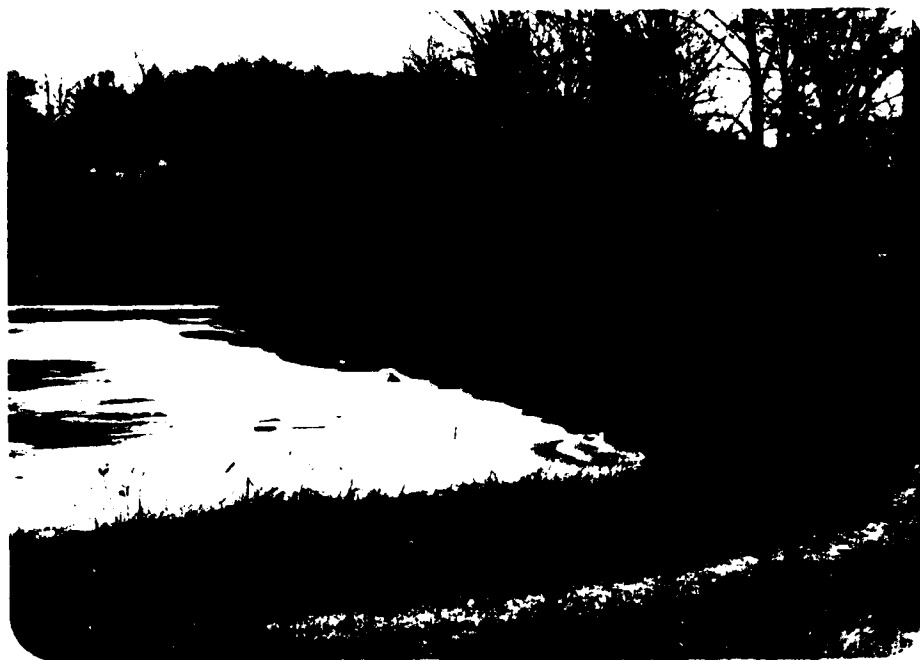
PHOTO NO. 3

The upstream slope of the dam is overgrown with numerous trees up to 8-inches in diameter, Photo 3. There is no riprap slope protection present, and considerable erosion has taken place at and above the normal water line, Photo 4. The crest is fairly level and is covered with grass, brush and small trees, Photo 1. An erosion path is worn at about the centerline of the crest. The downstream slope is covered with numerous trees up to 12-inches in diameter, Photo 5. The slope is relatively steep in some areas and has an average slope of about 1.5 horizontal to 1 vertical. Several erosion paths are present on the downstream slope, including one at the left end of the earth embankment which cuts back into the crest and measures approximately 5 feet wide and 5 feet deep, Photo 6. Near the center of the earth embankment at the top of the downstream slope there are two small concrete piers which serve no apparent purpose at the present time. There was no seepage observed on either the downstream slope or in the area immediately downstream of the dam.

UPSTREAM SLOPE FROM RIGHT ABUTMENT.  
NOTE TREES.
