NATIONAL PROGRAM FOR INSPECTION OF NON-FEDERAL DAMS  
LAKE KONOHOOC DAM (CT.) (U) CORPS OF ENGINEERS WALTHAM MA  
NEW ENGLAND DIV JUN 79

LAKE KONOMOC DAM

CT. 00152

PHASE I INSPECTION REPORT  
NATIONAL DAM INSPECTION PROGRAM

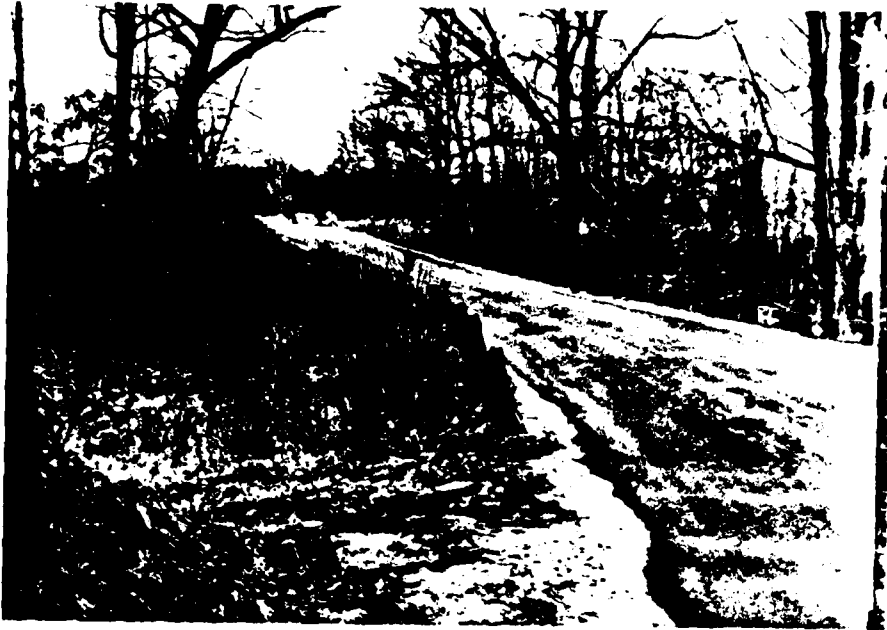
9. Upstream face of Davis Pond Dike.

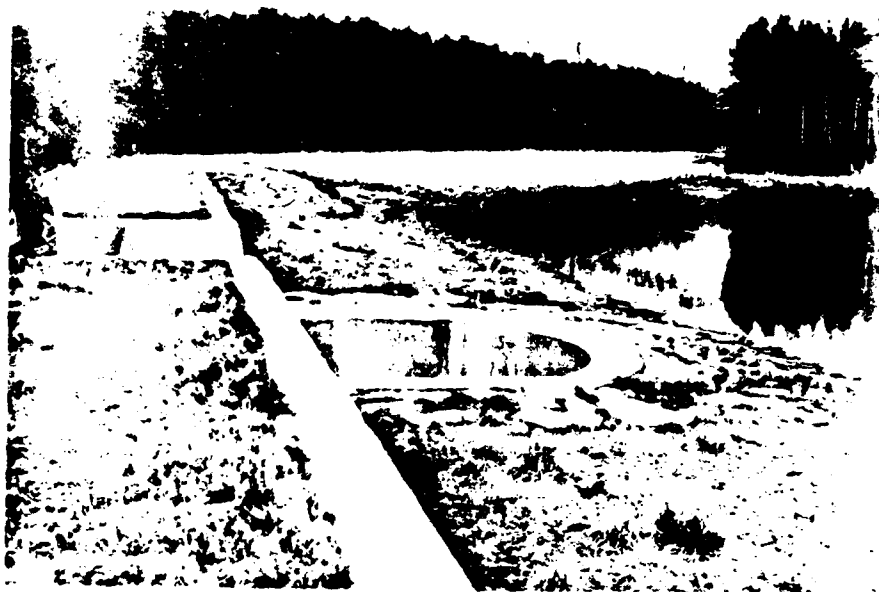
transported a slight but steady flow across its width leading either ground water intrusion through defective concrete slabs, or release of rain water or spillway flow retained in the 3.5 ft. thick boulders in the stilling basin. However, the "as-builts" indicate the joints of the spillway to have been equipped with rubber waterstops; there are no weep holes and little or no precipitation is said to have occurred for some period before the inspection. Site personnel stated that this moisture has been evident almost from the completion of construction (see Photo Nos. 11, 12, 13 and 14, Appendix C).

11. Overview of spillway crest.

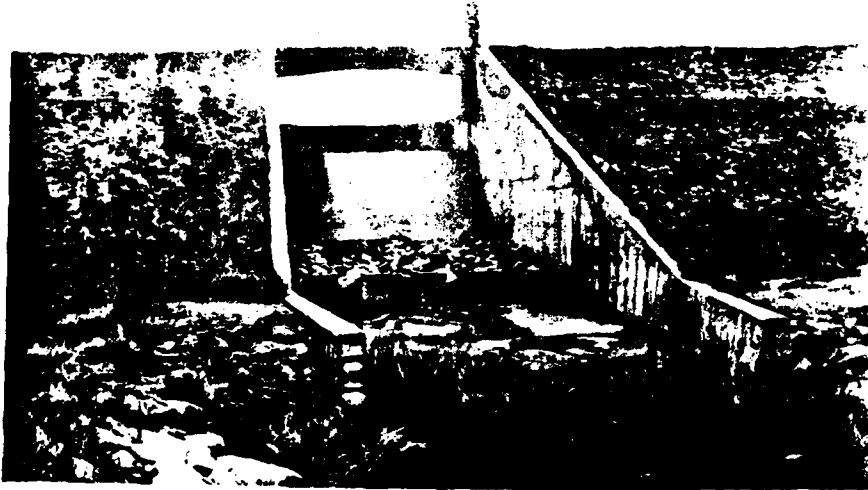
13. View of spillway chute from downstream channel.

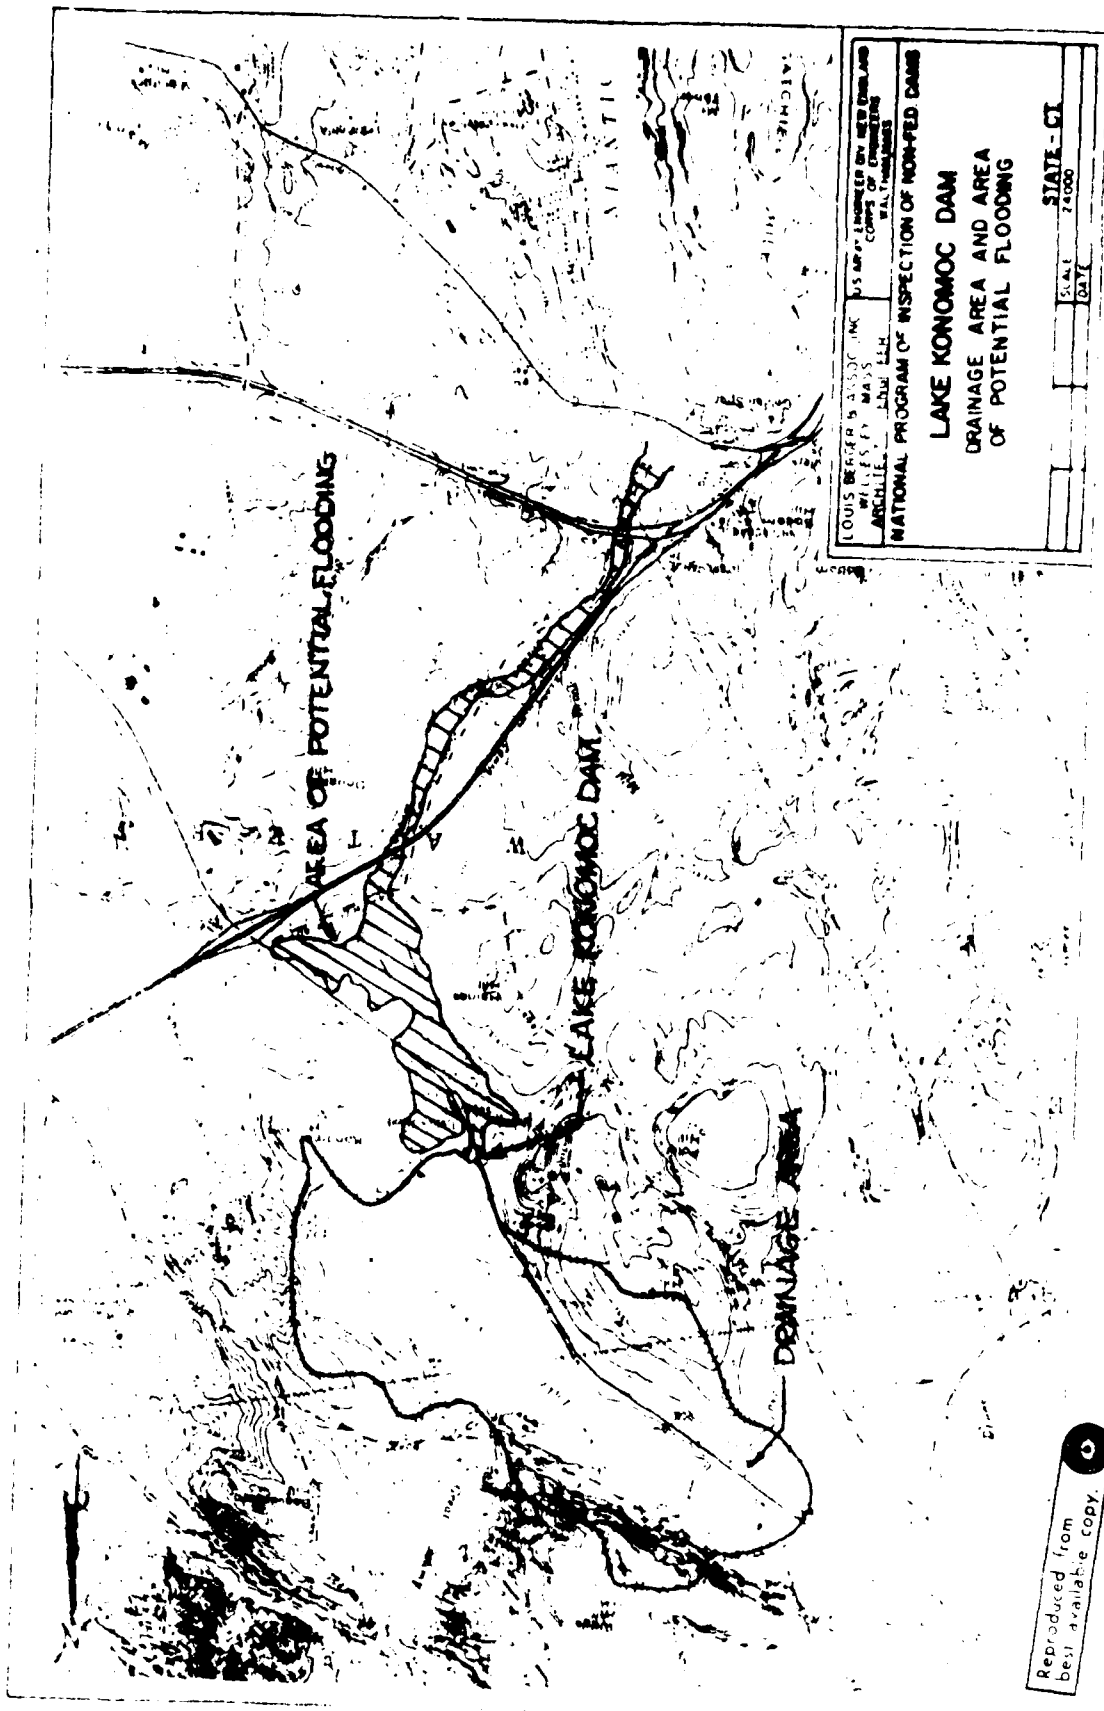
FIGURE 5 SHEET D-8

In summary, about 14 homes, a racetrack, two local roads, and a two lane state highway (Route 85) are within the area of potential flooding. The Connecticut Turnpike and Interstate Route 95 also might sustain damage. Figure 5, Sheet D-18, Appendix D, shows the area of potential flooding.
