MILL POND DAM  
CT 00164

INSPECTION REPORT

MAY 1981

CONNECTICUT RIVER BASIN  
 NEWINGTON, CONNECTICUT

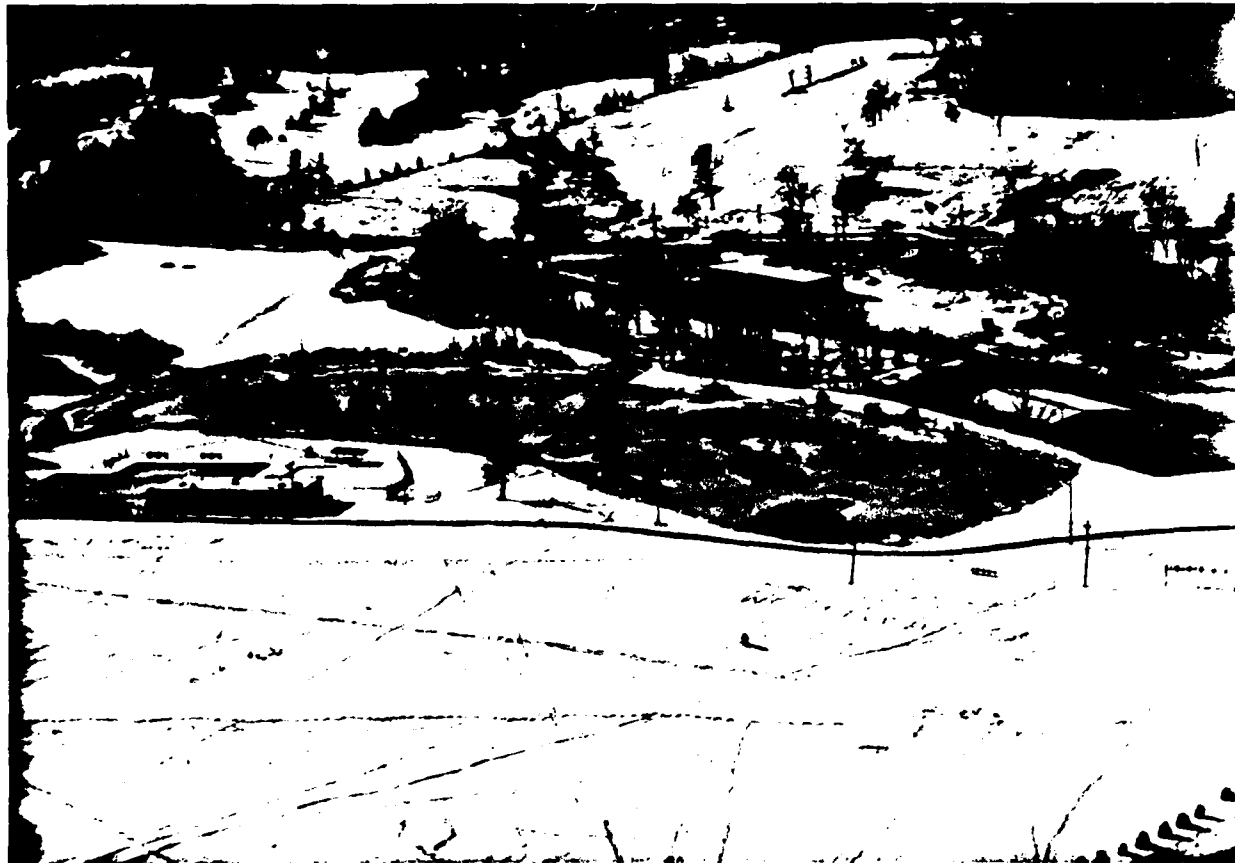
- 1.) VIEW OF DAM LOOKING DOWNSTREAM.
- 2.) OVERVIEW PHOTO TAKEN DECEMBER 20, 1980.

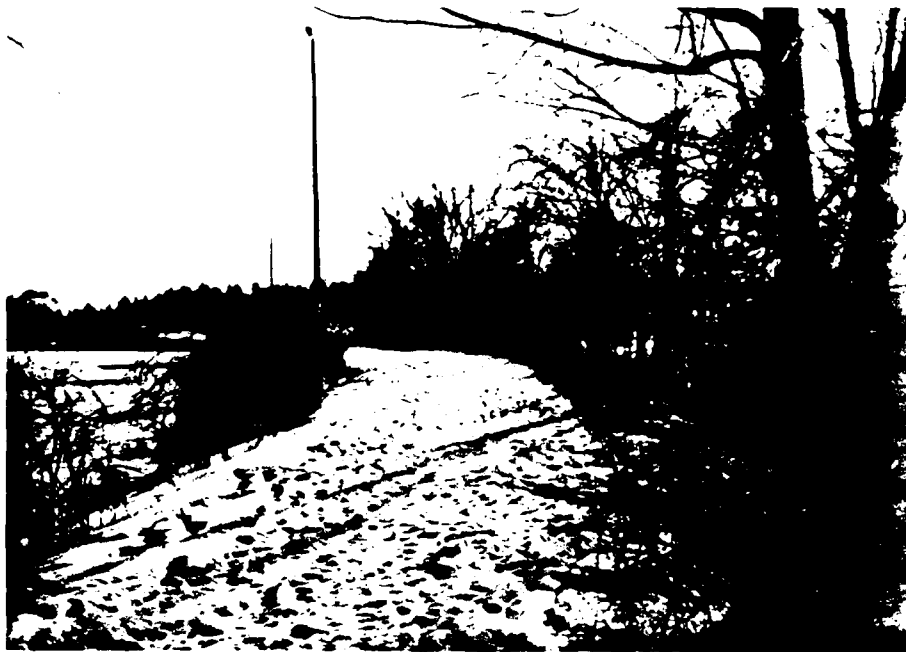
The downstream slope was very steep and covered with a large number of shrubs and trees, up to 18" in diameter (See Photo 1, 2 & 3). Remnants of a brick masonry wall partially retaining earthfill were observed along the downstream dam embankment as shown in Photo 4. The wall which is located on the general dam plan in Appendix B is founded on a rock base and appears to have been part of an old building. As shown in Photo 5, a four foot wide, rockfilled depression with a bottom approximately 8 ft. below the gravel path was observed on the downstream slope. The depression, which may at one time have been a sluiceway for the old waterpowered mills, showed no sign of seepage.

Photo 2 - View looking south along crest of dam.

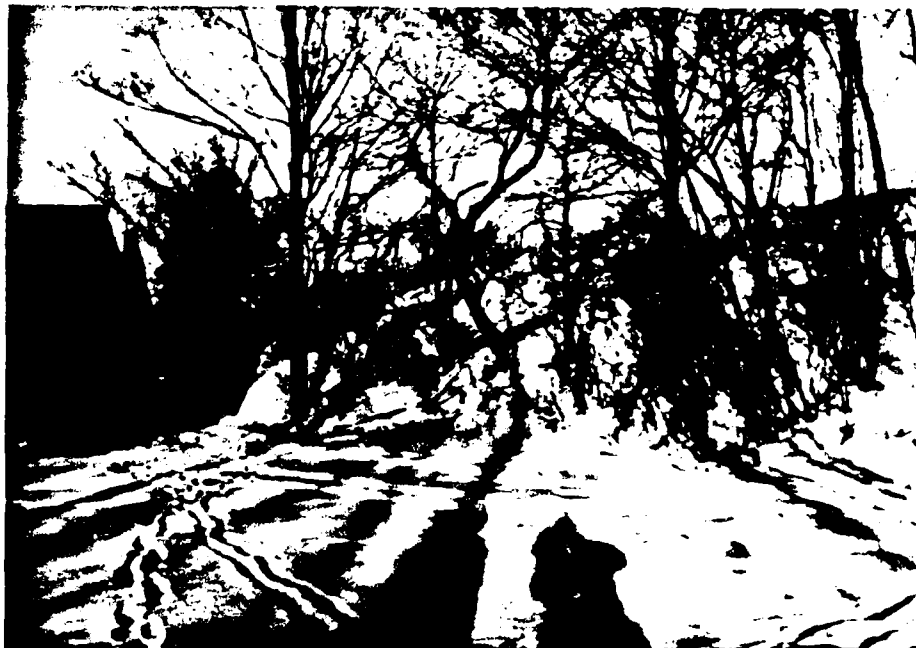
Photo 3 - View looking north along downstream side of dam showing outcrops of bedrock.

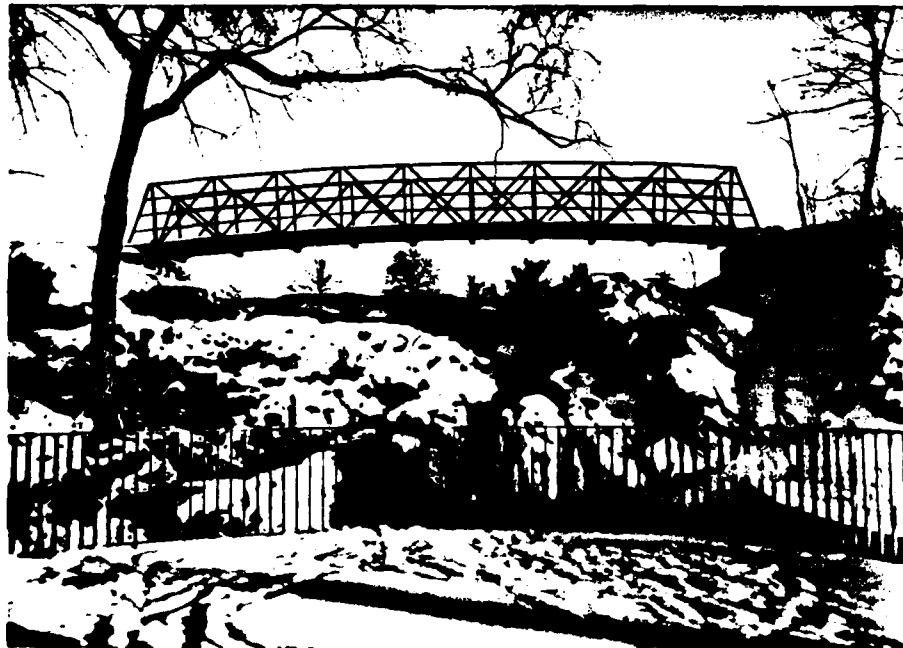
The spillway, which is an irregular natural rock formation, is in good condition with no signs of loose rock or unusual wear (See Photos 7 & 8). Extending over the spillway, the wood and steel footbridge was also in good condition. There was no evidence of any cracking or spalling of the concrete footing or abutments which can be seen in Photo 8. The wooden walkway and railings and the steel supporting substructure were well painted and appeared structurally sound.

Immediately downstream from the spillway, the rocky discharge channel was generally clean with a few trees overhanging the channel (See Photo 7).

Photo 7 - View of natural rock spillway and foot-bridge over spillway.

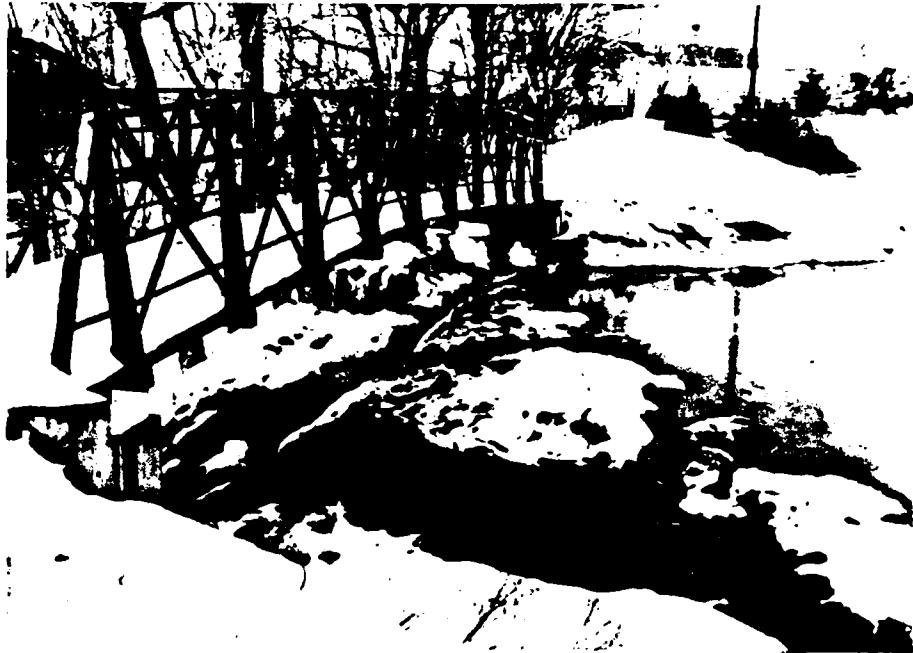
Photo 8 - Spillway Crest - Natural Rock

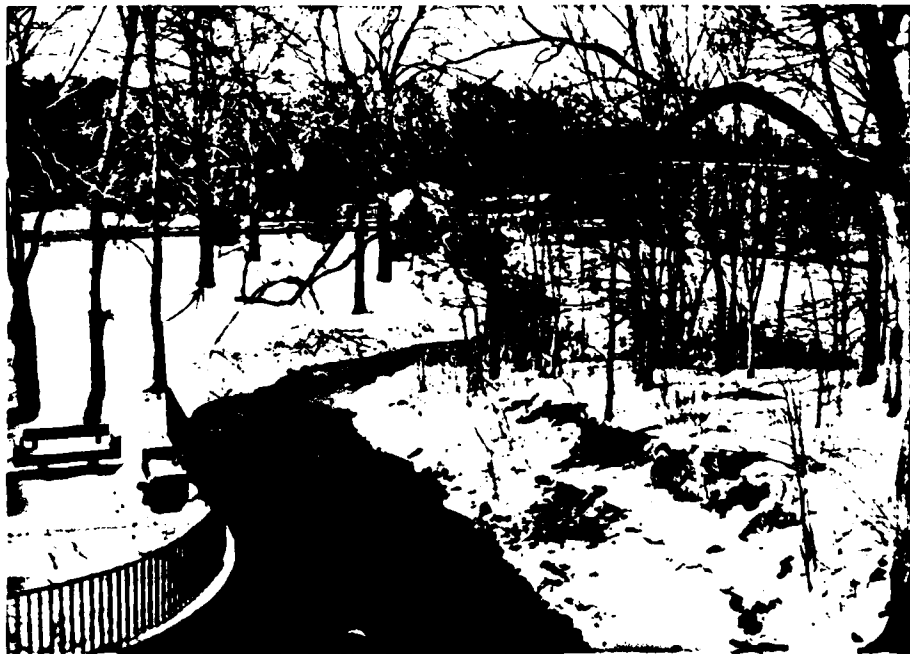
Consisting of a rocky bottom and grass lined slopes, the downstream channel (Mill Brook) is generally in good condition. As can be seen in Photo 9, moderate erosion was observed along the north bank of the channel immediately downstream from the spillway. Across the channel from the eroded area is the recently built concrete patio which is in good

condition as shown in Photos 7 and 9.

Photo 9 - Downstream Channel

1. Institute a formal program of maintenance procedures and fully document it to provide accurate records for future reference.
2. Remove trees and shrubs and their root systems in the vicinity of the rock filled depression.
3. Repair eroded area along the north slope of the downstream channel.
