THAMES RIVER BASIN
THOMPSON , CONNECTICUT

QUADDICK RESERVOIR DAM
CT 00184

PHASE I INSPECTION REPORT
NATIONAL DAM INSPECTION PROGRAM

FEBRUARY , 1979

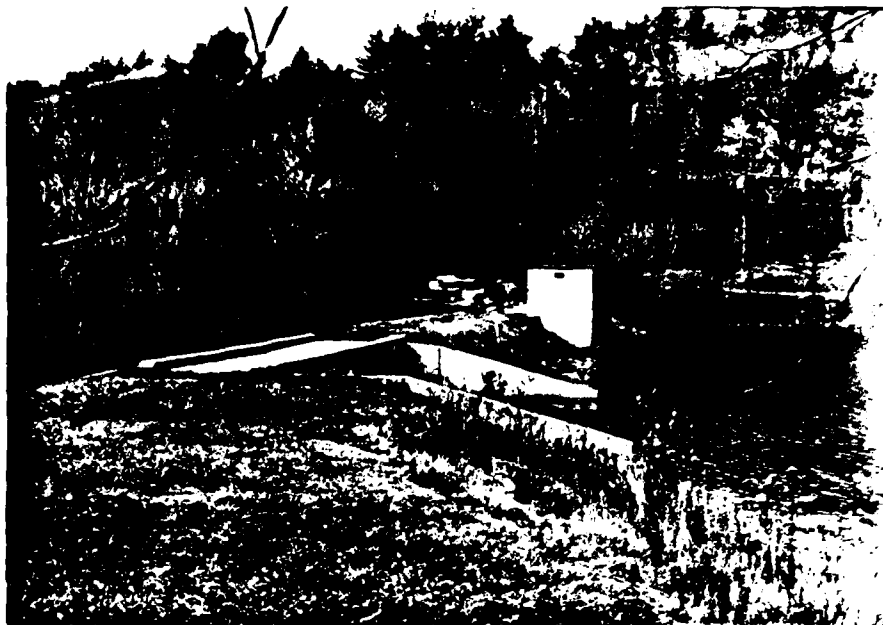
Overview of dam from left abutment

The right abutment (west) embankment was in good condition, with no leaks evident at the embankment itself or where it joins with the right spillway's masonry retaining wall. The crest of the dam was lower in this section and showed heavy vehicular wear. Riprap on the upstream face, particularly on the right embankment, was of rather small size, perhaps 1 cu. ft. on the average, and was somewhat randomly placed about 2 to 3 ft. below the crest. The crest itself was in good condition except as noted (see overview photos).

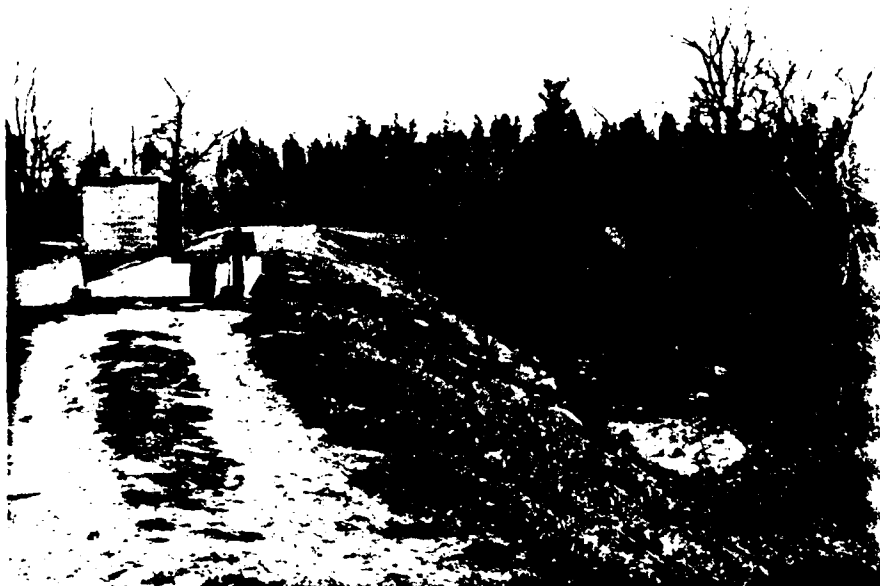
Overview of dam from right abutment

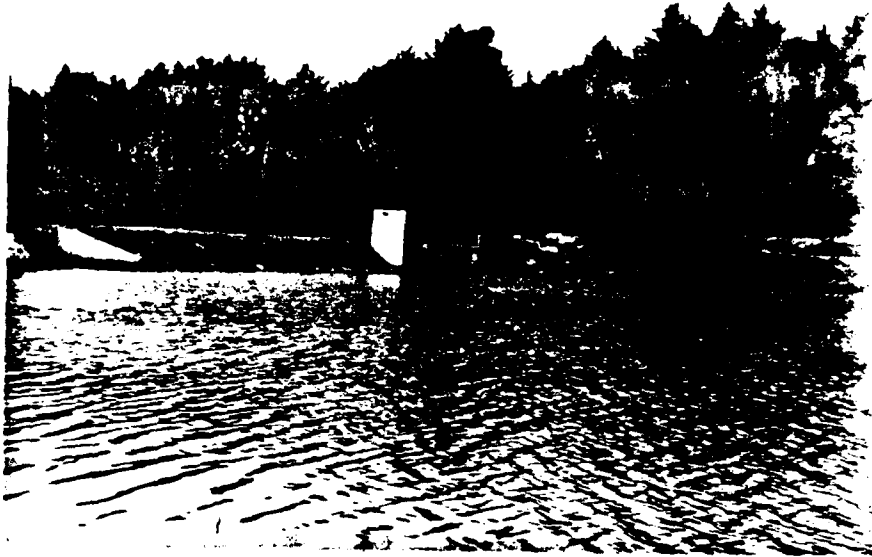
The west spillway is an old structure, built principally of ashlar masonry (Appendix C, Photo No. 3). There are later additions of concrete at the overflow weir and piers, stepped apron toe and spanning bridge (Appendix C, Photo No. 4). Stoplogs were not in place and about 3 in. of flow was being discharged through the spillway. This flow was cascading down the horizontal steps of the downstream apron, so that the condition of the floor could not be observed. The 1965 repair work to the apron involved anchoring the loose blocks in the lower part of the apron and covering the last step with reinforced concrete paving.

3. Gatehouse and right spillway from left abutment.

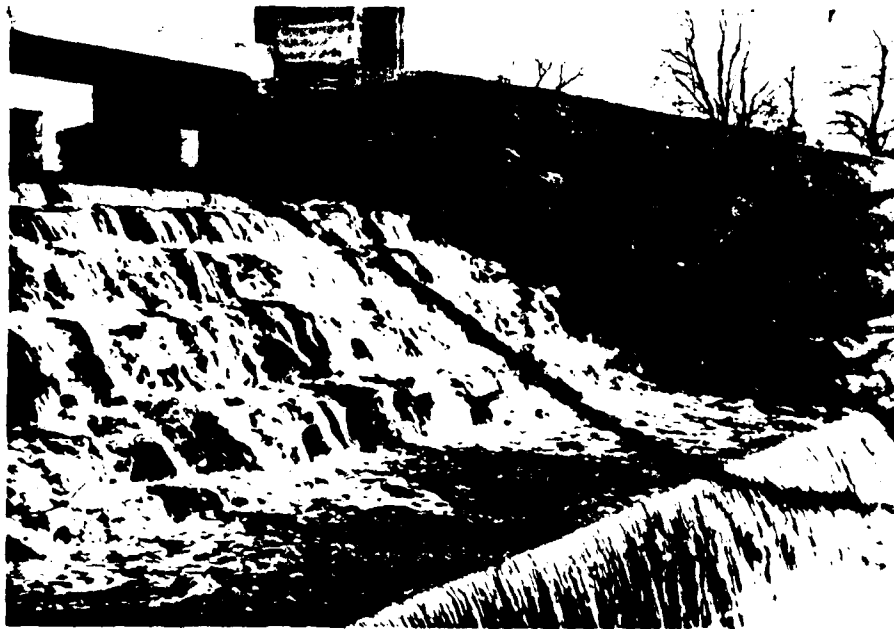
4. Downstream side of right spillway.

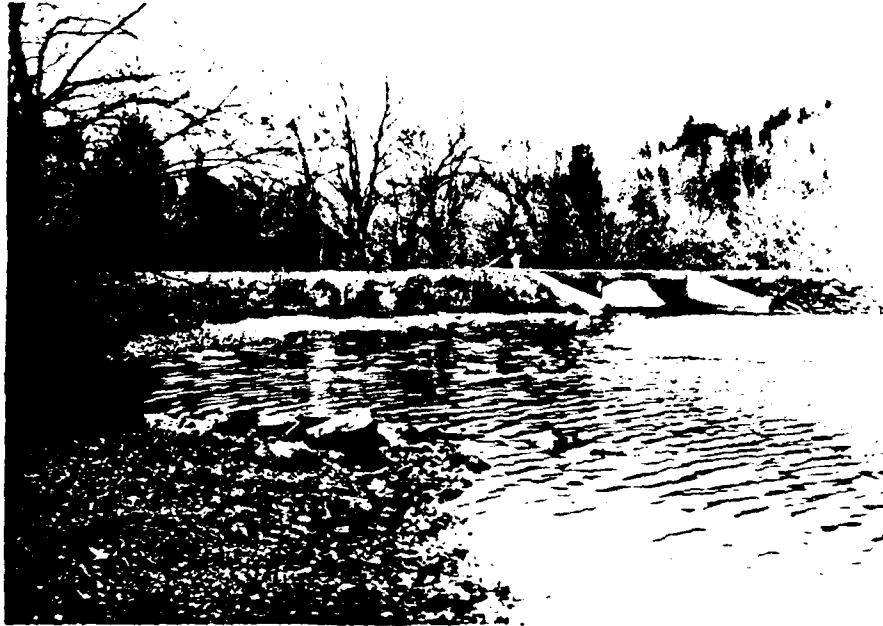
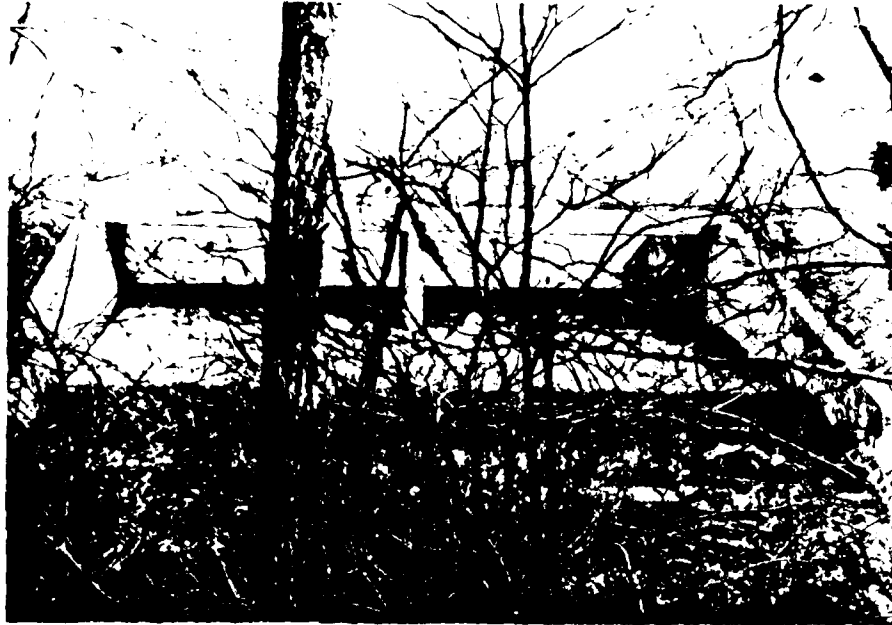
The east spillway was constructed in 1965; except for some cracking and spalling, it appeared to be in good condition (Appendix C, Photo Nos. 5 & 6). There was a large open crack, about $\frac{1}{2}$ in. wide at about the midpoint of the right inlet wall, undoubtedly owing to an unequal settlement of the wall footing. A large spall has occurred in the left downstream retaining wall, at the contraction joint about 14 ft. downstream from the crest. This spall was apparently the result of unequal deflections of the two adjacent wall panels, or because of binding owing to improper alignment of the joints during construction. Some spalling was also noted at the horizontal joint in the lower step, between the horizontal floor slab and the end wall below the slab.

5. Left spillway from left abutment.

6. Left spillway from downstream channel.

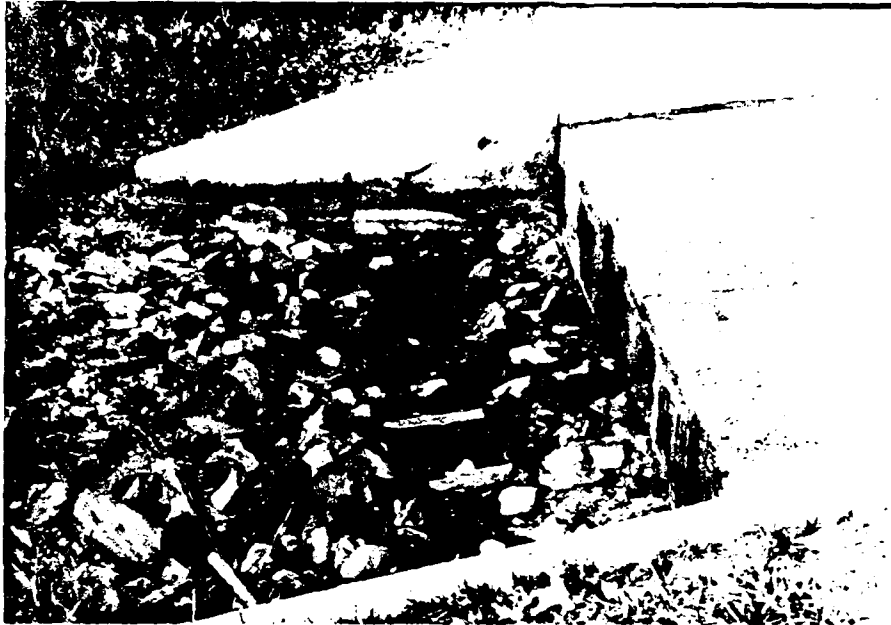
Riprap was specified on the design drawings downstream from the vertical step, to be placed to a level near the top of the step. Such riprap as was evident has washed down to about 3 ft. below the step (Appendix C, Photo No. 7). This condition was noted in the March 2, 1970, inspection report by John J. Mozzochi & Assoc. with the suggestion that the riprap be replaced. It is not known whether this suggestion was carried out or whether the riprap has since become eroded again.

7. Displaced, undersized riprap in downstream channel of left spillway.

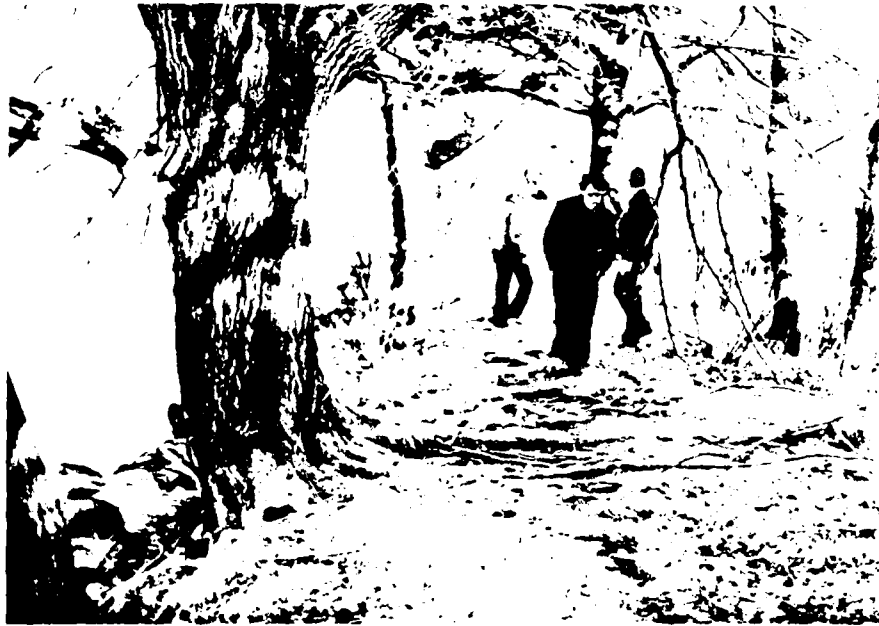
An earth dike closes off a low swale along the reservoir rim about 2,000 ft. east of the main dam. The dike spans a distance of about 190 ft., with its crest about 1.5 ft. lower than the main dam. The dike has a top width of about 10 ft., with approximately 2 to 1 side slopes. The area for about 150 ft. to each side of the dike is at about the same elevation as the top of the dike, and a number of homes are sited along this reach of the reservoir shoreline. The swale area below the dike appeared quite marshy, but it could not be ascertained how much of the swampiness was caused by seepage either through or under the dike (see Appendix C, Photo Nos. 9 & 10).

9. Upstream slope of dike

10. View along crest of dike
