NATIONAL PROGRAM FOR INSPECTION OF NON-FEDERAL DAMS
WHEATSTONE BROOK DAM (CT 00167) PHASE I INSPECTION
REPORT(U) CORPS OF ENGINEERS WALTHAM MA NEW ENGLAND DIV
JUN 80 F/8 13/13 ML

WHETSTONE BROOK DAM
CT-00167

INSPECTION REPORT

WHETSTONE BROOK DAM - CT 00167

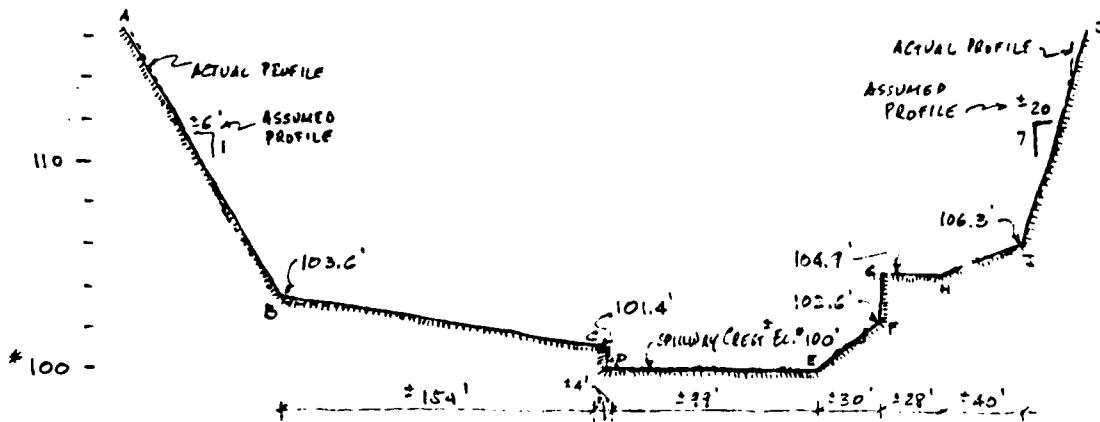
WHETSTONE BROOK DAM
APPROXIMATE OVERFLOW PROFILE

SPILLWAY (2) 99' LONG, BROAD-CRESTED (2) 6' BROADTH) WITH ROUGH AND UNEVEN CREST FORMED BY A COARSE CONCRETE CAP DUMPED OVER TO REPAIR THE ORIGINAL STONE MASONRY. THIS COARSE CONCRETE ALSO CAPS THE SLOPING SECTION TO THE RIGHT OF THE DAM (SEE PROFILE - PCT. CF) WHICH IS ALSO ASSUMED AN EXTENSION OF THE SPILLWAY.

THE OVERFLOW SECTION EXTENDS ON HOSTLY CLEAR TERRAIN INCLUDING ROADS (PAVED (RIGHT); DIRT (LEFT)) AT BOTH SIDES OF THE DAM; ASSUME $C=2.8$ FOR THE FLOW OVER THE ENTIRE SECTION (SEE PROFILE BELOW).

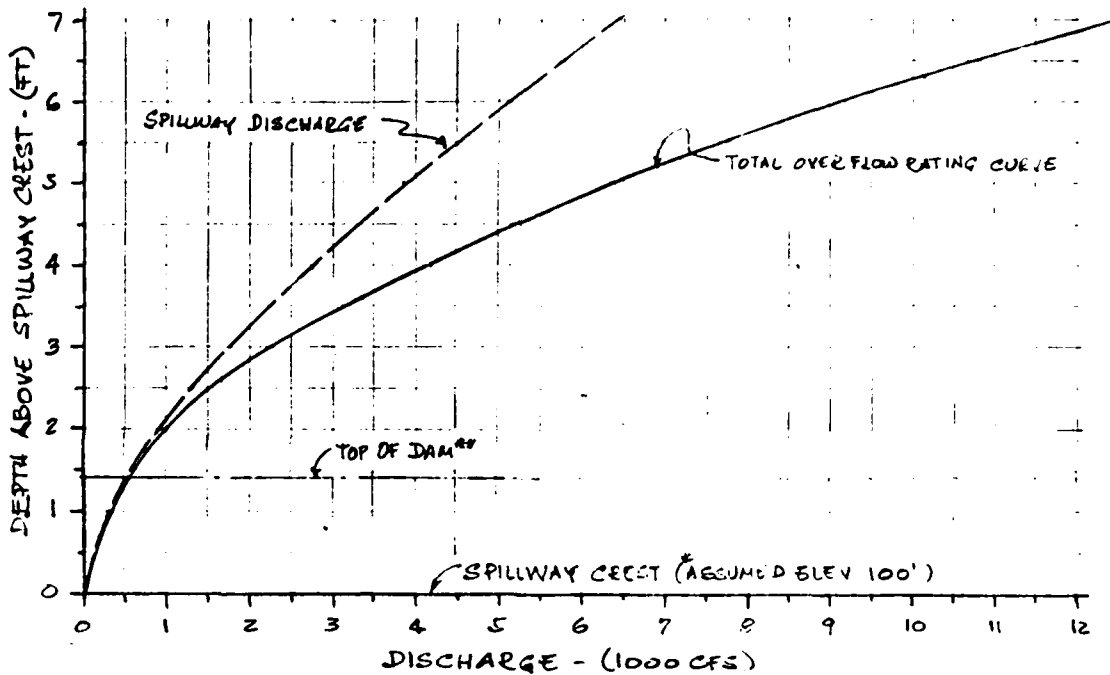
(ii) WETSTONE BROOK DAM - OUTFLOW RATING CURVE

** ASSUMED TOP OF DAM AT LOW OVERFLOW POINT TO THE LEFT OF THE SPILLWAY.
