LOWER CONNECTICUT RIVER BASIN  
BERLIN , CONNECTICUT

**KENMERE RESERVOIR DAM**  
**CT - 00251**

PHASE I INSPECTION REPORT  
NATIONAL DAM INSPECTION PROGRAM

FEBRUARY 1980

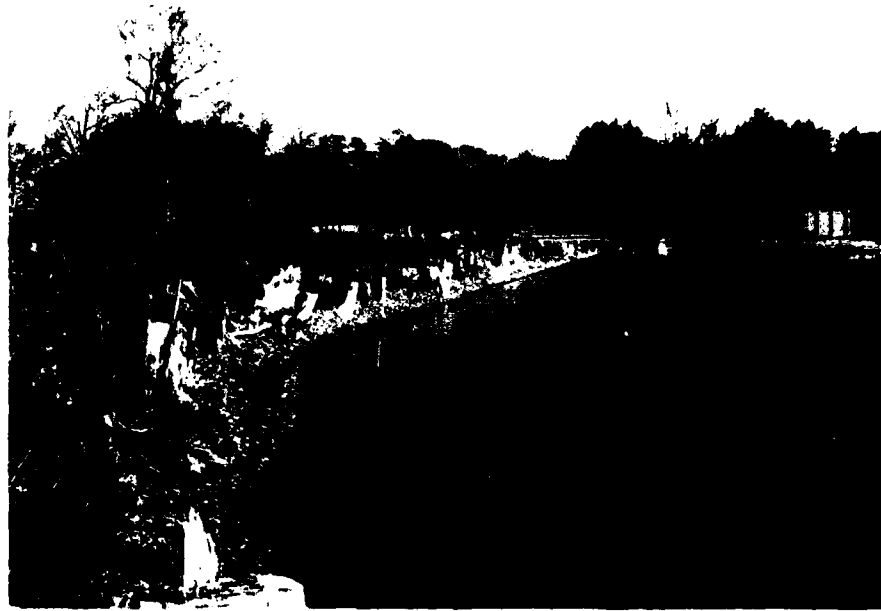
1) Upstream slope - The exposed part of the upstream slope of the main dam is partially covered with riprap. (Photo No. 1 and Photo No. 2) The riprap only extends approximately halfway up the slope from the reservoir surface and is missing or has been eroded away at many locations. Numerous tree stumps up to 3 ft. diameter were observed on the upstream slope. (as shown on Photo No. 3 and Photo No. 4)

PHOTO #3: Upstream face of dam from vicinity of spillway.

4) Design and oversee the repair of erosion on the upstream slope of the dam and the installation of required erosion protection measures.

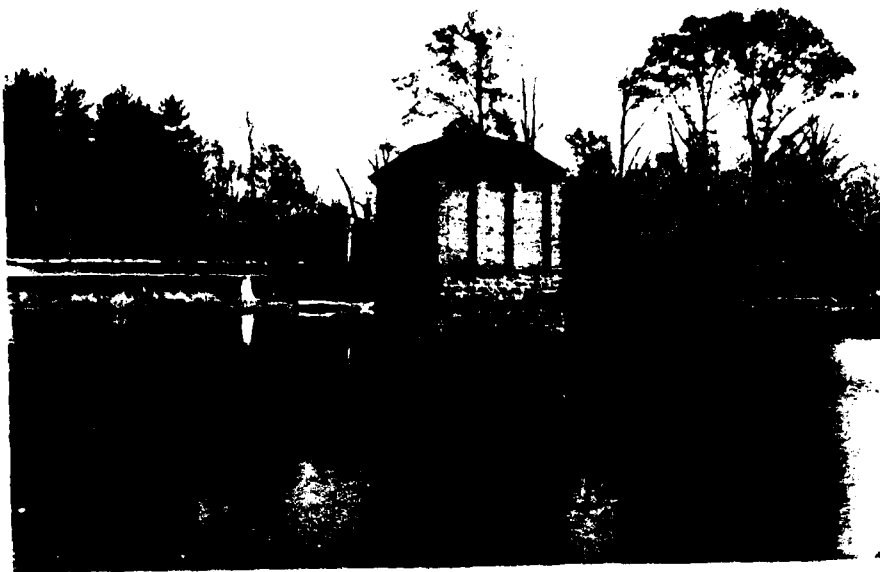
c. Appurtenant Structures. The freestanding control tower is in disrepair. The plywood floor is unsafe. Two valve stems without operator handles were observed extending to the floor.

f. Footbridge. The prestressed concrete T-beam that serves as the access bridge to the control tower is deteriorating and steel reinforcing bars are exposed. The bridge is in generally poor condition.

PHOTO #7: Gatehouse and service bridge.

5) Repair gatehouse and service bridge.

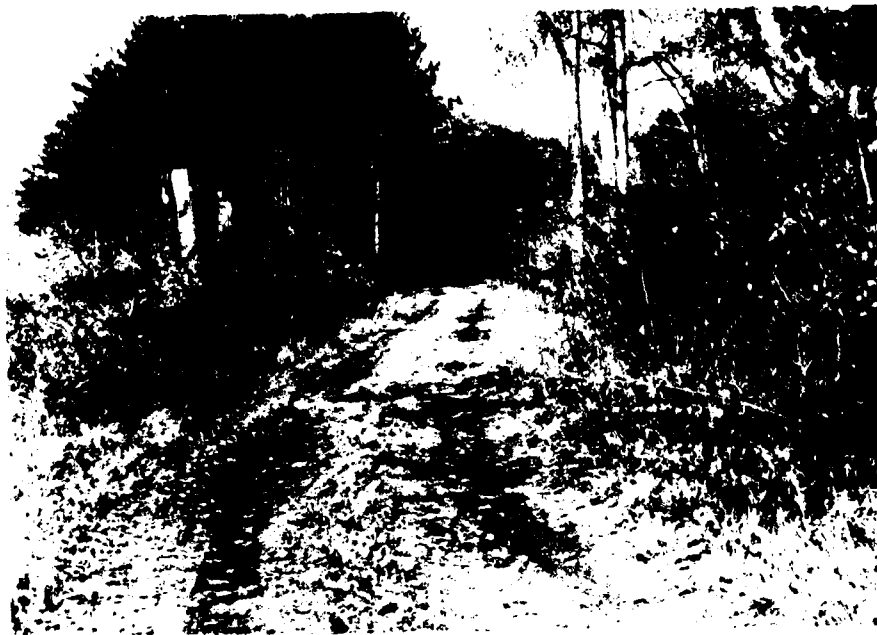
trees and stumps as shown in Photo No. 12. No riprap was observed on the upstream face. Photo No. 13 shows the unprotected earth face and a typical large tree stump that was noted. An access road traverses the crest of the dike as seen in Photo No. 14.

PHOTO #14: Crest of dike from right (east) side.

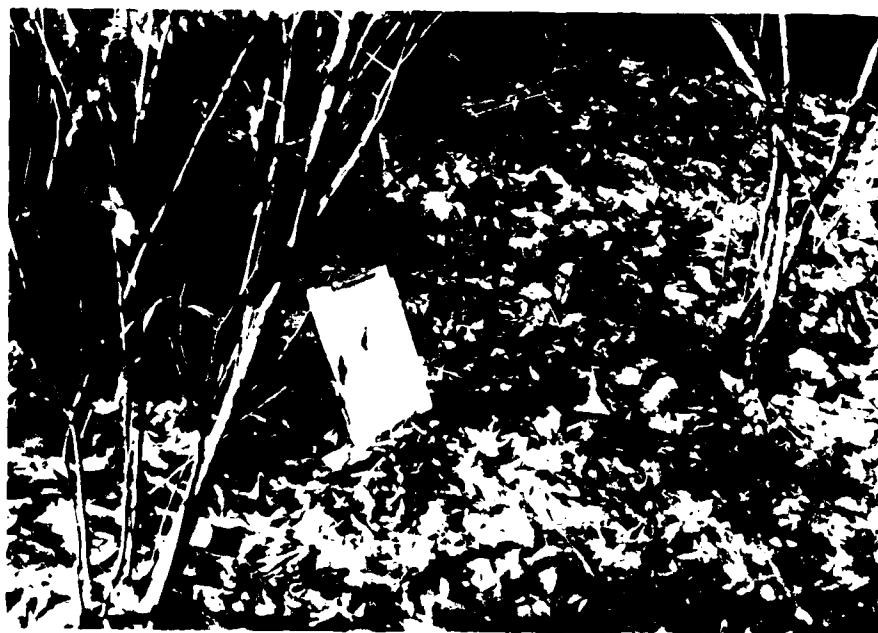
PHOTO #16: Toe of slope at Sta. D5+0. Standing and flowing water.
