LOWER CONNECTICUT RIVER BASIN  
BERLIN , CONNECTICUT

**KENSINGTON DAM  
CT 00250**

PHASE I INSPECTION REPORT  
NATIONAL DAM INSPECTION PROGRAM

FEBRUARY 1979

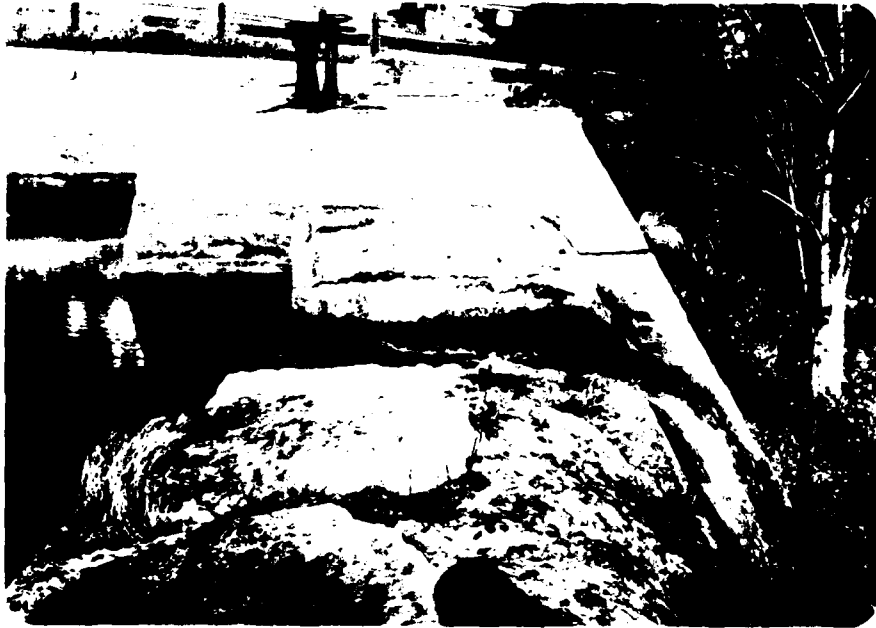
The spillway (Photo 1) is in poor condition having been partially removed by jackhammering for a distance of approximately 16 feet to a maximum depth of 3 feet. The crest of the spillway for the remainder of its length is intact although an attempt was made to remove it by jackhammering downstream of the crest. The attempt was abandoned while this portion of the spillway crest was still intact.

The inlet gate structure is located immediately to the left of the spillway on the upstream side of the dam. The hand-crank pedestal lift which operates the right gate is operable and feeds the low level outlet, shown in Photo 2. The hand wheel lift to the left gate is cracked and presently inoperable. Photo 1 shows the cast iron gate operating mechanisms.

A concrete retaining wall extends from the left abutment of the dam westerly along the shoreline of the lake and adjacent to the roadway above it. The concrete wall is cracked and spalled near the top as shown partially in Photo 1, as well as near the water line adjacent to the dam. The cracking at the water line is in both the horizontal and vertical direction, and appears to be up to 0.5+ feet deep. It is possible that contact seepage emerging on the downstream face of the dam could be due, at least in part, to infiltration through the observed cracking, and through any unseen cracking below the water level.

Of the two existing hand operated gates, only the right gate feeding the 42 inch cast iron low level outlet is operable. ( See Photo 1.) The gate is opened a maximum of one foot during major storms or when the water level rises to the original elevation of the spillway. Usually the gate is opened only two or three times a year, as the lack of trash racks causes concern that a log or other debris could block up the gate and prevent it from being closed.

PHOTO NO.1 - Spillway cutaway, gate valves, and upstream concrete retaining wall.

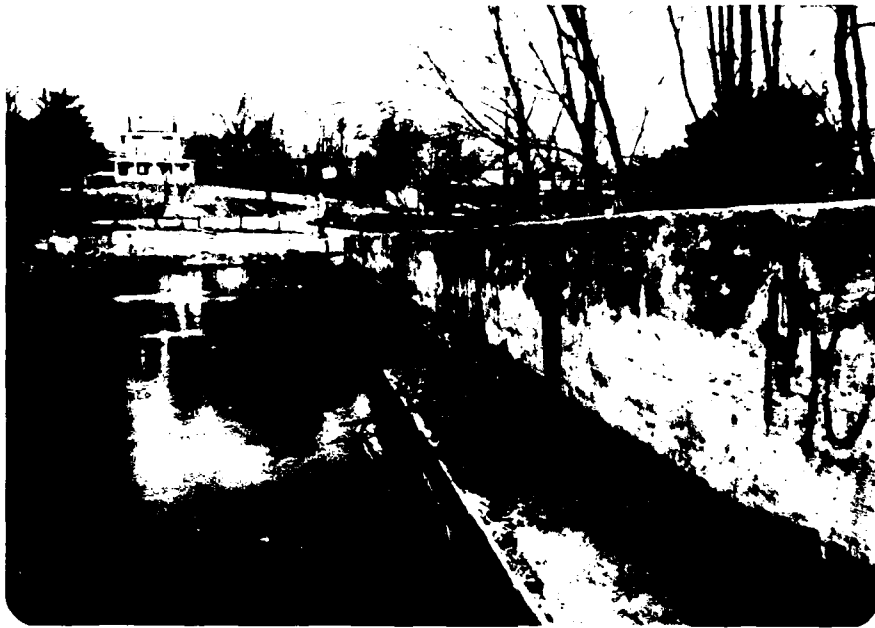
The upstream face of the dam also exhibits cracks, the worst area being near the right and left abutments. Near the right abutment, a horizontal crack up to 0.4 feet in depth exposed the interior concrete of the dam. At the time of our field investigation, this crack was above the water line. Any cracking below the water line was not observable. Refer to Photos 7 and 8 for views of the upstream face from the right abutment. Cracking of the upstream face of the dam was also observed adjacent to the left abutment.

PHOTO NO.7 - Upstream face of right section of dam with horizontal cracking.

2. An engineer qualified in dam design and inspection should investigate the cracking of the dam and the left upstream retaining wall, and recommend methods of sealing the upstream cracks in the dam and retaining wall against seepage. The engineer should also develop a system of monitoring the seepage both through the dam and along the contact with the left dam abutment. The seepage should be monitored monthly (complete with photographic records) to ascertain the volume of flow, the degree of silt transport, especially along the contact with the left abutment, and the development of any new seepage. Turbidity of the water, appearance of new seeps, or substantial changes in flow not related to changes in the lake level should be considered as possible indications of an unsafe condition. Should any of these occur, the engineer should investigate the problem to determine any required actions.
