CONNECTICUT RIVER BASIN
BERLIN, CONNECTICUT

LOWER HART POND DAM CT 00247

PHASE I INSPECTION REPORT
NATIONAL DAM INSPECTION PROGRAM

FEBRUARY, 1981

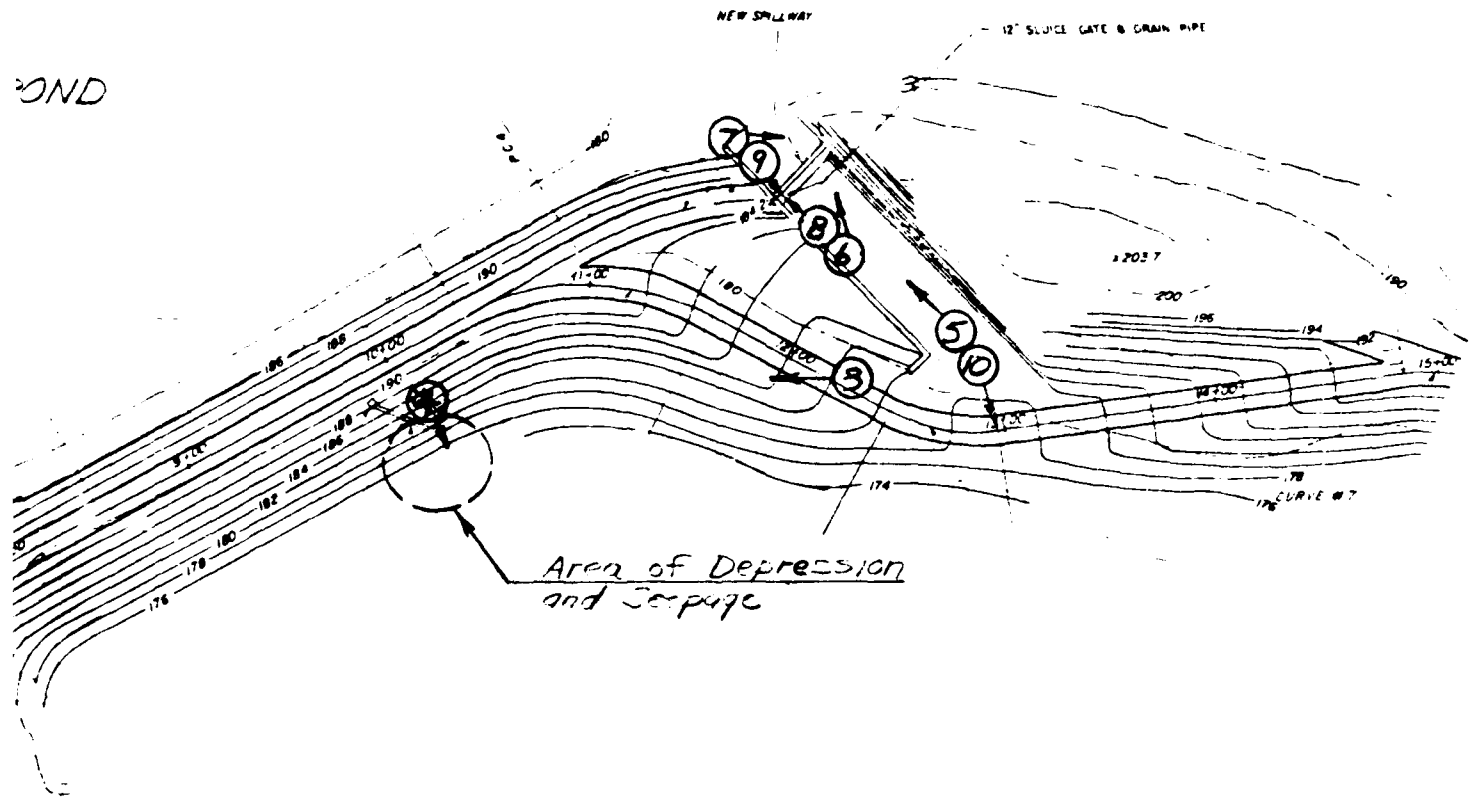
Plate 3

Area of Depression and Seepage

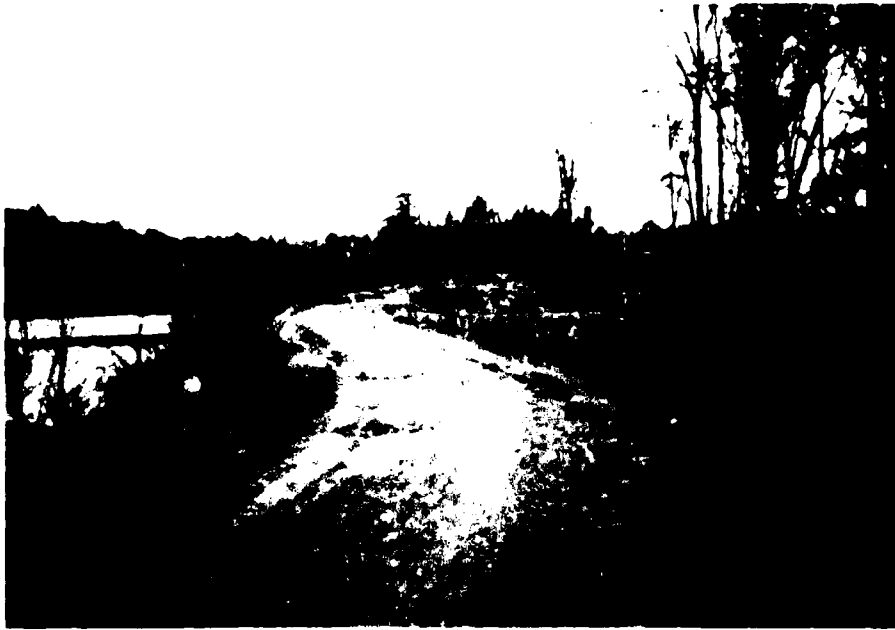
b. Dam - The dam is an earth embankment. The downstream face is well vegetated with grass and some brush (Photos 1 and 3) and the slopes are 2.5:1. Along the toe of the dam, there are trees and brush which obscured the view of the toe (Photos 1 and 3). The upstream face is in good condition with no signs of distress. Also, there are several areas on the upstream embankment where brush and small trees are growing (Photos 1 and 2). The riprap protection shows no signs of erosion or sloughing (Photo 2). Along the southern abutment of the spillway and on the upstream face of the dam, there is evidence of erosion from rain water running off the top of the dam. The top of the dam is level with no signs of settlement.

PHOTO 1
TOP OF DAM LOOKING NORTH

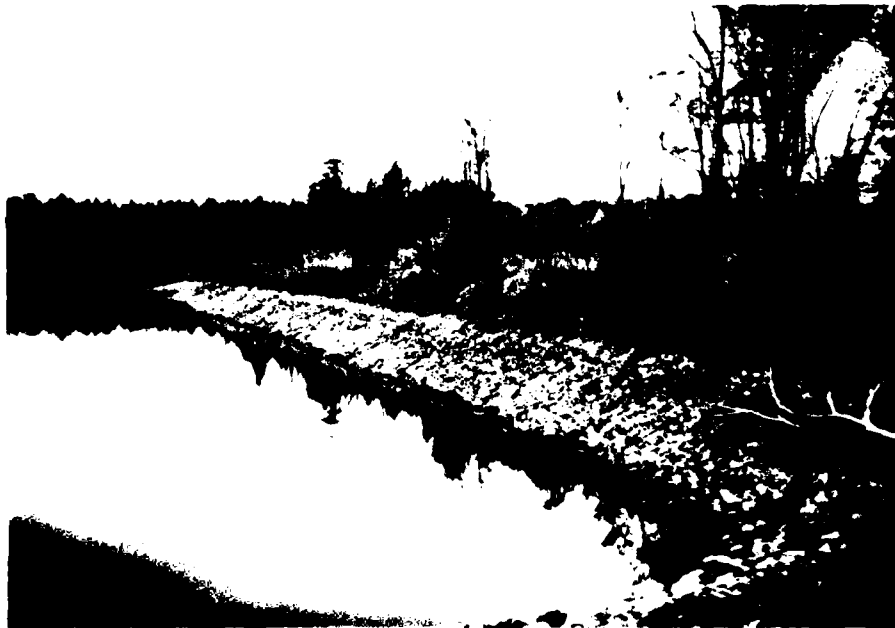
PHOTO 2
UPSTREAM FACE OF DAM
