HOCKANUM RIVER BASIN
VERNON, CONNECTICUT

SHENIPSIT LAKE DAM
CT. 00209

PHASE I INSPECTION REPORT
NATIONAL DAM INSPECTION PROGRAM

SEPTEMBER 1978

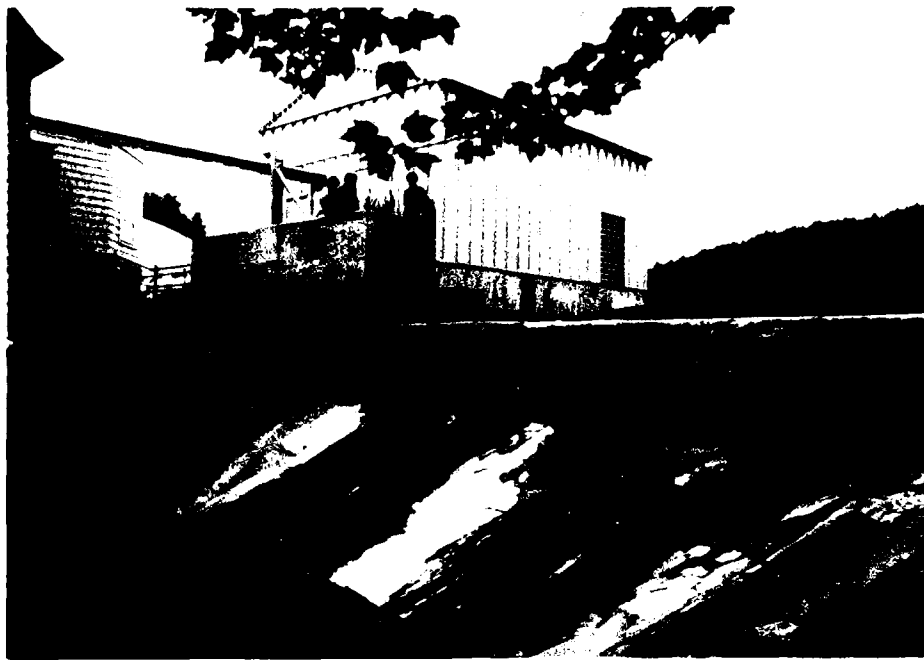
c. Appurtenant Structures - The upper gate house was reconditioned in 1968 in conjunction with the construction of the water treatment plant. Our inspection showed the structure to be in good condition except for water that was leaking into the intake well through the joints in the granite blocks. It appears that the chemical content of the

PHOTO 3
SPILLWAY - UPPER GATE HOUSE
