**CONNECTICUT COASTAL BASIN  
EAST LYME, CONNECTICUT**

**GORTON POND DAM  
CT. 00157**

**PHASE I INSPECTION REPORT  
NATIONAL DAM INSPECTION PROGRAM**

**JANUARY, 1981**

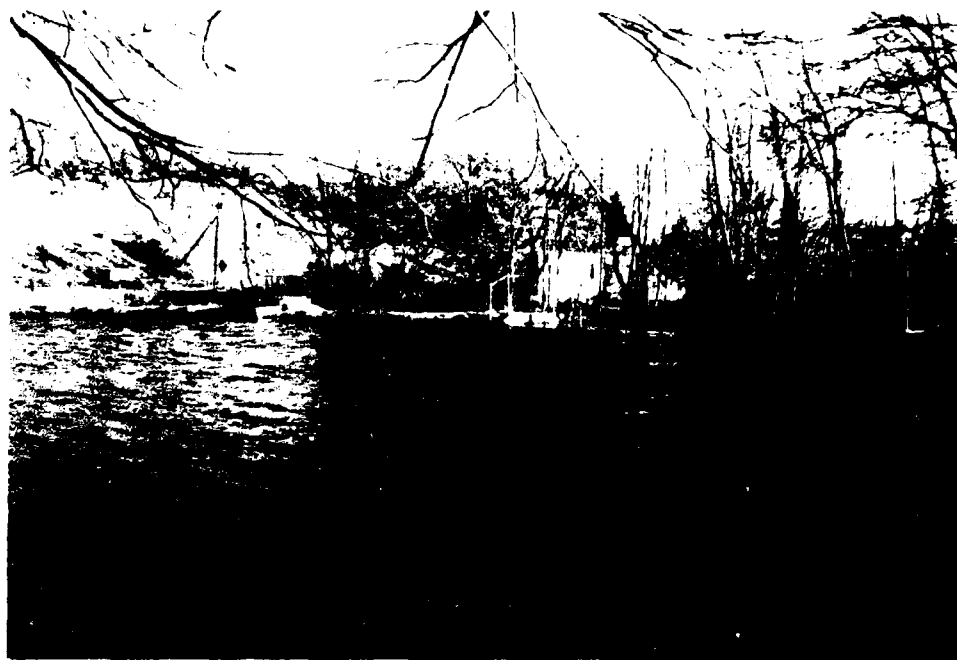
1. Upstream Face. The upstream face of the dam (Photo C-1) is riprap covered with a slope of 2:1. The riprap protection has brush growing through the rock. Some minor erosion has occurred. The right abutment area at the end of the spillway training wall has no riprap protection. The left abutment has incomplete riprap protection. However, there was no significant erosion observed at these locations.

PHOTO C-1: Upstream face of dam from right side.

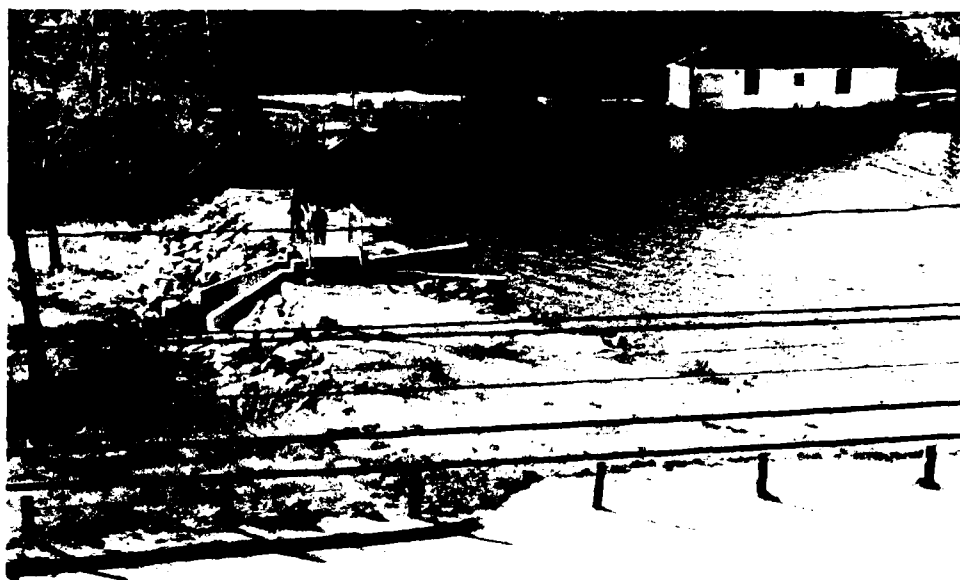
2. Crest. The crest of the dam (Photos C-3 and C-4) varies from 12 to 18 feet wide and is covered with a layer of riprap and then crushed stone filling the voids presenting a smooth crushed stone surface. There is some brush growing through this stone surface. At the contact between the crest and the left abutment (Photo C-4), riprap protection appears inadequate to prevent erosion during overtopping of the embankment.

PHOTO C-3: Embankment, outlet structure and spillway from left side.

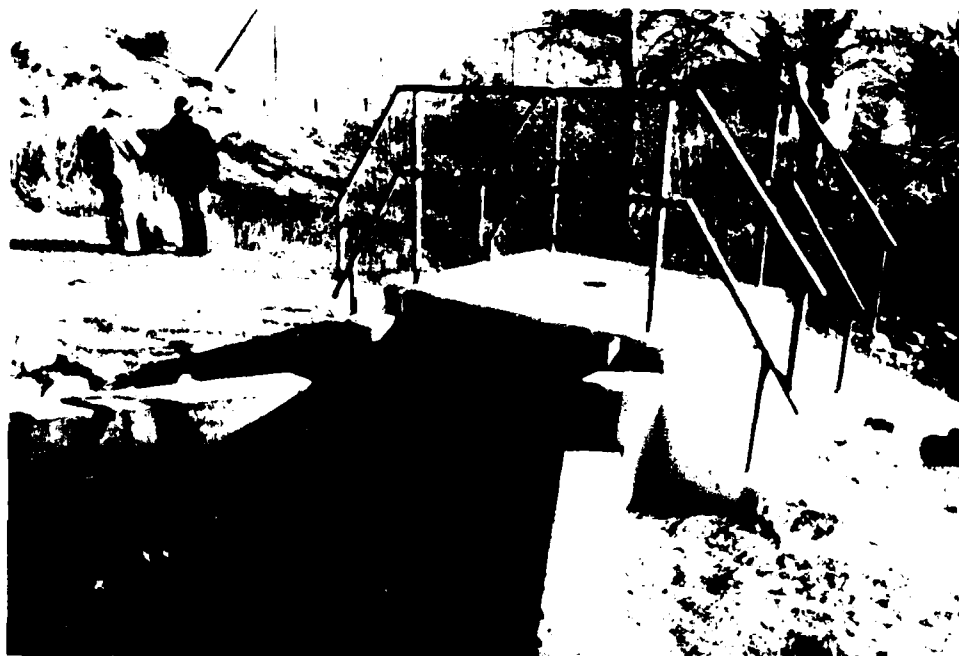
2. Outlet Works. A concrete drawdown structure is located near the center of the embankment (Photos C-7 and C-8). The outlet is controlled with a 36 inch square sluice gate, operated from above. At the time of inspection the gate was closed and minor seepage at less than 1 gpm was observed to emerge from the bottom of the gate. Concrete on the upstream and downstream sides of the structure appeared to be in good condition. Both sides of the structure have stop log slots but no boards. The upstream and downstream training walls contained small hairline cracks in the construction joints.

PHOTO C-7: Outlet structure from upstream.

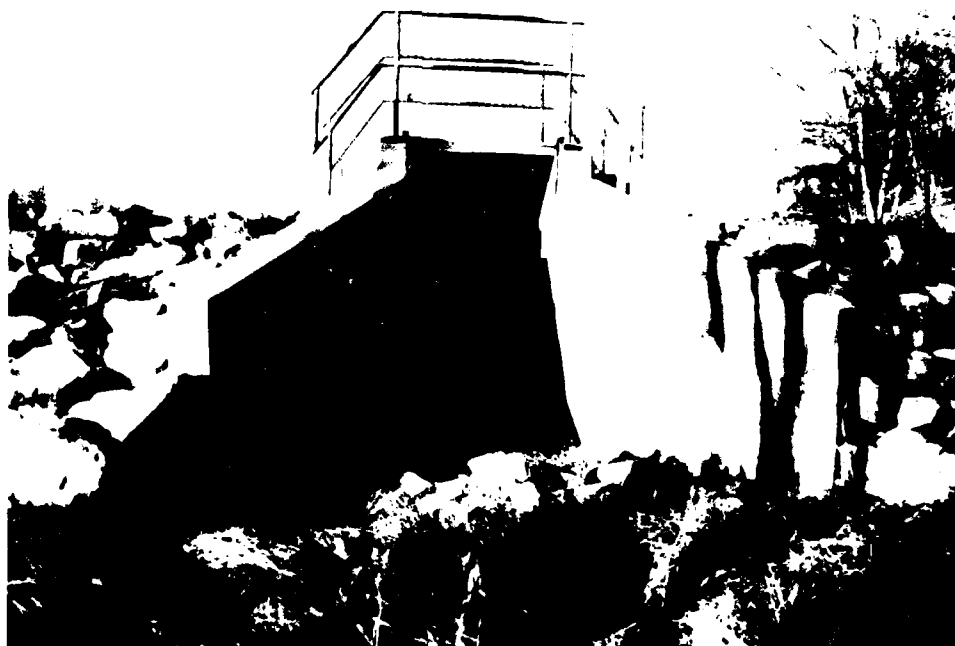
PHOTO C-8: Outlet structure from downstream.
