**SHETUCKET RIVER BASIN
NORWICH, CONNECTICUT**

SPAULDING POND BROOK

**PHASE 1 INSPECTION REPORT
NATIONAL DAM INSPECTION PROGRAM**

JUNE 1981

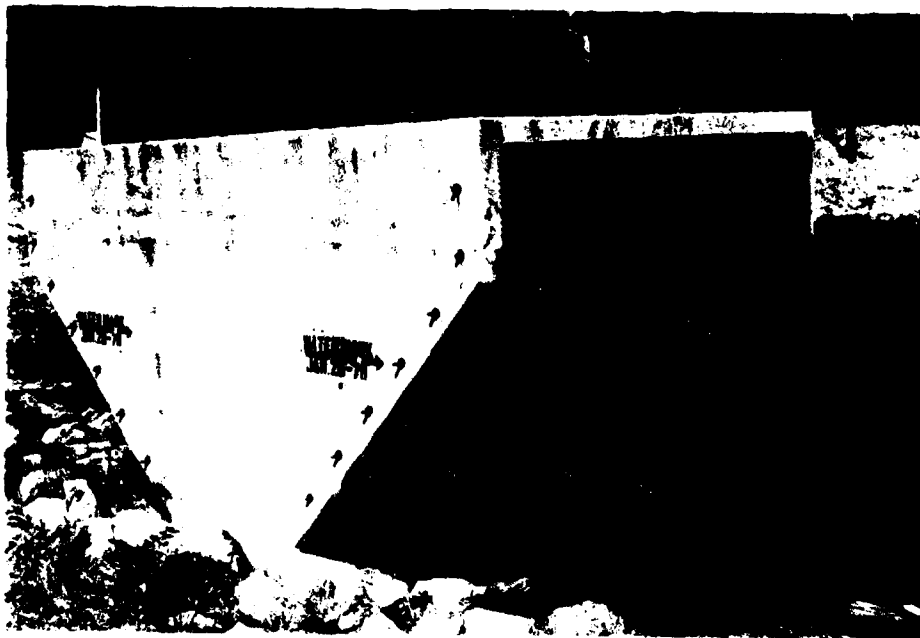
1. Drop Inlet Spillway: The concrete structure and the trash racks are in good condition (Photo 4). There is a gate controlling a low-level inlet on the upstream face of the concrete structure (Photo 4). At the time of inspection, the gate was partially open. The outlet pipe discharges into a riprap-lined channel (Photo 7). There is some brush growing in the channel which may present some obstruction to the flow.

Photo 4. Drop inlet primary spillway structure. Note grate for pipe inlet on upstream side.
