BRANDEGEE LAKE DAM  
CT. 00153

PHASE I INSPECTION REPORT  
NATIONAL DAM INSPECTION PROGRAM

JUNE 1981

IDENTIFICATION NO: CT 00153  
NAME OF DAM: Brandegee Lake Dam  
COUNTY AND STATE: New London County,  
Connecticut  
STREAM: Great Swamp Brook  
DATE OF INSPECTION: 20 May 1981

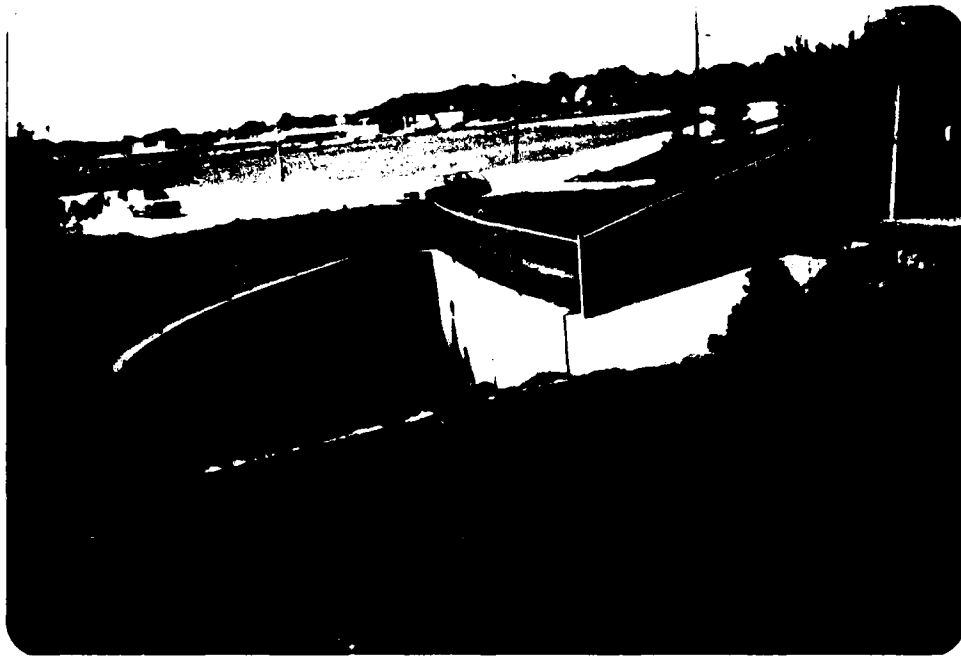
1. Spillway. The spillway is located 100 feet to the right of the left abutment and is 28 feet wide with a crest elevation of 129.5 NGVD (Photos C-7 and C-8). The spillway discharge channel was resurfaced in 1972 with concrete and a culvert was constructed which carries all discharges to Perry Pond located 1500 feet downstream (Photo C-7). The concrete paving of the channel has a misaligned construction joint approximately 20 feet downstream from the crest. The downstream slab at this joint is approximately 1/2 inch higher than the upstream slab (Photo C-8). This joint should be observed in the future to determine if movement is occurring.

PHOTO C-7. Spillway crest, discharge channel and culvert. Seepage through the left training wall is visible as a wet area just upstream from entrance to the culvert near the floor of the channel.

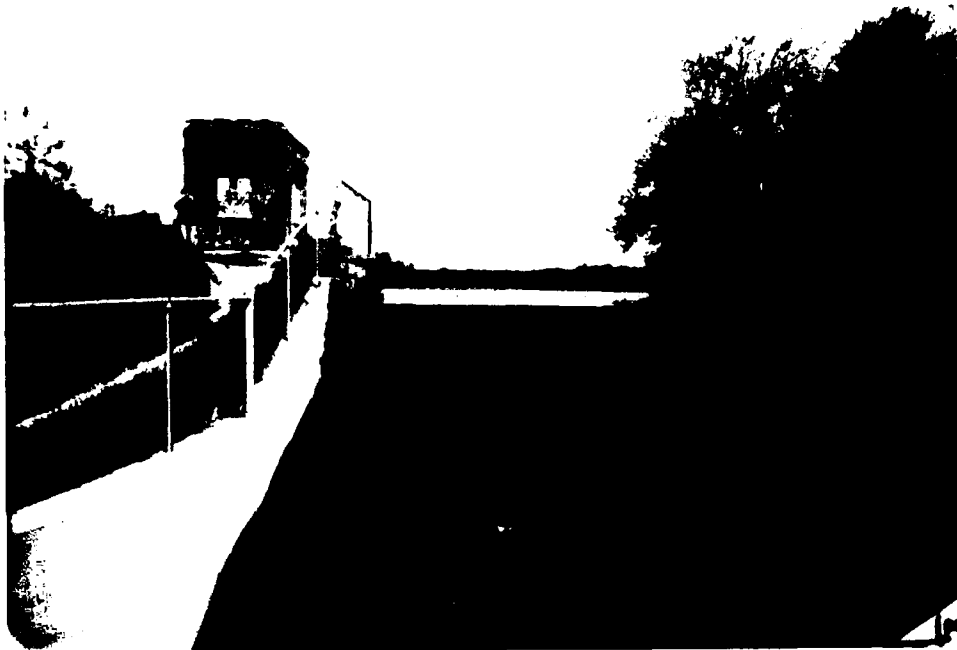
PHOTO C-8. Spillway and discharge channel from downstream. Note the vertical displacement of the construction joint in the floor of the channel.

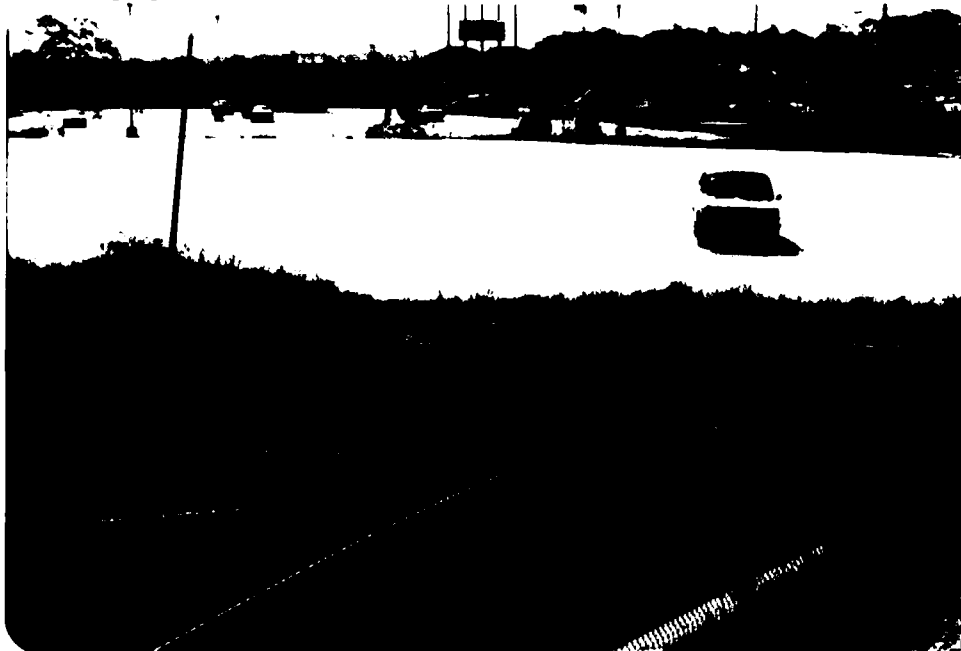
PHOTO C-10. Downstream area below dam with spillway discharge channel in the foreground. Note the two parking lots and Route 95 Fontage Road which are located in the dam failure impact area.
