**THAMES RIVER BASIN  
NORWICH, CONNECTICUT**

**FAIRVIEW RESERVOIR DAM  
CT 00205**

**PHASE 1 INSPECTION REPORT  
NATIONAL DAM INSPECTION PROGRAM**

**NOVEMBER 1978**

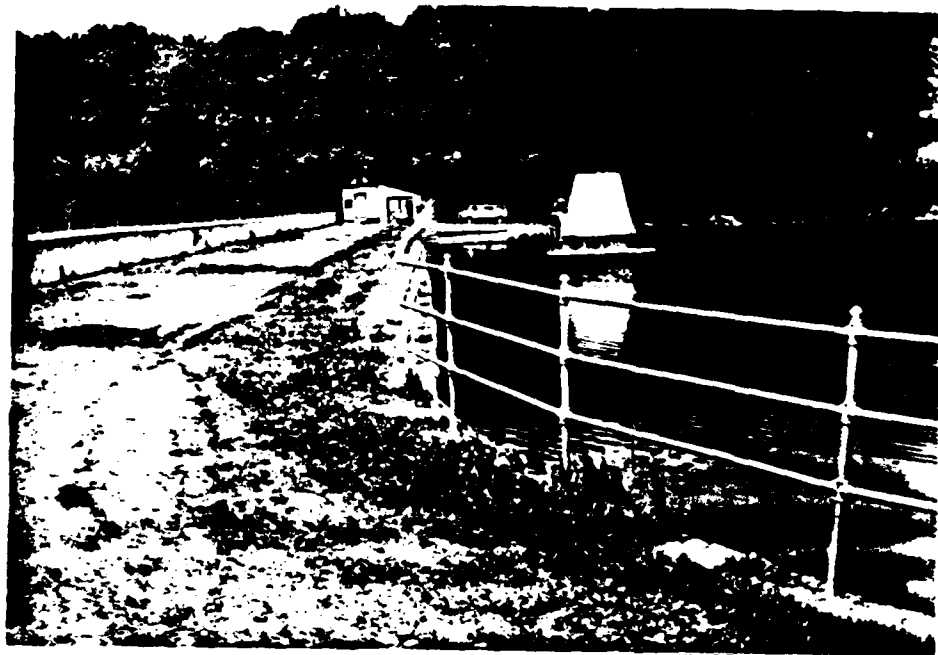
C-2 MAIN DAM-LOOKING FROM LEFT ABUTMENT ALONG  
UPSTREAM FACE.

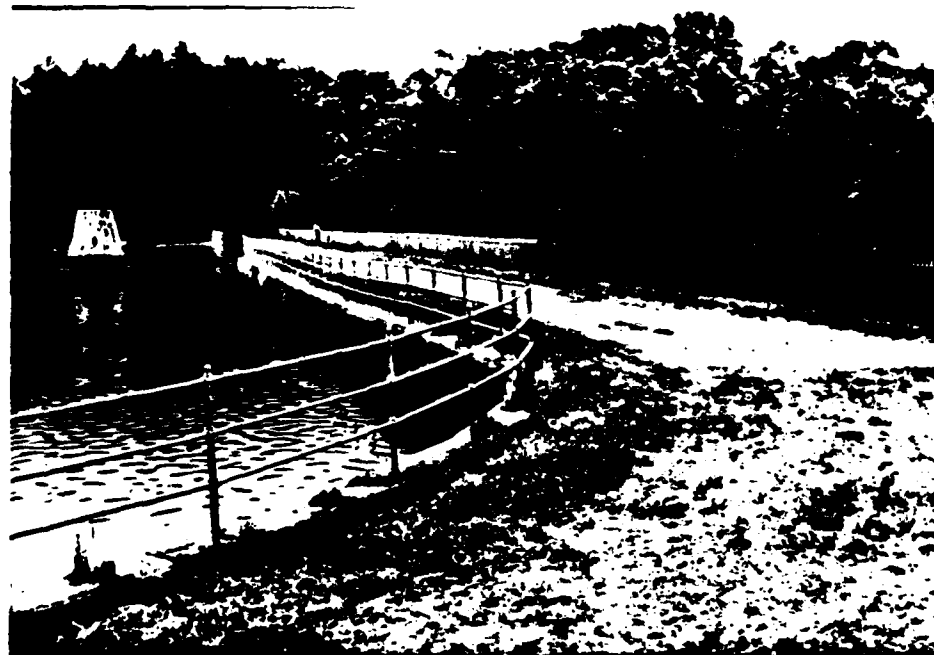
| AREA EVALUATED | CONDITION |
|---|---|
| Condition at Abutment and at Concrete Structures | Horizontal upstream curvature of top of stone wall at upstream face, near both ends of the dam |

C-3 MAIN DAM-LOOKING FROM RIGHT ABUTMENT ALONG  
UPSTREAM FACE. (NOTE: CURVATURE OF FACE AND RAILING.)
