QUINNIPIAC RIVER BASIN
MERIDEN, CONNECTICUT

BLACK POND DAM CT 00135

PHASE I INSPECTION REPORT NATIONAL DAM INSPECTION PROGRAM

FEBRUARY, 1981

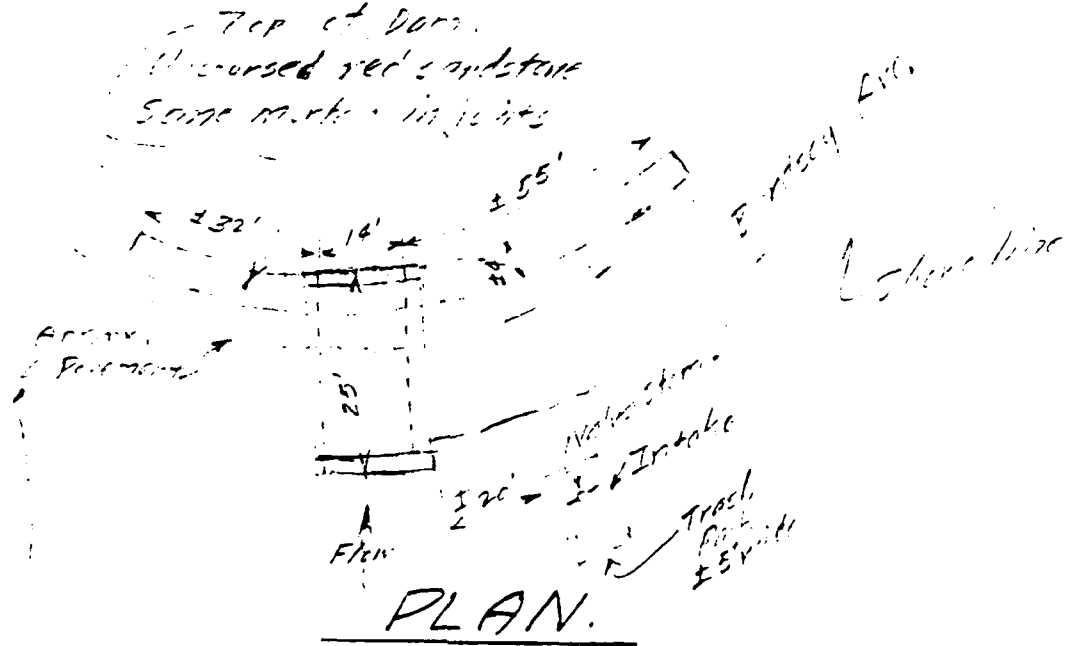
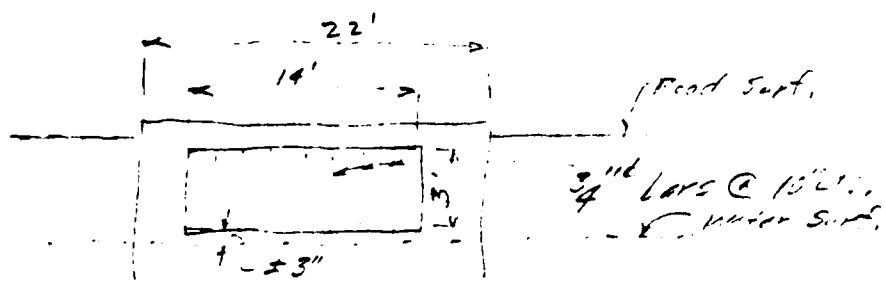
Upstream Elev. of Conc. Box Culvert
Under Birdsey Ave.

Leak thru dam are on west
side of spillway - at ground surface
and about 10'-12' below top of
dam.

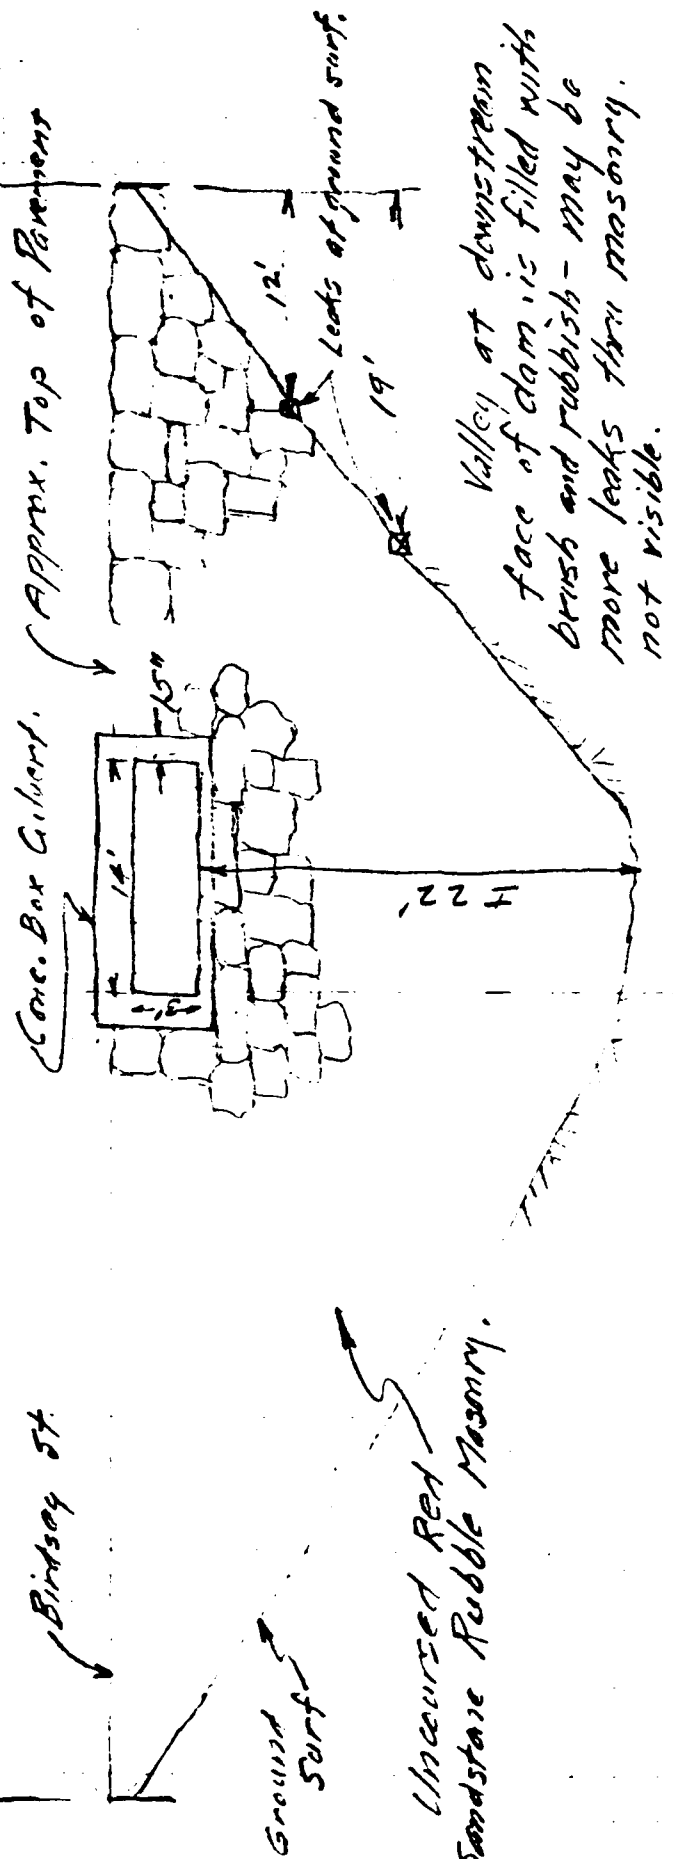
Downstream Elevation of Dam.

Valley at downstream face of dam is filled with brush and rubbish - may be more leaks thru masonry. not visible.

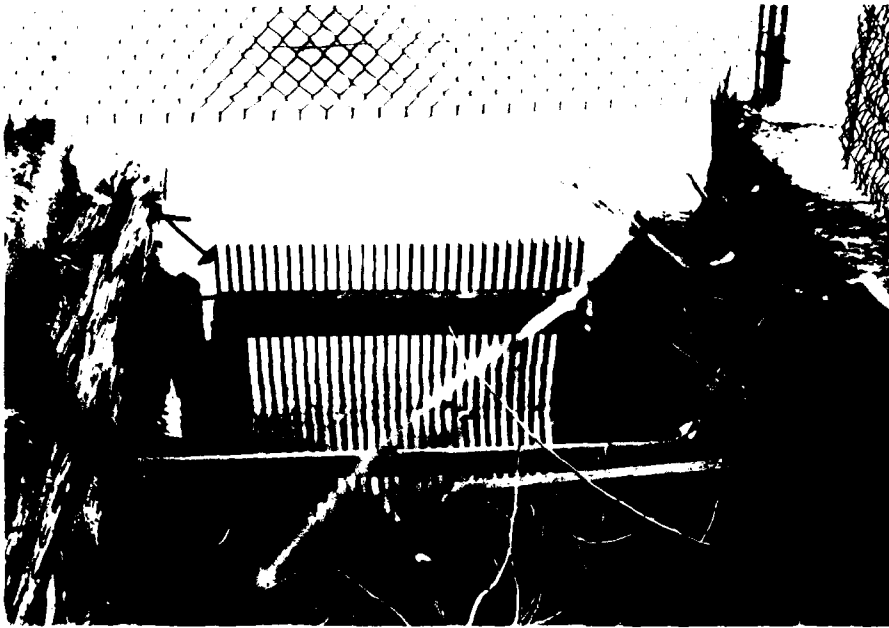
There is a mortared stone masonry gate inlet structure next to the spillway on the upstream side of the embankment (Photo 7). The structure is poorly fenced and can be entered. There is a bar rack at the inlet and a manually operated gate. The gate controls a 20-inch cast iron water main that is no longer used for water supply. A leak exists near the downstream face where the pipe passes through the dam. The pipe continues along the downstream channel and connects to the City's distribution system.

PHOTO 7
INLET STRUCTURE - WATER MAIN
