NATIONAL PROGRAM FOR INSPECTION OF NON-FEDERAL DAMS
FACTORY POND DAM (CT. (U) CORPS OF ENGINEERS WALTHAM MA
NEW ENGLAND DIV JUL 80

FACTORY POND DAM CT 00217

PHASE I INSPECTION REPORT NATIONAL DAM INSPECTION PROGRAM

JULY 1980

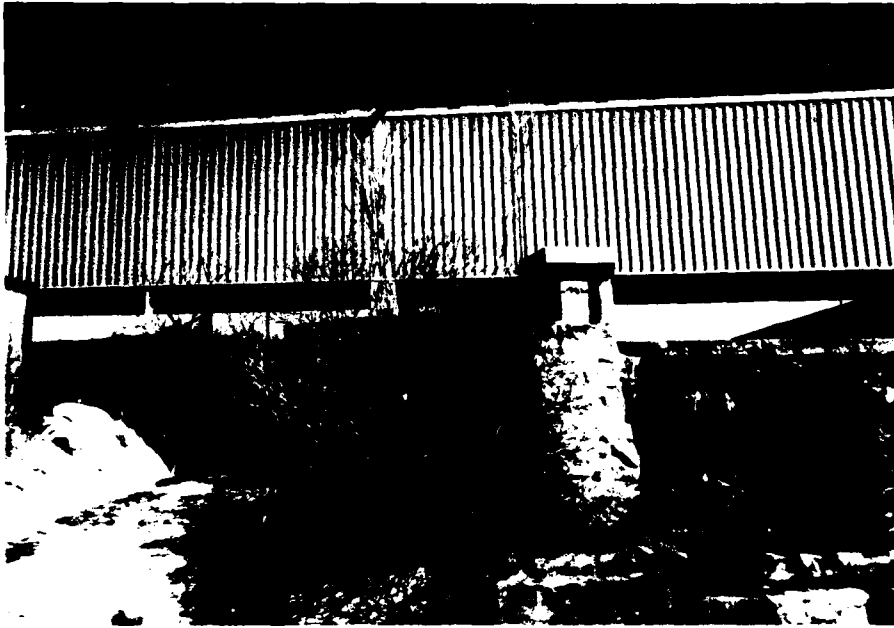
PHOTO 1
DOWNSTREAM FACE OF DAM

b. Dam - The dam is a combination of sheet piling/concrete fill and masonry. The sheet piling and concrete fill are in good condition (Photo 1). The sheet piling is painted with some areas that are rusting. The concrete cap is in good condition with no cracking (Photo 3). There is no evidence of settlement or lateral movement. There are some areas along the toe where vegetation is growing (Photo 1). The masonry portion of the dam is fair with some joints in need of repointing (Photo 8).

The spillway is a fixed weir that appears to be in fair condition (Photos 2 and 5). The downstream training wall and western abutment (Photos 1 and 6) show some seepage and cracks.
