THAMES RIVER BASIN
COVENTRY-MANSFIELD, CONNECTICUT

EAGLEVILLE LAKE DAM
CT 00161

PHASE 1 INSPECTION REPORT
NATIONAL DAM INSPECTION PROGRAM

JUNE 1979

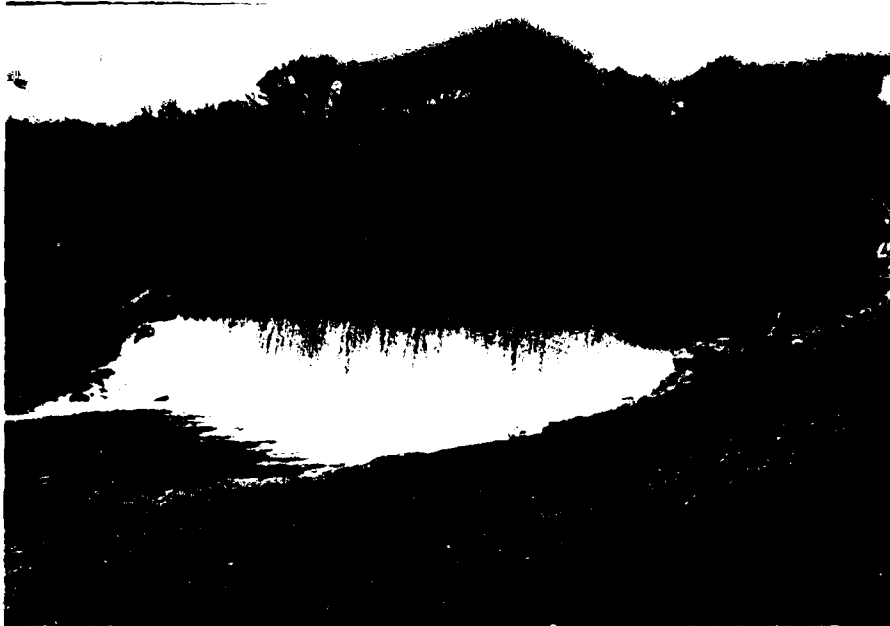
ing (foreground of Photo C-1). Grass cover is largely missing and the slope is rutted with numerous vehicular tracks up to 6 inches deep. An erosion gully about 2 feet wide was observed adjacent to the left spillway training wall, shown in Photo C-1 near the spillway and in C-11 downstream of the spillway. Several large bushes are growing in one area of the slope.

C-1 Spillway from left side of channel.

4. Repair erosion gullies and install cover material to prevent further erosion on dam embankment crest and downstream slope.
 5. Repair the concreted riprap at the right spillway abutment.

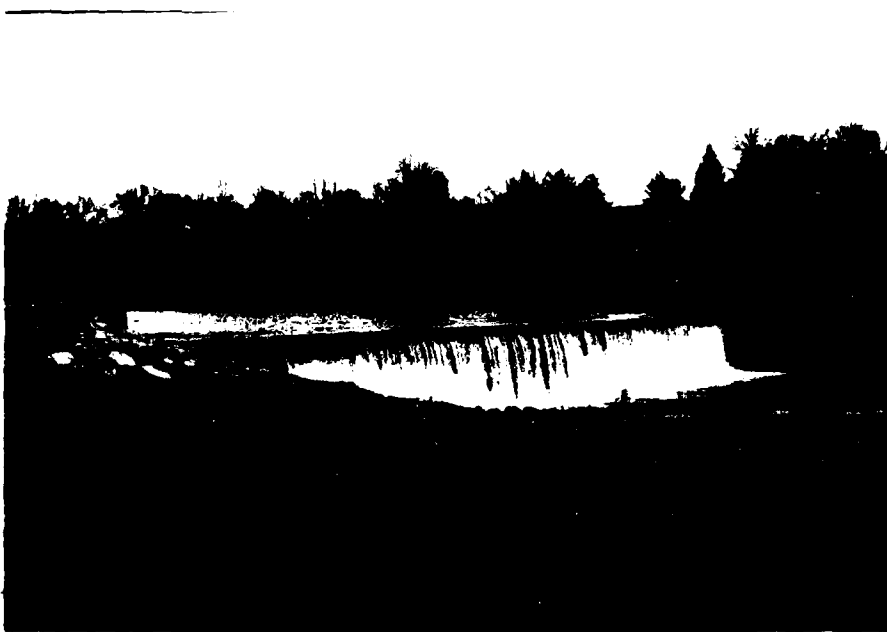
To the right of the spillway, the downstream slope is extremely gentle, grass covered and reasonably well-maintained, as shown in Photo C-2. The downstream end of the concreted-riprap apron at the right end of the spillway is cracked and broken, and erosion is occurring along the downstream edge of the apron, as shown in Photo C-10.

C-2 Spillway from right side of channel.

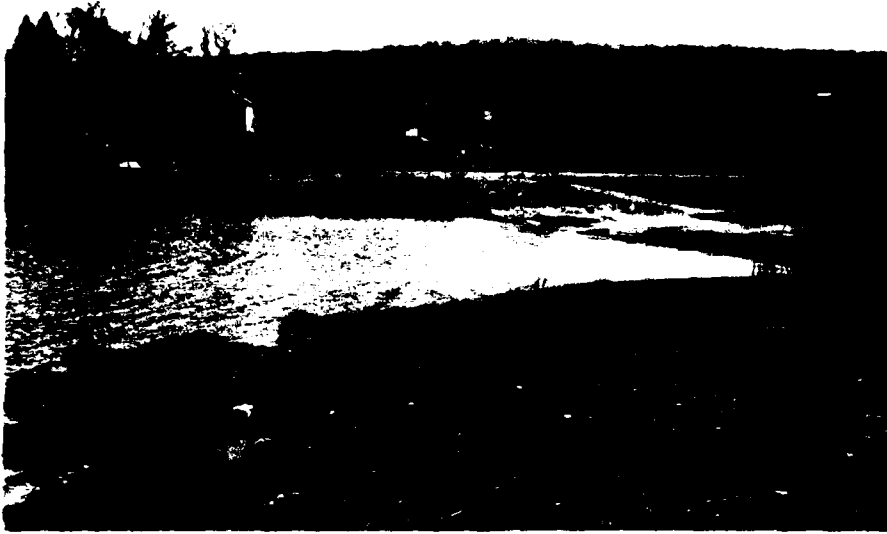
The upstream slope to the right of the spillway is generally gentle, as shown in Photo C-3. There is no riprap protection on the slope and some erosion has occurred. An erosion scarp near the spillway approach channel and an eroded area about 15 to 20 feet wide were observed near the right abutment. The slope in this vicinity is overgrown with brush and small trees.

3. Abandoned Mill Intake. This structure is shown in Photos C-9 and C-3 (background). This intake was of no further use when the mill facility ceased to exist. It was sealed with concrete panels as part of the repair work in 1970. The downstream end of this water course through the old mill is filled with earth.

C-3 Spillway, left training wall, outlet works, and abandoned intake to mill from right embankment.

1. Remove tree and brush growth on the upstream slopes.
 2. Provide riprap protection for the upstream slopes.
 3. Evaluate the causes of failure of the right embankment and take necessary corrective steps.

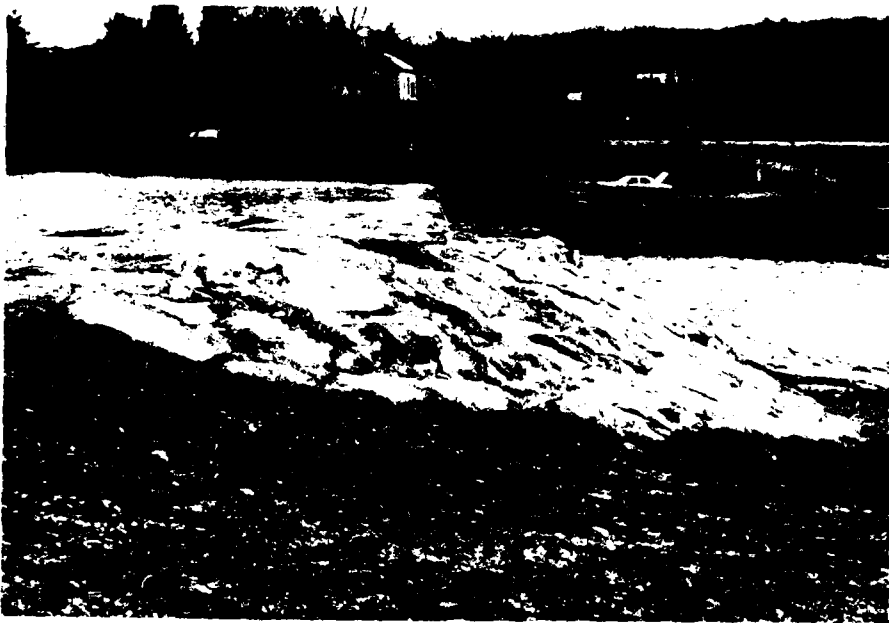
C-4 Left spillway abutment (background) and mortared riprap around right spillway abutment (foreground).

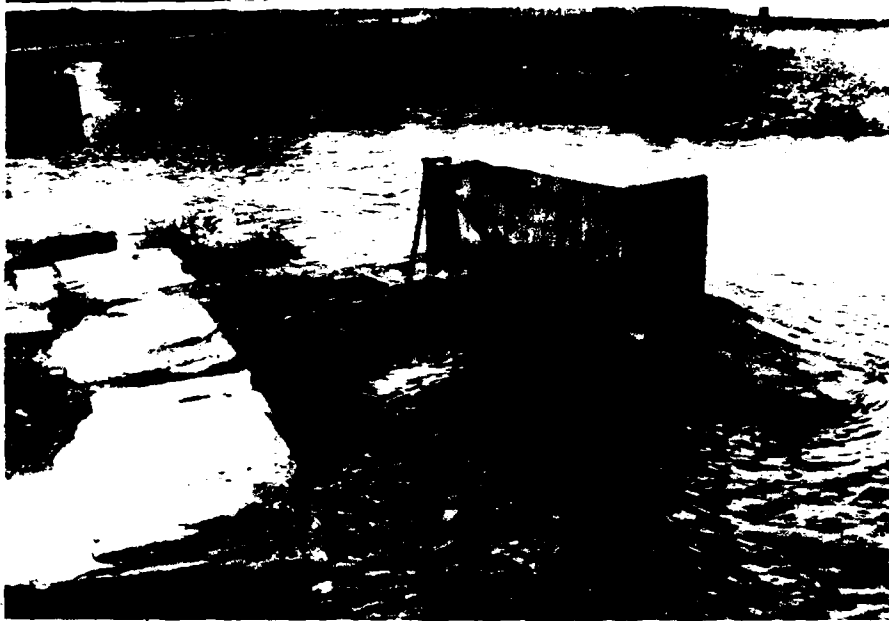
C-5 Outlet works from intake side.

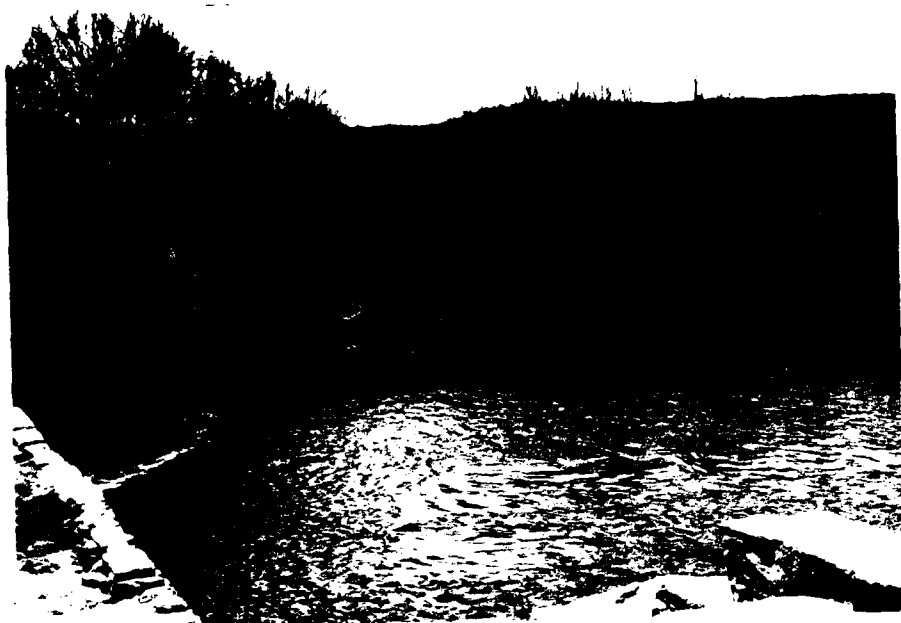
The left spillway training wall is a vertical stone masonry wall with mortared joints to a distance of about 50 feet upstream from the spillway crest. At this point the wall changes to unmortared stone masonry. Much of the pointing is missing from between the stones in the vertical masonry section, and a large stone is missing from the wall about 2 feet above the channel floor and 5 feet downstream from the spillway crest. There are trees growing in and overhanging the downstream spillway channel along the left training wall about 100 feet downstream from the spillway crest, as shown in the extreme left of Photo C-7.

C-7 Downstream Channel.

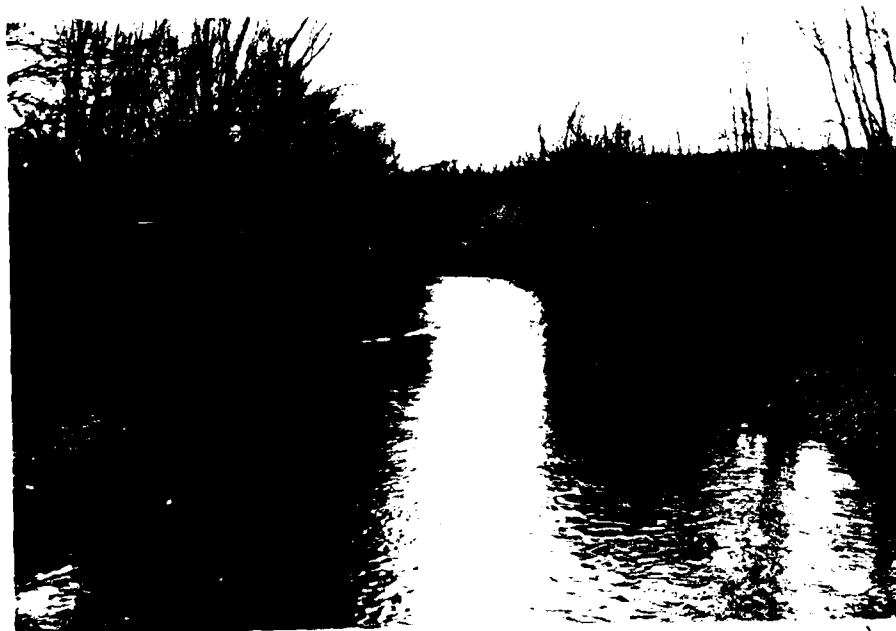
C-8 Downstream Channel below bridge.

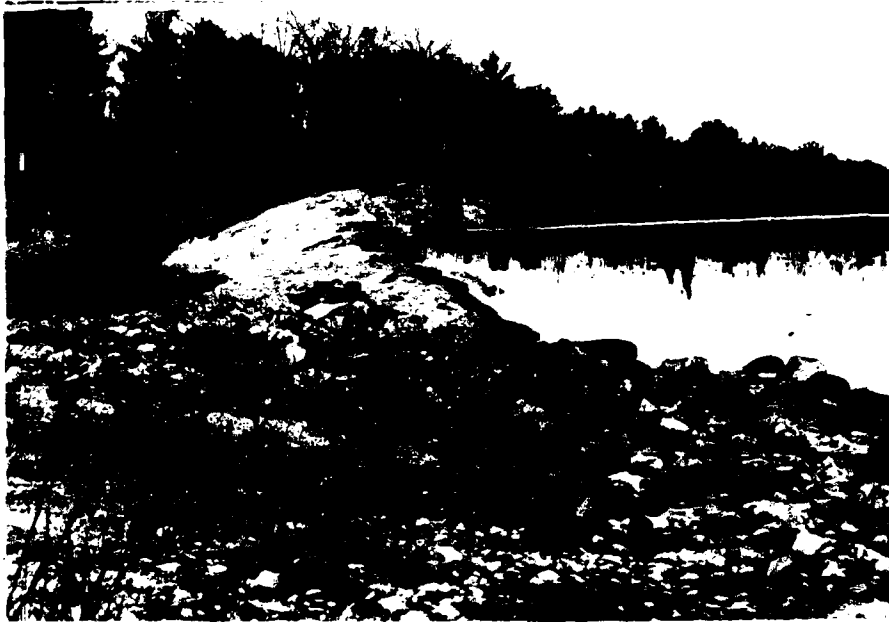
C-10 Right spillway abutment and embankment showing eroded masonry and seepage (in foreground).

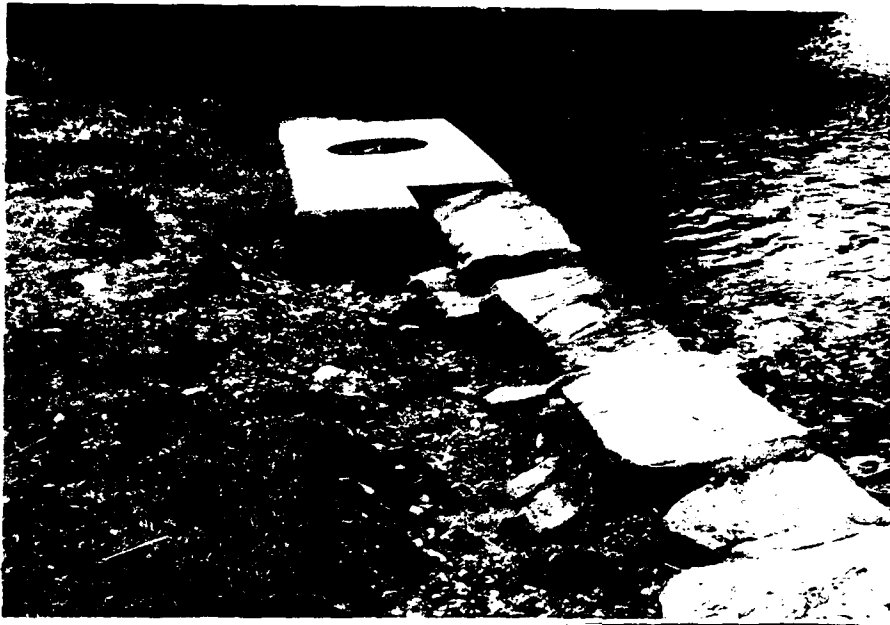
C-11 Erosion behind left training wall downstream of spillway, (manhole is sewer outfall).
