FARMINGTON RIVER BASIN  
HARWINTON, CONNECTICUT

**BRISTOL RESERVOIR NO.4 DAM  
CT 00364**

**PHASE I INSPECTION REPORT  
NATIONAL DAM INSPECTION PROGRAM**

JUNE 1981

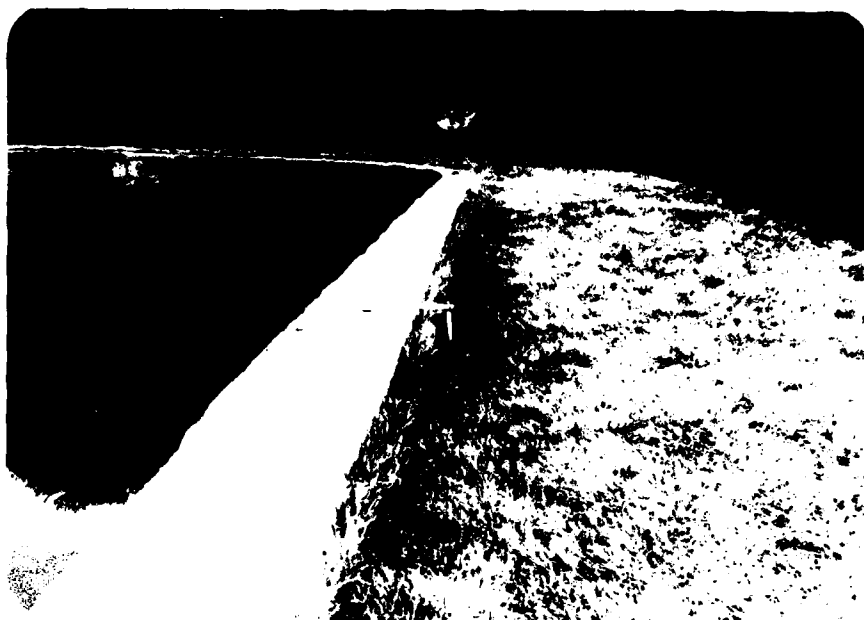
PHOTO NO. 3

UPSTREAM CONCRETE WALL AND CREST.  
NOTE POSSIBLE SETTLEMENT OF EMBANKMENT  
AND GRASS COVER ON CREST.
