FARMINGTON RIVER BASIN  
HARWINTON, CONNECTICUT

BRISTOL RESERVOIR NO.5 DAM  
CT 00366

PHASE I INSPECTION REPORT  
NATIONAL DAM INSPECTION PROGRAM

JULY 1980

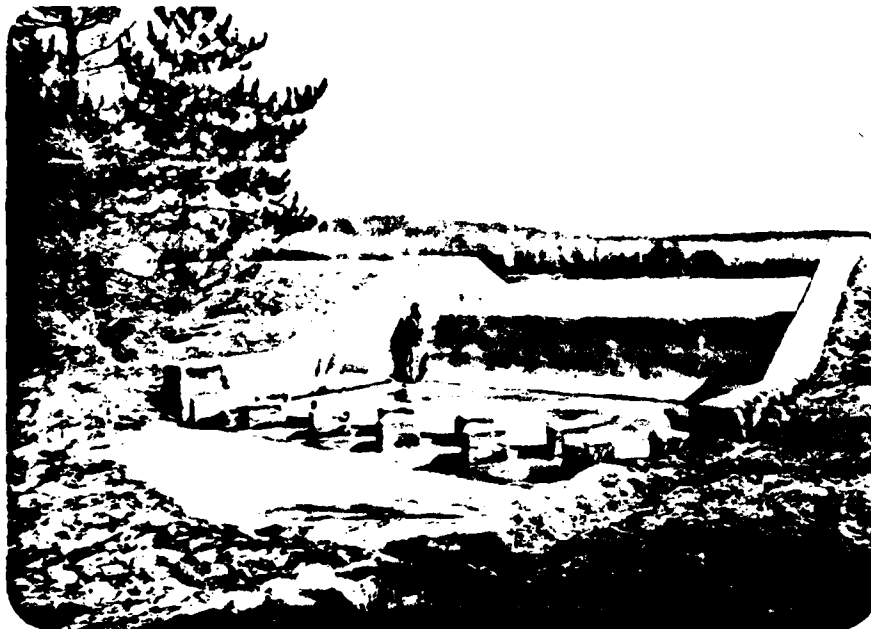
PHOTO NO. 10\*

The concrete overflow spillway appeared to be in good condition. The surface was recently gunited. Some seepage through the overflow section was observed along a crack in the gunite near the right end of the spillway, Photo 10. The training walls are generally in good condition. There are concrete impact baffle blocks downstream of the spillway weir. A concrete apron beyond the baffle blocks appears to have been recently added. Undermining was observed at the upstream end of the apron near the right side of the spillway. Seepage was also observed near the downstream end of the apron.

SPILLWAY. NOTE SEEPAGE NEAR RIGHT END  
AND CONCRETE APRON DOWNSTREAM OF IMPACT Baffle BLOCKS.

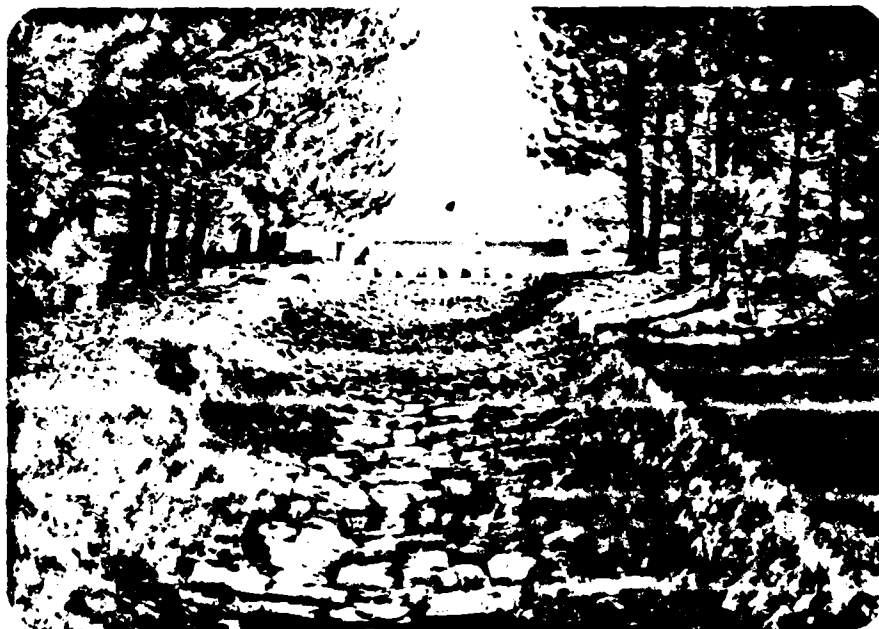
PHOTO NO. 11

The discharge channel is lined with hand-placed riprap. The left bank of the channel is inclined and faced with riprap. A section of the channel approximately 50 feet long washed out during a March 1980 storm. This section of the channel was repaired with crushed stone up to 8-inches in diameter, Photo 11.

4. Potential increase in the deterioration of the floor of the spillway discharge channel can lead to undermining of the spillway weir and adjoining training walls.

SPILLWAY DISCHARGE CHANNEL.  
NOTE HAND PLACED RIPRAP PAVING IN FOREGROUND  
AND CRUSHED STONE IN BACKGROUND.

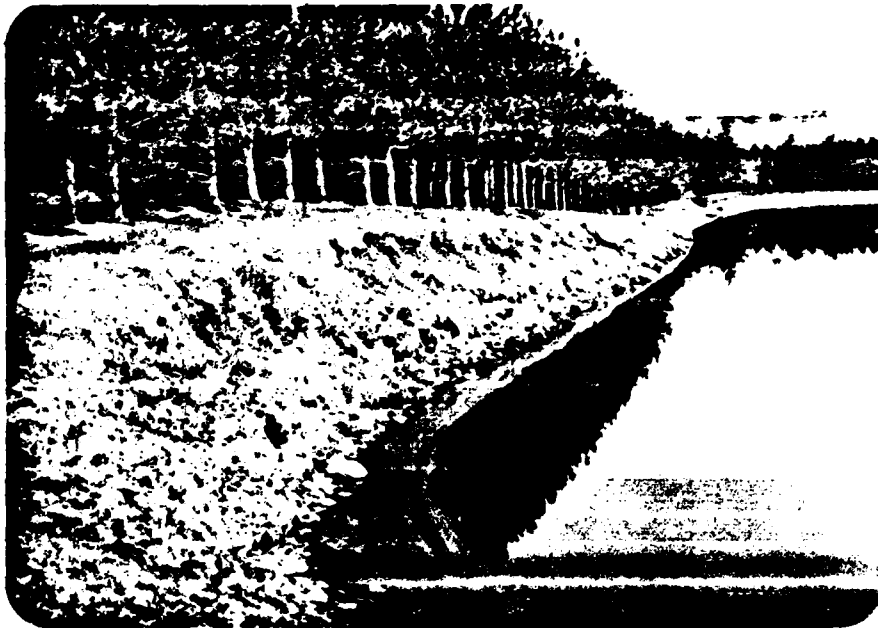
PHOTO NO. 14

EROSION OF RESERVOIR BANK  
UPSTREAM OF RIGHT ABUTMENT,  
DIKE AND SPILLWAY IN BACKGROUND.
