MOODUS RESERVOIR DAM

CT 00350

CONNECTICUT RIVER BASIN
EAST HADDAM, CONNECTICUT

PHASE 1 INSPECTION REPORT
NATIONAL DAM INSPECTION PROGRAM

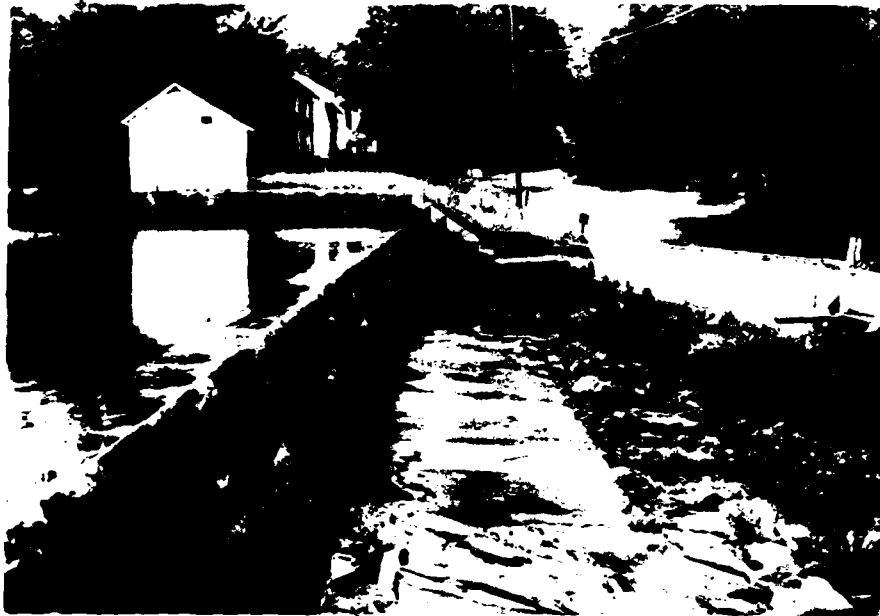
C-2 SPILLWAY, GATEHOUSE AND LEFT ABUTMENT-LOOKING FROM RIGHT ABUTMENT.

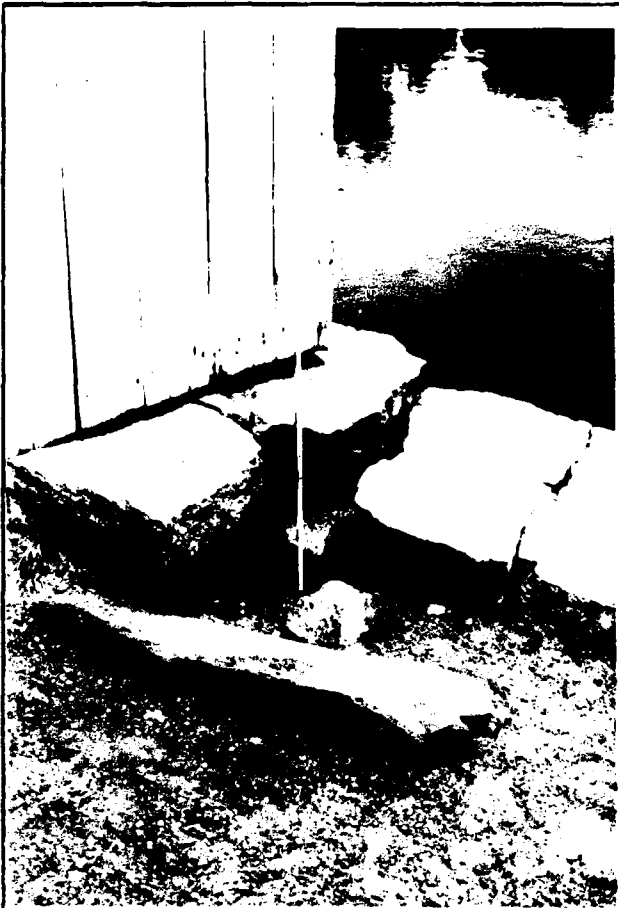
C-10 SURFACE EROSION AT
GATEHOUSE.

6. Institute immediately an analysis for the short term repairs and/or rehabilitation of the dam embankment in those areas where erosion has occurred including erosion near the gatehouse.
