LOWER CONNECTICUT RIVER BASIN
EAST HADDAM , CONNECTICUT

BASHAN LAKE DAM
CT 00354

PHASE I INSPECTION REPORT
NATIONAL DAM INSPECTION PROGRAM

FEBRUARY 1979

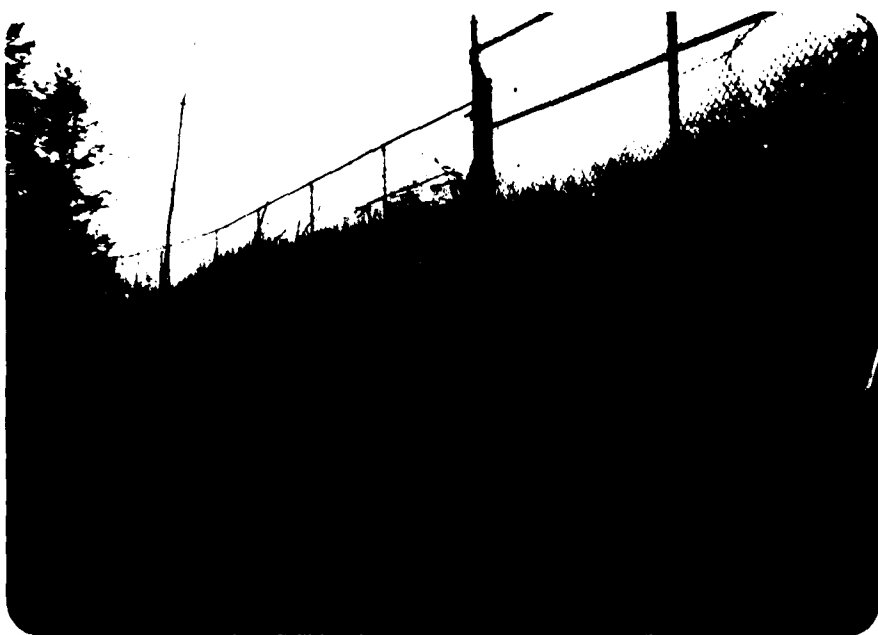
Due to the significant discharge of this area, there is a possibility that movement and initial failure of these spillway blocks could initiate further failures of the downstream granite block wall and possibly of the dam itself.

PHOTO NO.2 - Downstream view of spillway and downstream face of dam.

concrete lining or a similar impervious material. Such an approach could, however, have an adverse effect on the stability of the structure; therefore, a stability check should be performed prior to the recommendations being finalized.
