**CONNECTICUT RIVER BASIN  
AVON, CONNECTICUT**

**STUB POND DAM**

**CT 00265**

**PHASE 1 INSPECTION REPORT  
NATIONAL DAM INSPECTION PROGRAM**

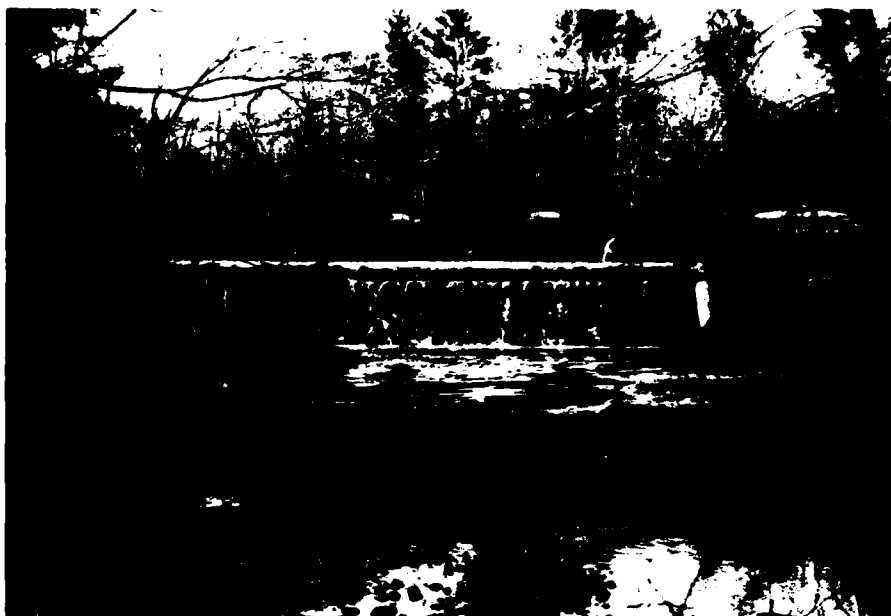
C-1 SPILLWAY - LOOKING NORTH

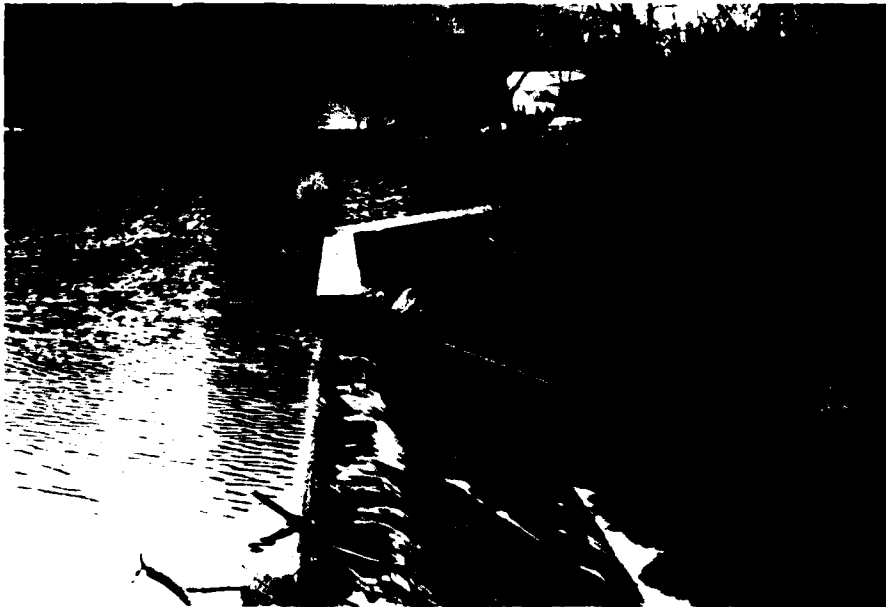
4. **Concrete Wall:** The area immediately downstream of the eastern wall is severely eroded (See Plan Page B-9) exposing much of the downstream face of the wall (Photo C-3). This wall is severely cracked and spalled with grass growing in the cracks (Photo C-4). The cracks extend from the spillway approximately 45 feet east. Approximately 1 to 2 gallons per minute of clear water is seeping through the wall (Photo C-4). The area below the western wall is also eroded (Photo C-6), and the wall is broken at the top of the eastern end with a large reinforcing bar exposed.

The most significant area of distress noted for this dam was the severe erosion downstream of the eastern concrete wall. This erosion is apparently caused by water flowing over the top of the wall and then parallel to the wall to the downstream channel.

C-3 EAST CONCRETE WALL - SHOWING ERODED  
AREA BELOW WALL

- a. All trees and their respective root systems be removed from the dam and within 15 feet of the downstream toe, and backfill with suitable compacted material.
- b. An analysis of the structural integrity of the broken and cracked concrete walls and concrete wingwalls be conducted and repairs designed as required.
- c. Investigate the upstream face of the embankment and concrete walls with the pond lowered and make appropriate recommendations.
- d. The eroded areas downstream of the concrete walls be filled and erosion control be provided.
- e. A detailed hydrologic/hydraulic investigation to determine the need for and the means of increasing the discharge capacity of the spillway and/or providing additional freeboard.
