THAMES RIVER BASIN  
COLCHESTER, CONNECTICUT

DEEP RIVER RESERVOIR DAM  
CT 00346

PHASE 1 INSPECTION REPORT  
NATIONAL DAM INSPECTION PROGRAM

MAY 1979

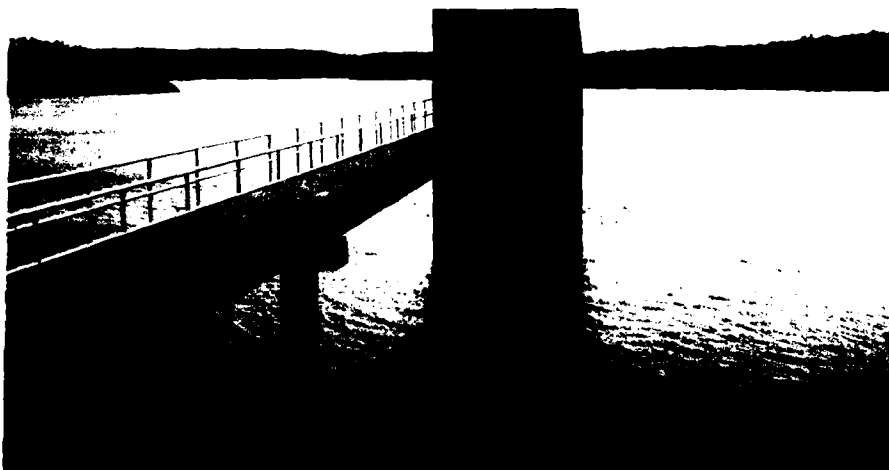
3. Outlet Works' Gatehouse. The gatehouse structure is constructed of reinforced concrete in good condition with a service bridge from the main embankment as its sole means of access. No spalling or cracking of concrete surfaces was noted and these structures appeared to be well maintained. See Photos C-2, 3, 10. The wet well of the gatehouse has three manually operated sluice gates (2 ft. wide by 4 ft. high) with invert elevations of 301.0, 306.0, and 322.0. The outlet conduit from the wet well also has a manually

C-10 OUTLET WORKS CONTROL TOWER

1. A program of regular operational checks of all the control valves of the gatehouse and outlet works should be implemented and incorporated into a regular maintenance schedule.
2. Develop and "post" an emergency action plan including a warning system in order to prevent or minimize the impact of dam failure. It should include the expedient action to be taken, authorities to be contacted and locations of emergency equipment and materials.
3. Continue the technical inspection of this facility on a biennial frequency.
4. Include in the monitoring program a check of the survey reference marks implanted in the core wall for alignment changes in the embankment.
