CONNECTICUT RIVER BASIN  
EAST HAMPTON, CONNECTICUT  
**BEVINS POND DAM**  
**CT 00360**

PHASE I INSPECTION REPORT  
NATIONAL DAM INSPECTION PROGRAM

AUGUST, 1980

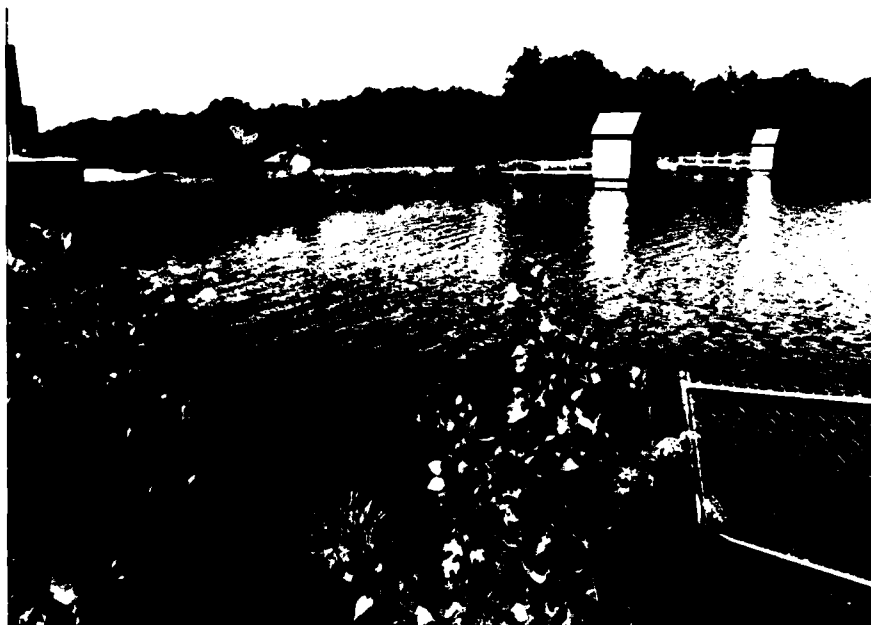
Photo 1 - Upstream slope of dam and gatehouse structures (7/7/80).

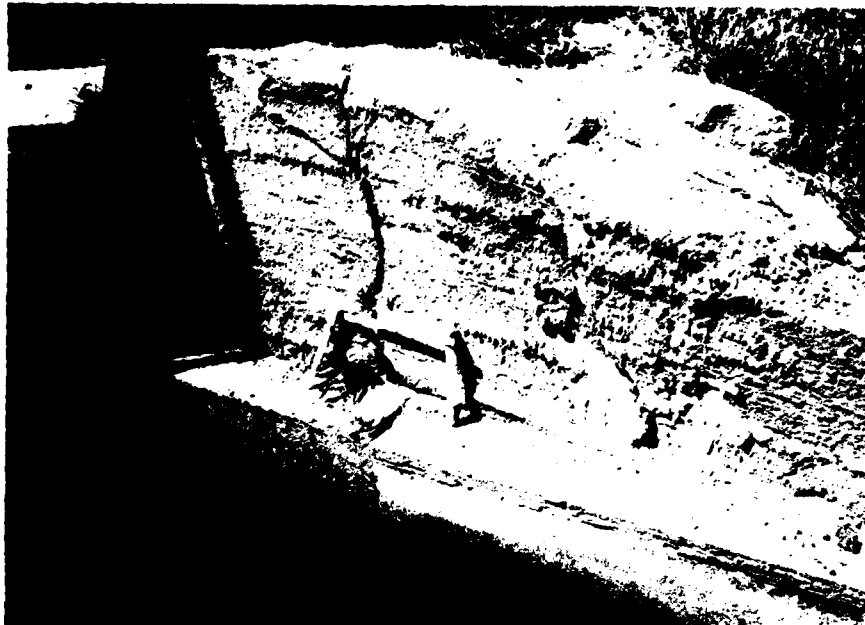
| AREA EVALUATED | CONDITION |
|---|---|
| General Condition of Concrete | Cracks and slight displacement of training walls |

Photo 7 - Cracks and displacement of right spillway training wall (7/7/80).

4. Cracks in the concrete of the spillway training walls should be repaired.
5. Grass growing through the joints of the wing walls should be removed and joints repointed.
