FARMINGTON RIVER BASIN  
BARKHAMSTED, CONNECTICUT

SAVILLE DAM  
CT. 00376

PHASE I INSPECTION REPORT  
NATIONAL DAM INSPECTION PROGRAM

SEPTEMBER 1978

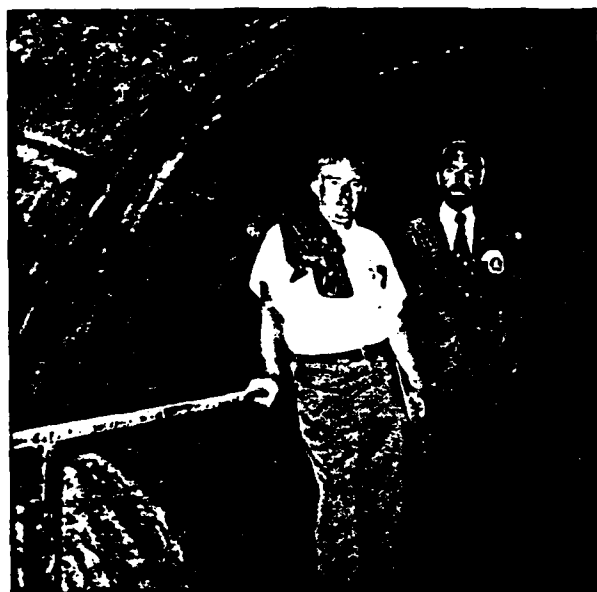
#11 Conduit between Houses,  
showing minor leak in  
roof, and handrail

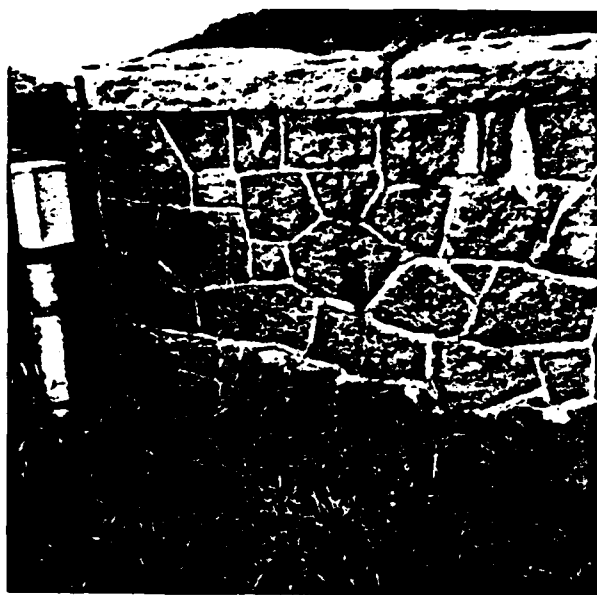
#18 Cracks on East Side  
of causeway wall.

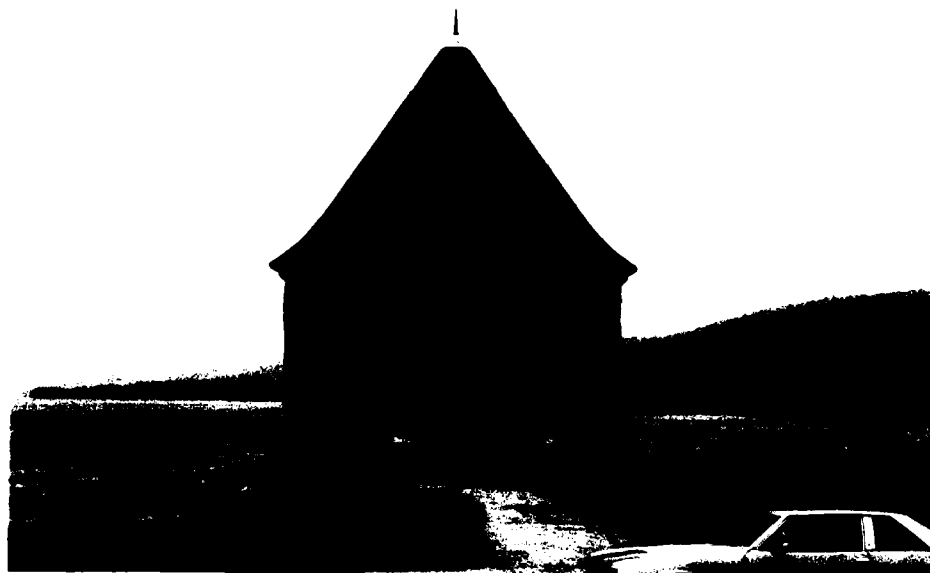
PHOTO 1  
UPPER GATE HOUSE

c. Appurtenant Structures - The upper gate house contains the operators for the sluice gates and emergency power equipment. Near the bottom of the gate house there are a number of places where there is evidence of seepage and efflorescence. The upper gate house is structurally sound and the equipment is in good condition, although it is old.

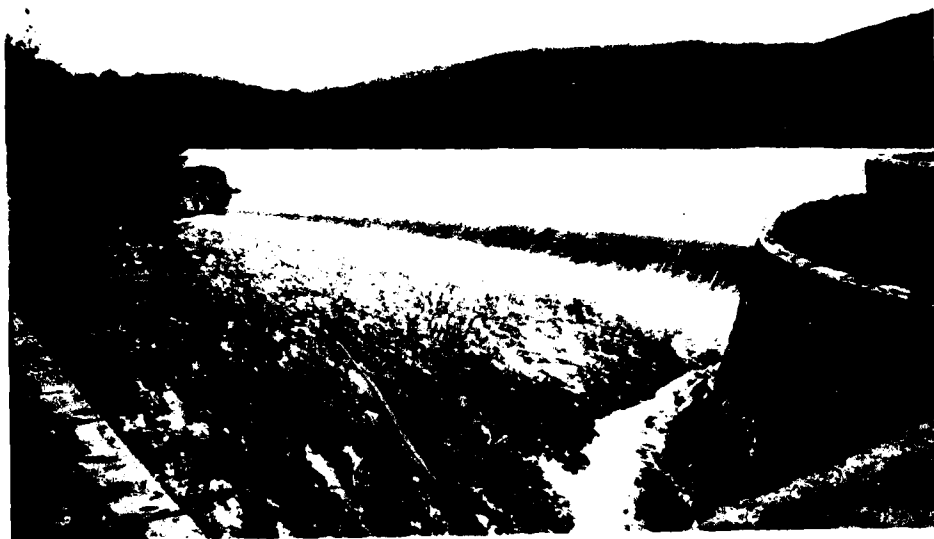
PHOTO 3  
SPILLWAY WEIR

e. Downstream Channel - The spillway and downstream channel are cut into ledge rock (Appendix C, Photos 3 and 4) and are in good condition. There is no visible erosion or sloughing of the floor or walls.

c. Visual Observations - The spillway and channel at the time of the inspection were in good condition. There are presently plans by the Metropolitan District to regrout the joints in the granite lined portion of the spillway and channel.

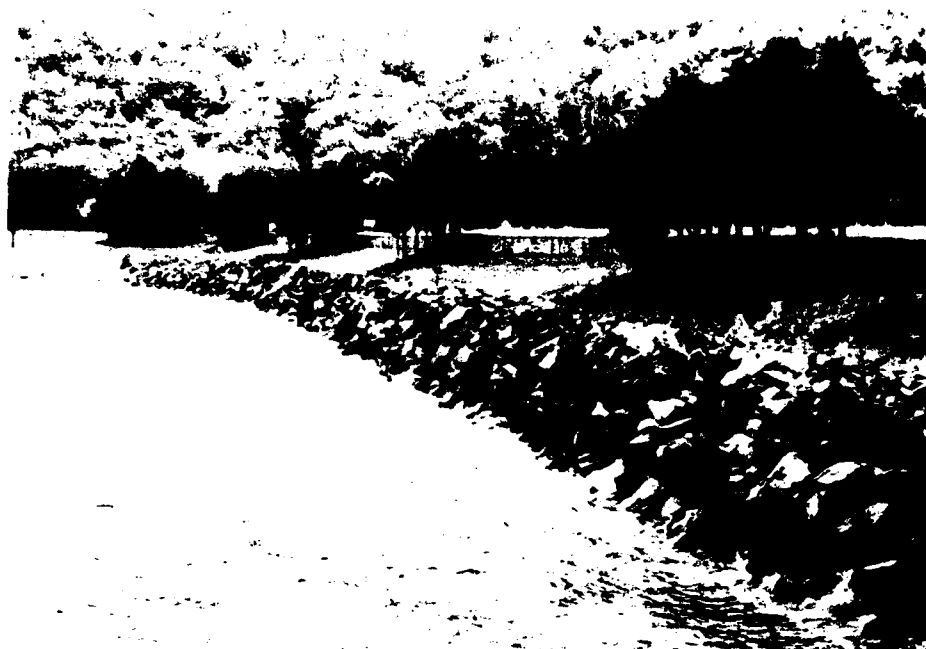
PHOTO 5  
UPSTREAM FACE OF DAM

d. Reservoir Area - An inspection of the upstream reservoir area by boat showed that the riprap is in satisfactory condition with no evidence of shifting or repair (Appendix C, Photo 5). The area immediately upstream of the dam embankment seem to be in a very natural state with no visible signs of erosion, sloughing or distress.
