FARMINGTON RIVER BASIN
BURLINGTON CONNECTICUT

WHIGVILLE RESERVOIR DAM
CT-00379

PHASE I INSPECTION REPORT
NATIONAL DAM INSPECTION PROGRAM

FEBRUARY 1980

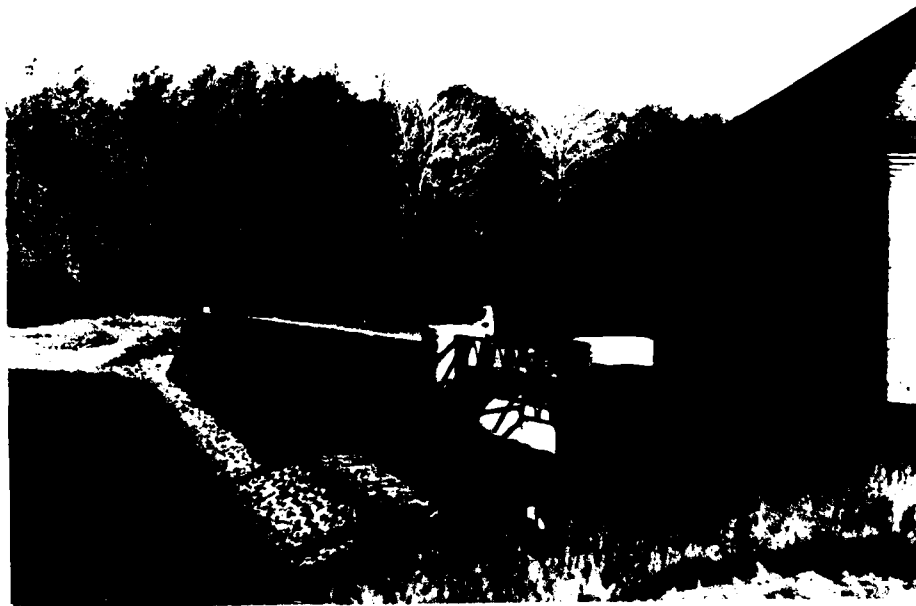
1) Upstream face - The upstream face is comprised of a 7 foot high concrete parapet and stone paving riprap which extends below the reservoir surface (see photo No. 1 and photo No. 2). The stone paving is in good condition with only a few openings visible which exposed the underlying embankment material. Spalling of the concrete parapet wall is evident and erosion/deterioration is especially noticeable at the recent waterline. The aggregate is exposed below the waterline (see photo No. 9).

PHOTO #1: Upstream face of dam from right (south) abutment.

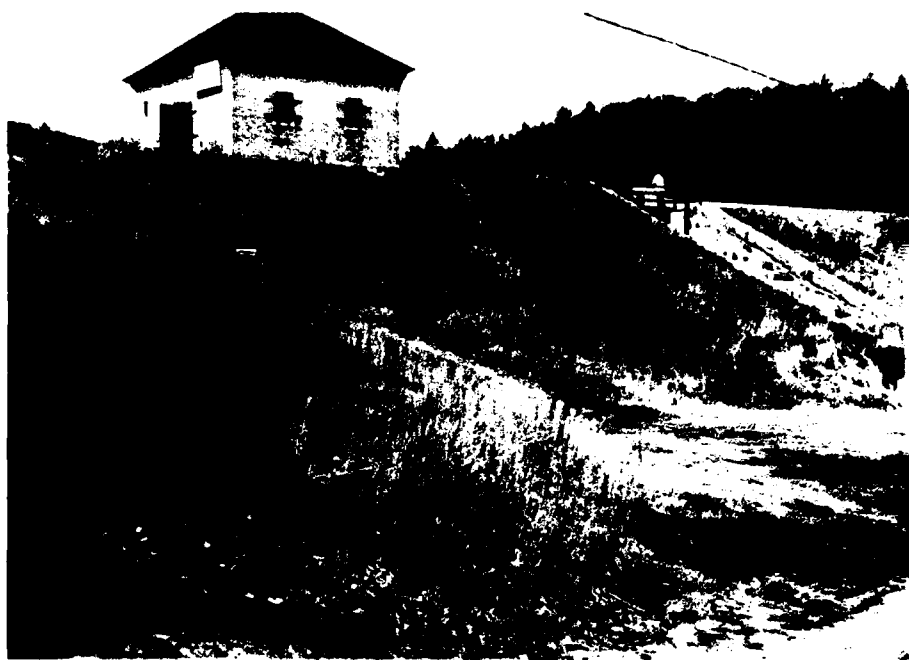
PHOTO #5: Downstream slope from right (south) abutment, looking towards spillway.

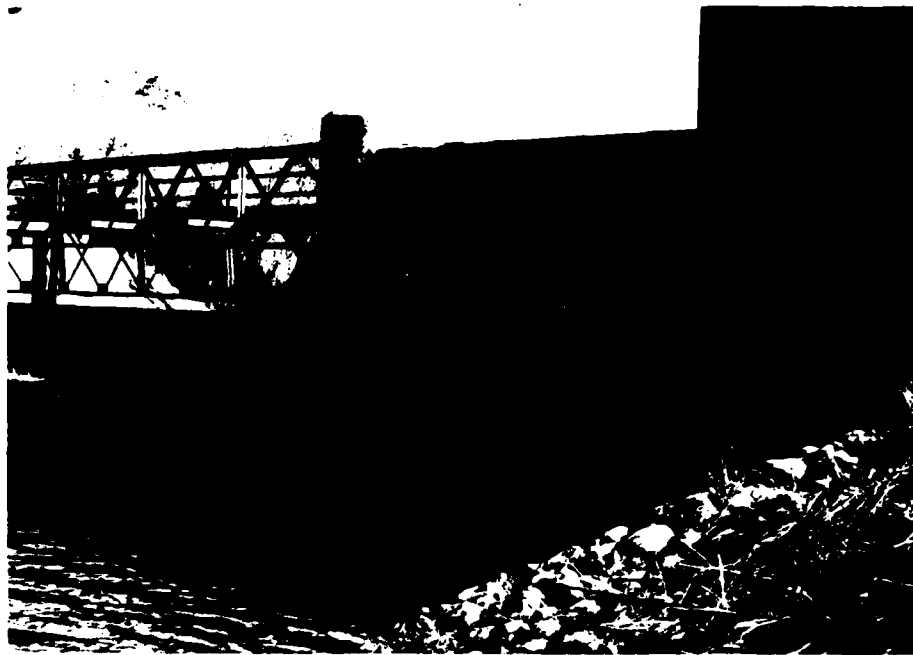
PHOTO #9: Upstream face, looking towards spillway approach.

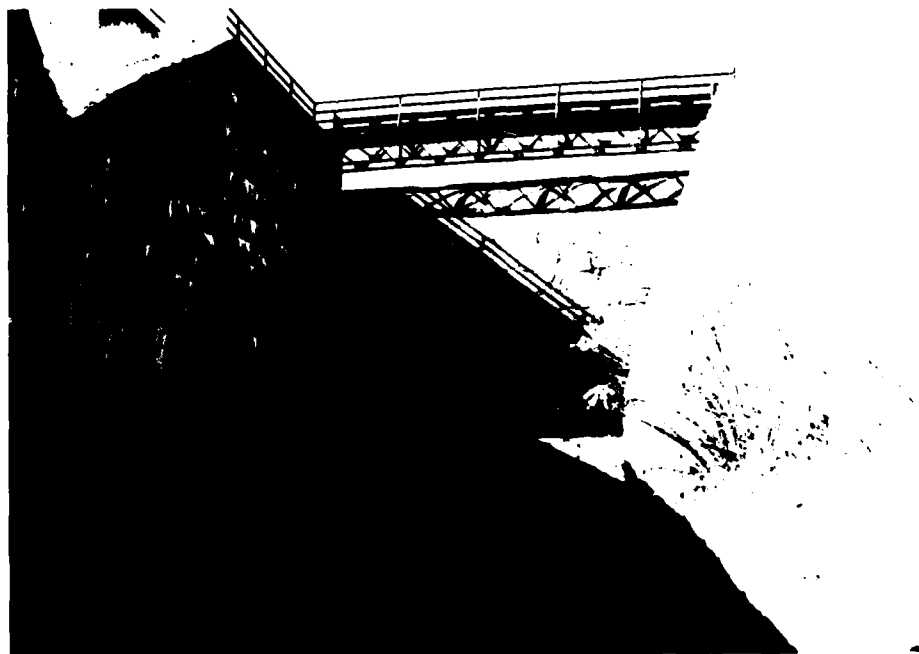
The nearly vertical downstream face of the spillway is generally in good condition, although there are numerous minor leaks and seepage noted at the joints (see photo No. 10).

2) Spillway Stilling Basin/Discharge Channel - The stilling basin at the toe of the spillway is in good condition. As shown in photo No. 10 the side walls are the extension of the spillway training walls, and have some leaks and efflorescence in the stone and mortar joints. The concrete slab that forms the floor is in good condition. The concrete weir at the downstream end of the stilling basin is in good condition. The spillway discharge channel is located downstream of the stilling basin, and has a concrete bottom with stone and mortar walls (photo No. 13). The concrete slab is in poor condition and shows evidence of surface wear, erosion and deterioration. The coarse aggregate is exposed, and there are numerous areas of spalling. A portion of the 4 foot high (right) south retaining wall has failed. Both walls shown signs of severe deterioration and seepage is occurring as indicated in photo No. 12.

f. Service Bridge. The foot bridge over the spillway is in good condition (photo No. 10). Some rusting of the steel members is taking place.

PHOTO #10: Spillway and service bridge.

b. Investigate the seepage through the joints in the stone masonry wing walls and recommend measures for repair to prevent erosion and piping of the embankment soils.
