CONNECTICUT RIVER BASIN  
NEW HARTFORD, CONNECTICUT  
**LAUREL LAKE DAM**  
**CT 00372**

PHASE I INSPECTION REPORT  
NATIONAL DAM INSPECTION PROGRAM

SEPTEMBER, 1980

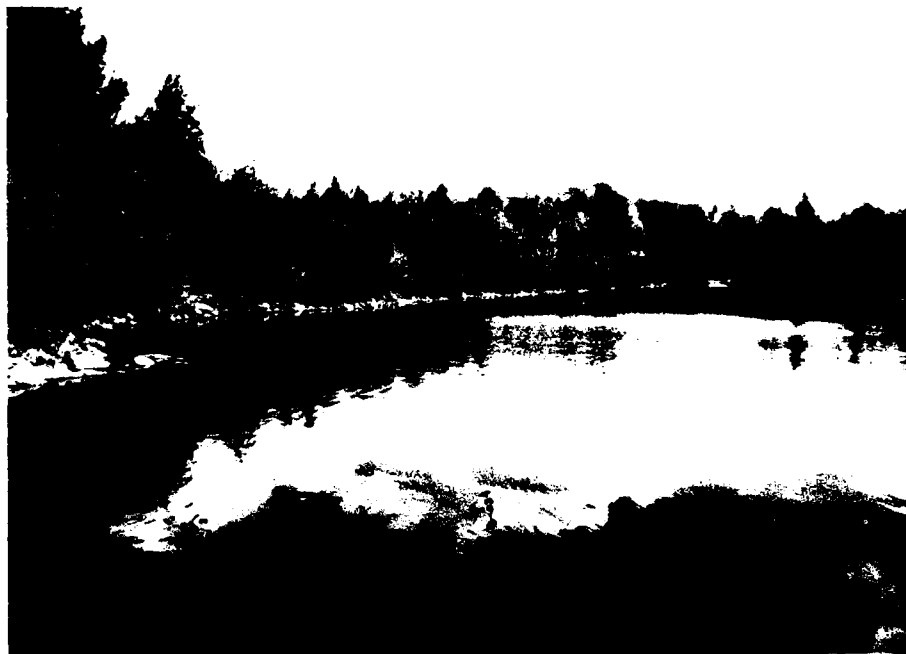
Upstream Slope - The upstream slope is also heavily vegetated and has dumped riprap present below elevation 101+ (Photo 1). No sloughing, washouts, or depressions were noted although some erosion from trespassing is present where paths lead to the edge of water (Photo 6). The riprap is in fair condition with some areas of displacement.

Photo 1 - Upstream slope from left shore, (May, 1980).

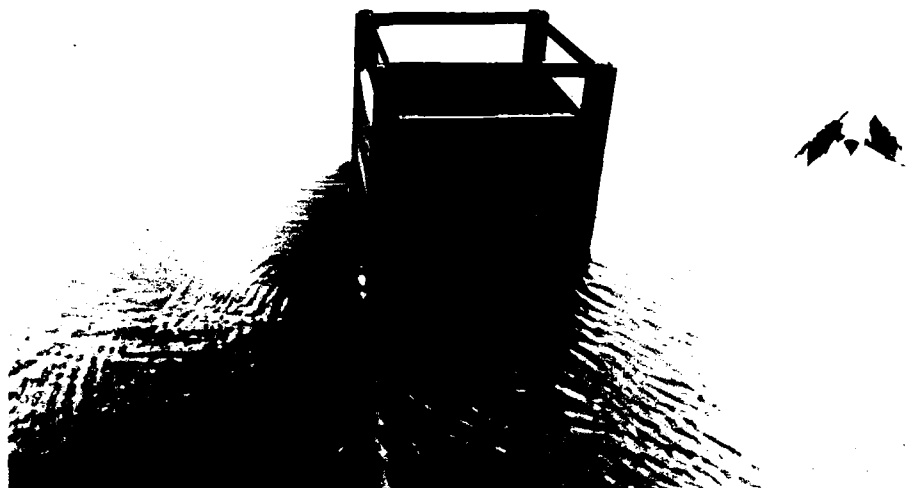
Intake Structure - The intake structure is a 24 inch cast iron drop inlet pipe and a steel framed structure with wooden boards to control the lake level. (Photo 5). It is located approximately 10 feet upstream from the top of the slope. Some wood and boulders were noted at the base of the drop inlet. No low-level outlet for lowering the pond was found during the inspection.

Photo 5 - Drop inlet (2' x 2') with metal frame, wood slats and pipe for control mechanism, (May, 1980).

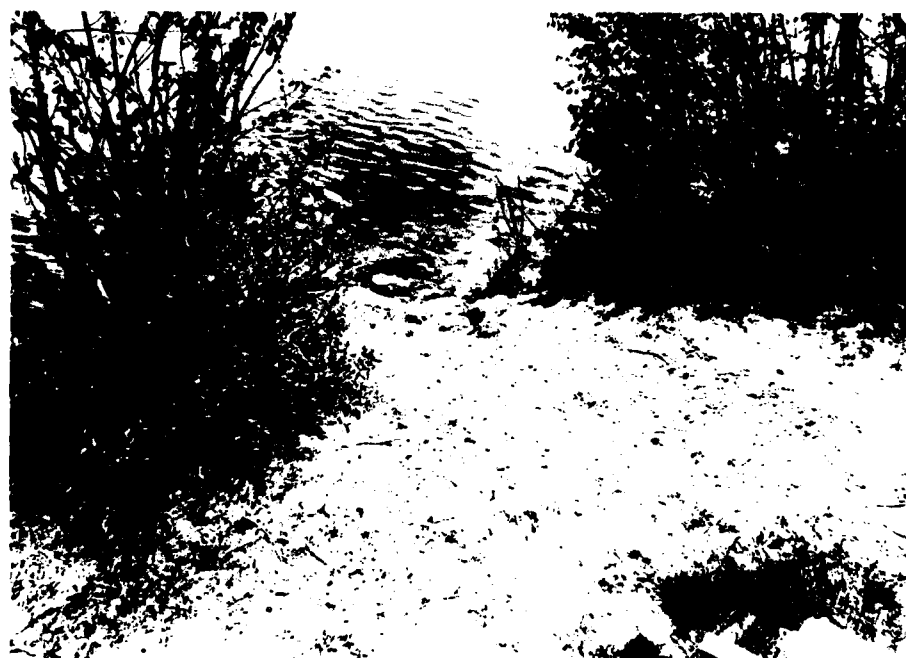
1. Erosion areas with riprap displacement on the upstream slope caused by access paths, could present stability problems should the dam be overtopped.
2. Dense, immature, woody vegetation covering the entire dam will result in root penetration which will present stability problems by providing seepage paths along root systems and weakening the embankment should trees blow over during strong winds.

Photo 6 - Area of erosion from trespassing on upstream slope, (May, 1980).
