QUINNIPIAC RIVER BASIN
PROSPECT , CONNECTICUT

**CHESHIRE RESERVOIR DAM
CT 00303**

**PHASE I INSPECTION REPORT
NATIONAL DAM INSPECTION PROGRAM**

APRIL 1980

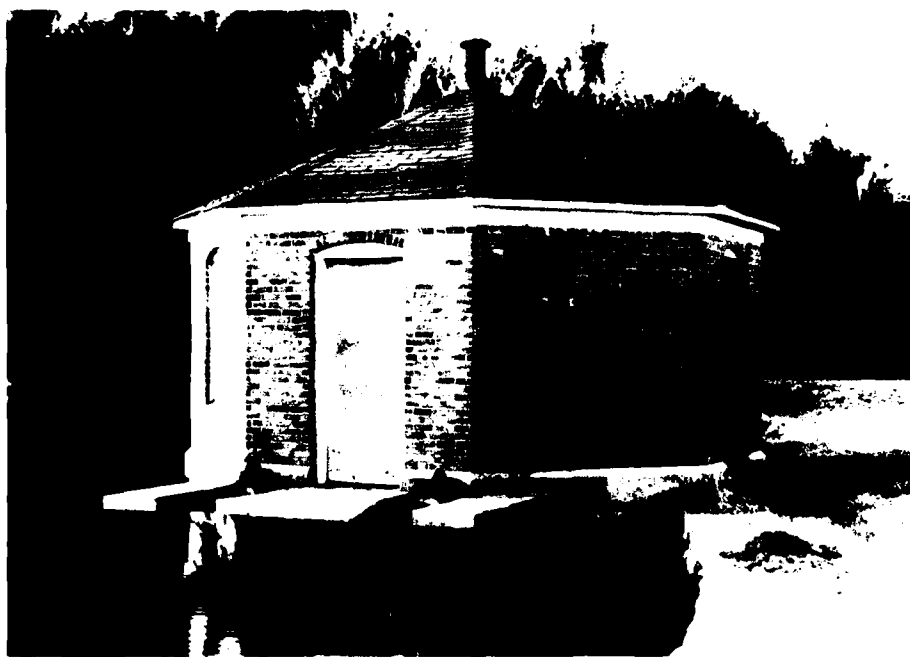
c. Appurtenant Structures. The exterior of the brick gatehouse is in good condition as indicated in Photo No. 11 (the interior was not inspected). The outlets of the 16 inch C.I.P. and 24 inch C.I.P. blow off pipes were located (Photo No. 9) and both pipe ends were in good condition and free of debris. The conduits have control valves located in the upper gatehouse.

PHOTO #11: Gatehouse.
