THAMES RIVER BASIN
STAFFORD, CONNECTICUT

RIVERSIDE POND DAM
CT. 00336

PHASE 1 INSPECTION REPORT
NATIONAL DAM INSPECTION PROGRAM

OCTOBER, 1980

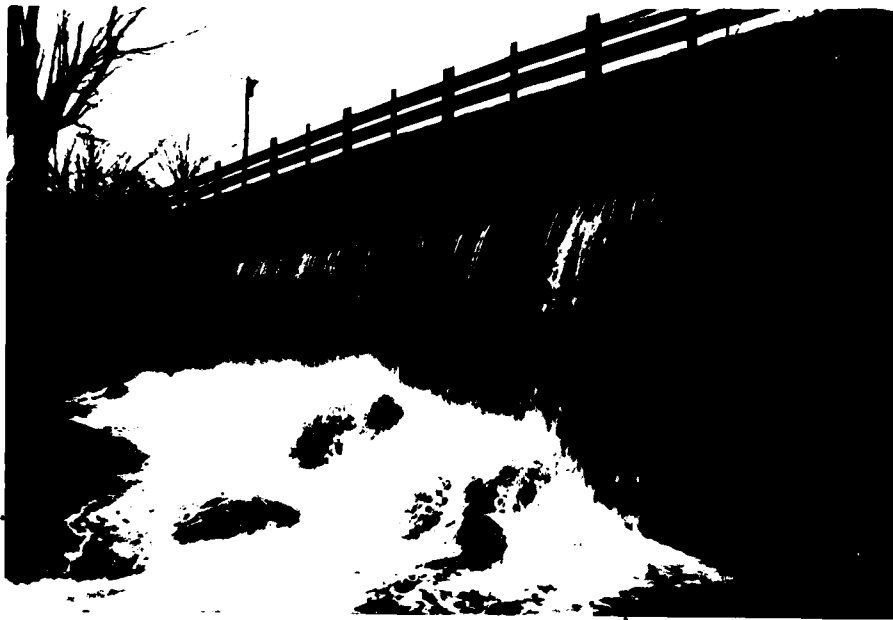
PHOTO C-3 Crest and downstream face of dam from left abutment.

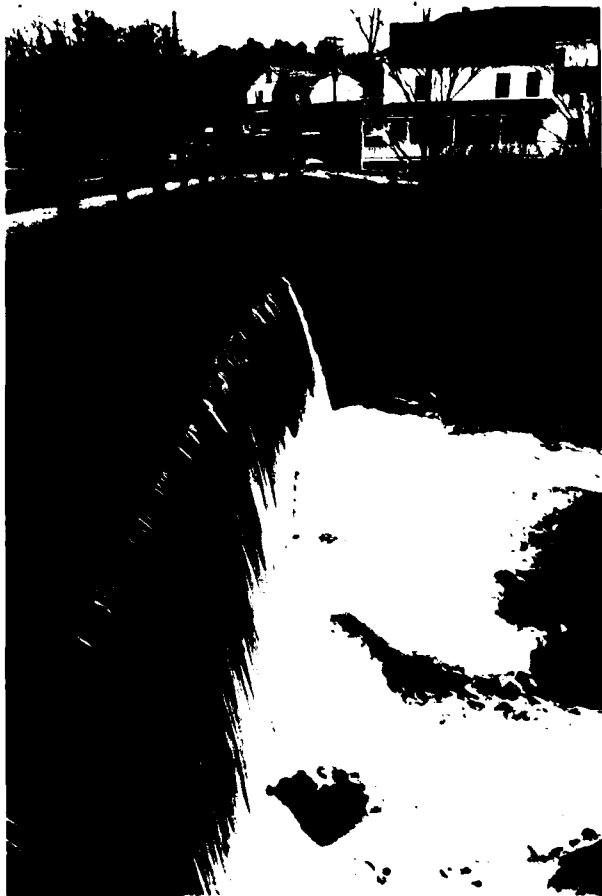
PHOTO C-4 Crest and downstream face from right abutment.
