CURTIS POND DAM
CT 00312

PHASE I INSPECTION REPORT
NATIONAL DAM INSPECTION PROGRAM

DEPARTMENT OF THE ARMY
NEW ENGLAND DIVISION, CORPS OF ENGINEERS
WALTHAM, MASS. 02154

MARCH 1981

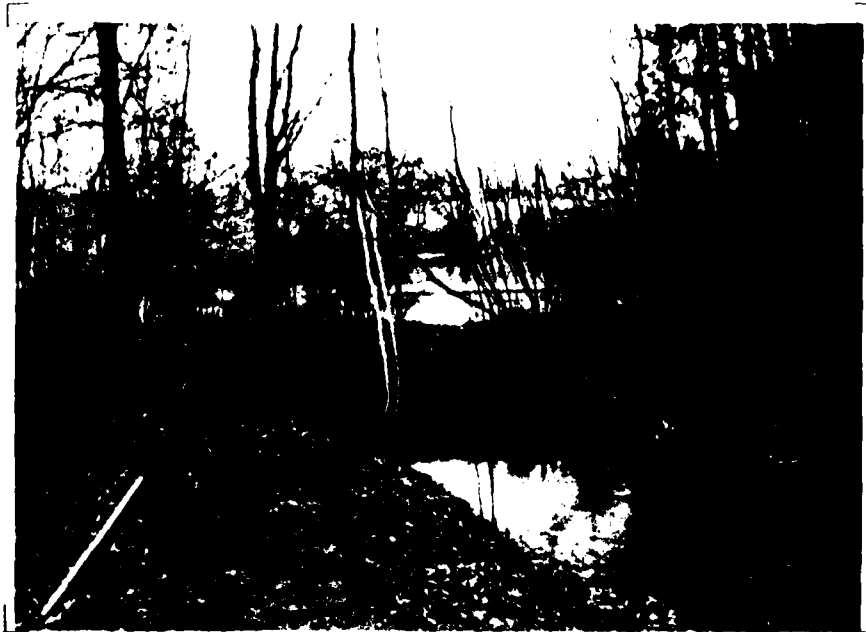
The fire canal and the containment dike are overgrown with vegetation. Trees ranging from 3 to 15 inches in diameter were noted on the dike and in the fire canal (Photos 5 and 6). The depth of the canal appears to have been significantly decreased due to an accumulation of debris in the canal bottom. At the time of the inspection, no flow was observable in the canal.

The masonry joints on the cut stone wall surrounding the 18-inch canal intake conduit have deteriorated (Photo 5). The inspection team was unable to locate the upstream entrance to the intake conduit due to the water level and the silt in the pond.

Photo 5 Top of embankment dam, canal dike, canal intake, and Curtis Pond.

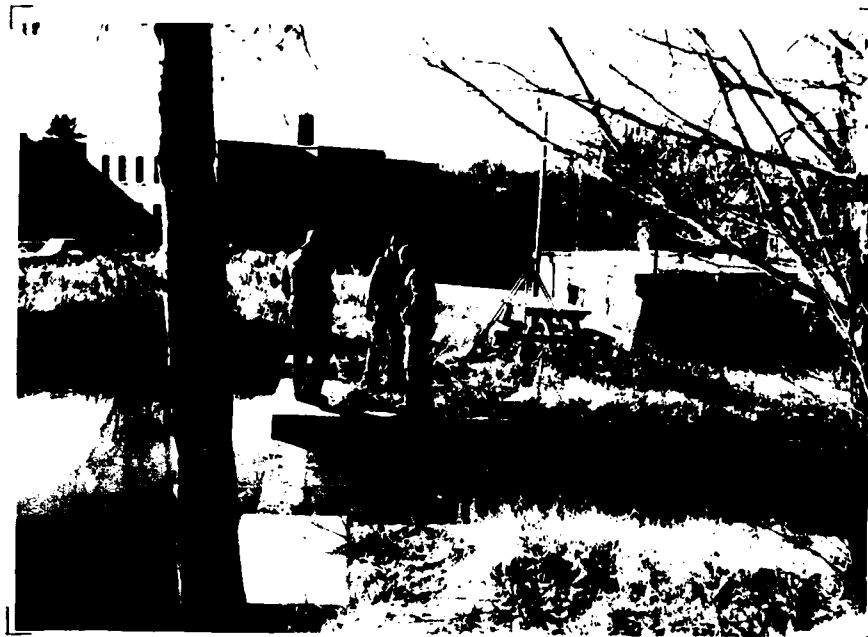
The concrete waste weir was generally sound, but some minor spalling was noted along the crest (Photo 7). The fire protection equipment, intakes, and trashracks appeared to be in relatively good condition.

Photo 7 End of canal, waste weir, pumphouse intakes,
pumphouses (right), and S. Curtis and Sons, Inc.
factory in background.
