HOUSATONIC RIVER BASIN
SHERMAN, CONNECTICUT

LAKE MAUWEEHOO DAM
CT 00321

PHASE I INSPECTION REPORT
NATIONAL DAM INSPECTION PROGRAM

June, 1981

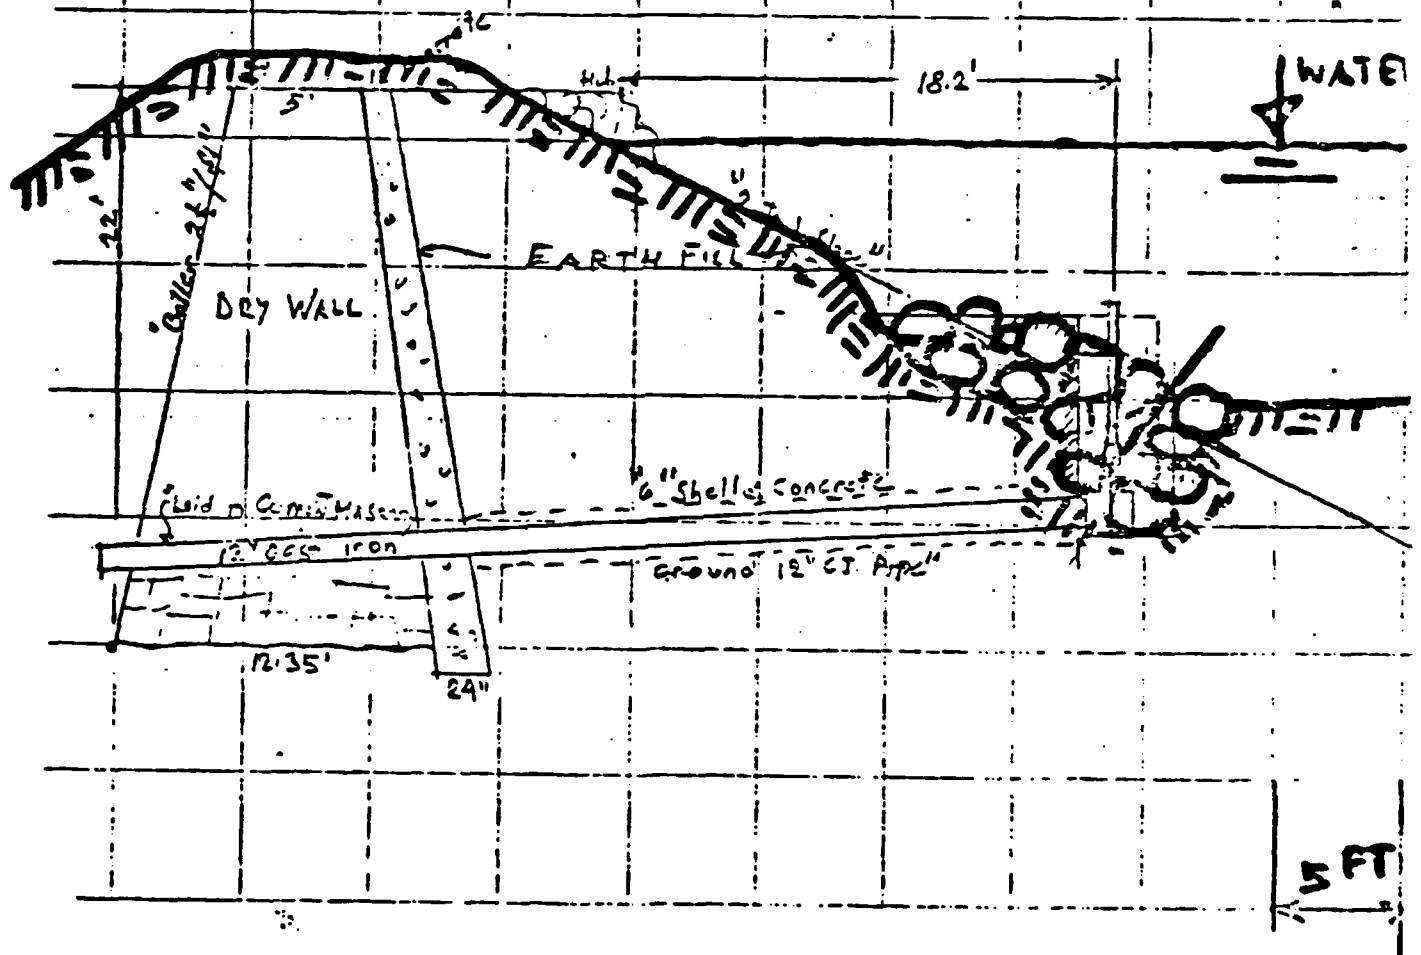
MUNWEHOO DAM

1. The fill slope is about 2 to 1 as shown on drawings, however it is steeper at the lower part.
2. The depth of water is about 10 ft. Bottom is covered with silt and weeds.
3. At a depth of about 8 ft. boulders are projecting from fill. They appear to be the remains of the original dry stone U shaped wall built around the valve (gate). A metal rod is projecting from the rubble on an angle of about 45 degrees. This is probably the original valve operation rod.
4. For schematic lay out see the enclosed sketch.

9. The underwater valve inspection is described in enclosure E2. The repair of this valve is not possible without siphoning the lake dry, and is not required at present (see 8.1).

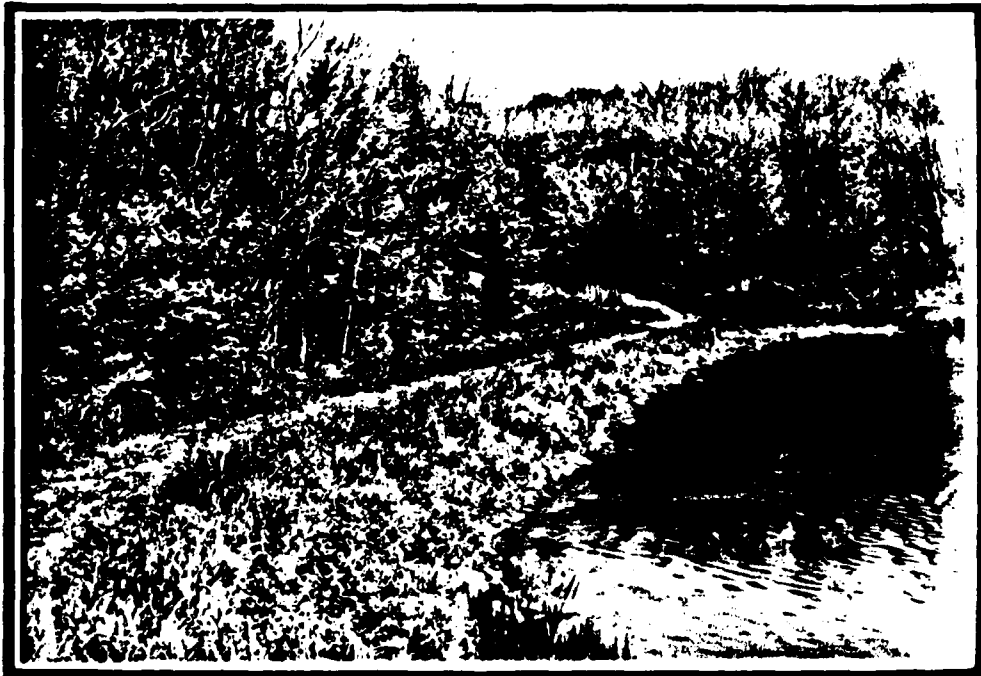
UPSTREAM FACE

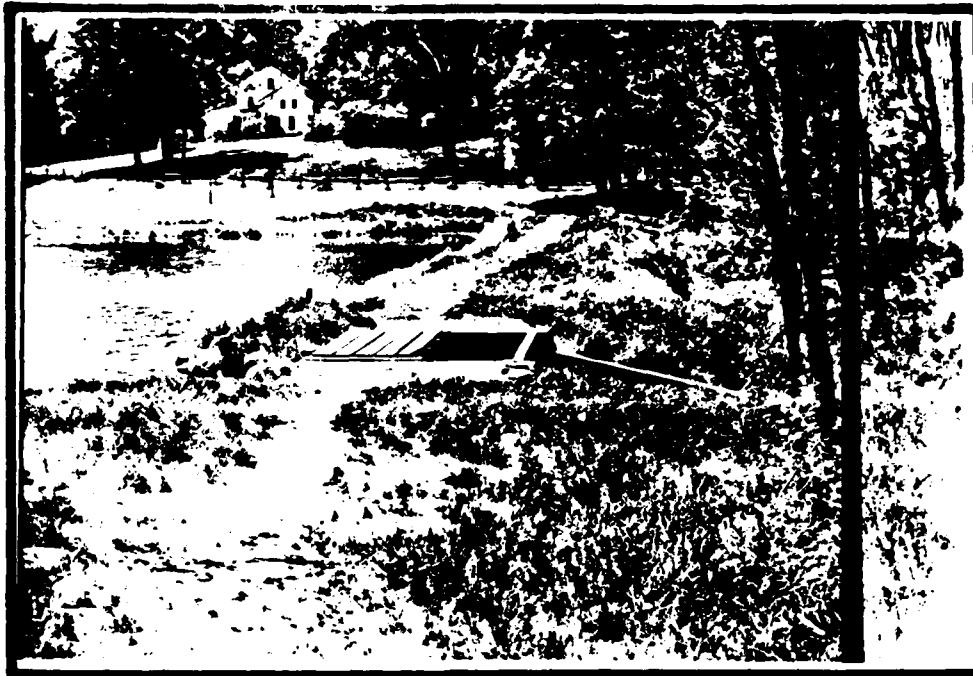
CREST OF DAM

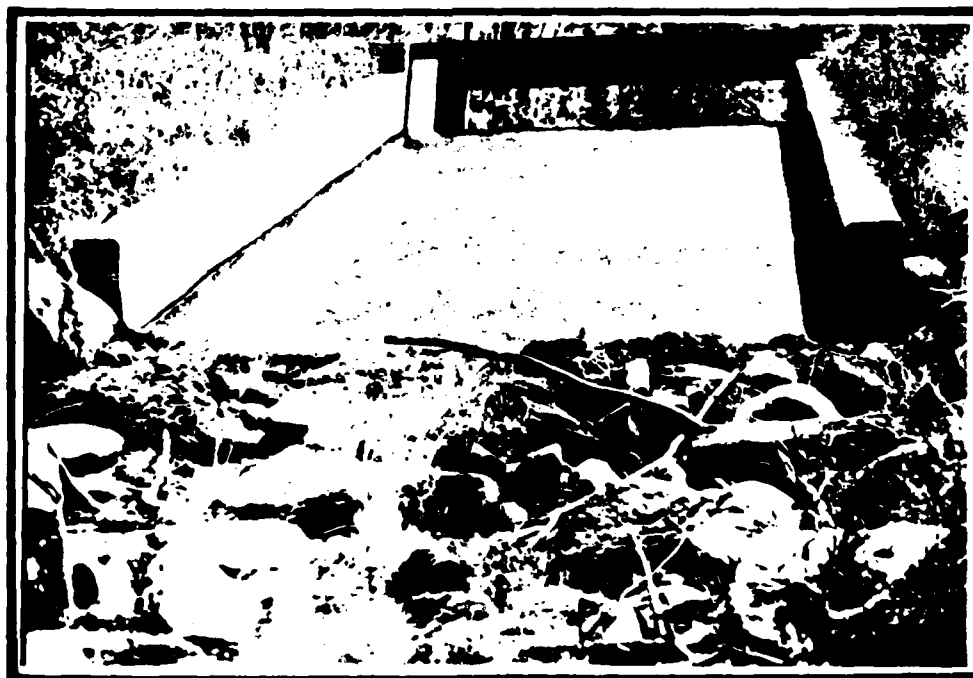
EMERGENCY SPILLWAY - PRINCIPAL SPILLWAY

PRINCIPAL SPILLWAY
