QUINNIPIAC RIVER BASIN  
MERIDEN/CHESHIRE, CONNECTICUT

BROAD BROOK DAM  
CT. 00301

PHASE I INSPECTION REPORT  
NATIONAL DAM INSPECTION PROGRAM

SEPTEMBER 1978

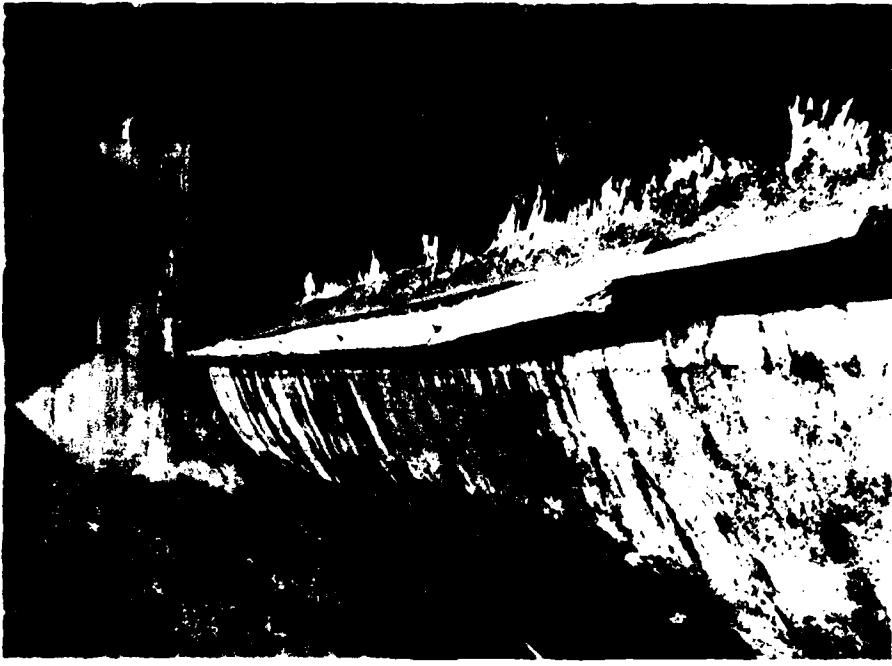
PHOTO 4  
FLASHBOARDS ON CREST OF SPILLWAY

- a. Alternatives - Not applicable.
- b. O & M Maintenance and Procedures -
  - (1) The grass, brush and trees on the downstream slopes of the dam and banks at the distance of 300 feet from the dam should be removed to facilitate the visual observation of existing and potential seepage.
  - (2) Restoration of the existing drainage system in the body of the dam.
  - (3) The repair of the concrete faces of the dam with the removal of weak and deteriorated concrete.
  - (4) The downstream channel of the spillway should be cleaned of rock deposits, brush and trees so that overflow discharges from the spillway and the blowoff can be passed freely.
  - (5) A formal warning system should be developed including an operational procedure to follow in the event of an emergency.
  - (6) The flashboards that are on top of the spillway should either be repaired or removed.
