CONNECTICUT RIVER BASIN  
PLYMOUTH, CONNECTICUT

OLD MARSH POND DAM

CT 00285

PHASE I INSPECTION REPORT  
NATIONAL DAM INSPECTION PROGRAM

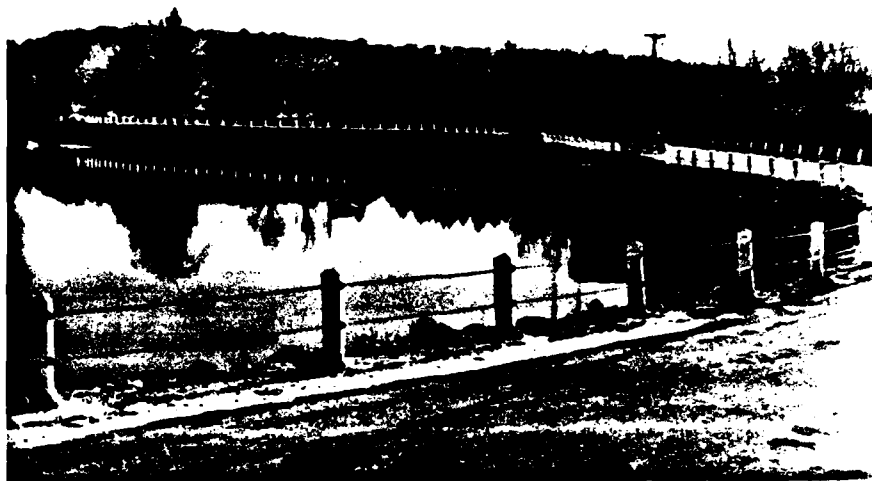
Overview of dam from right abutment of dam.

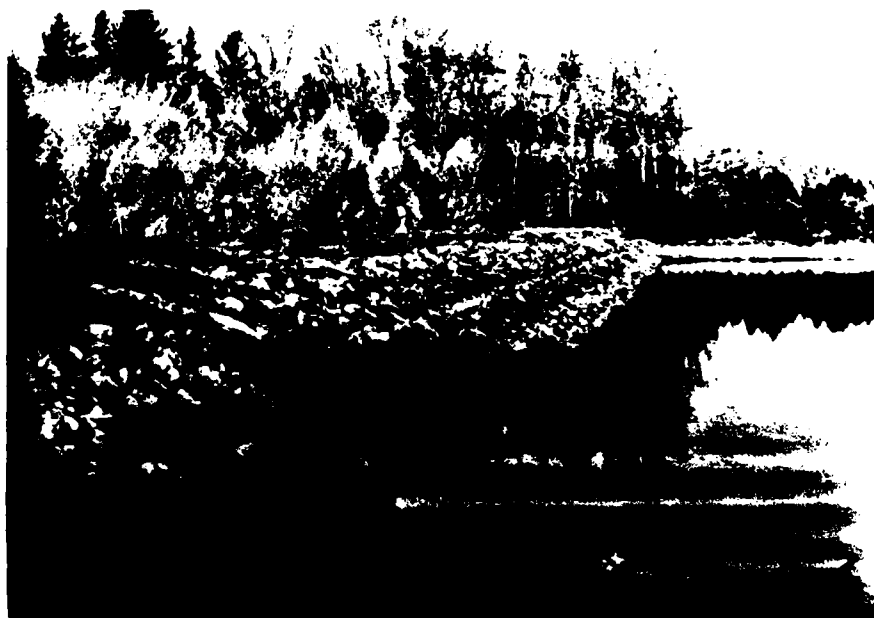
Overview of closure dike from left abutment of dike.

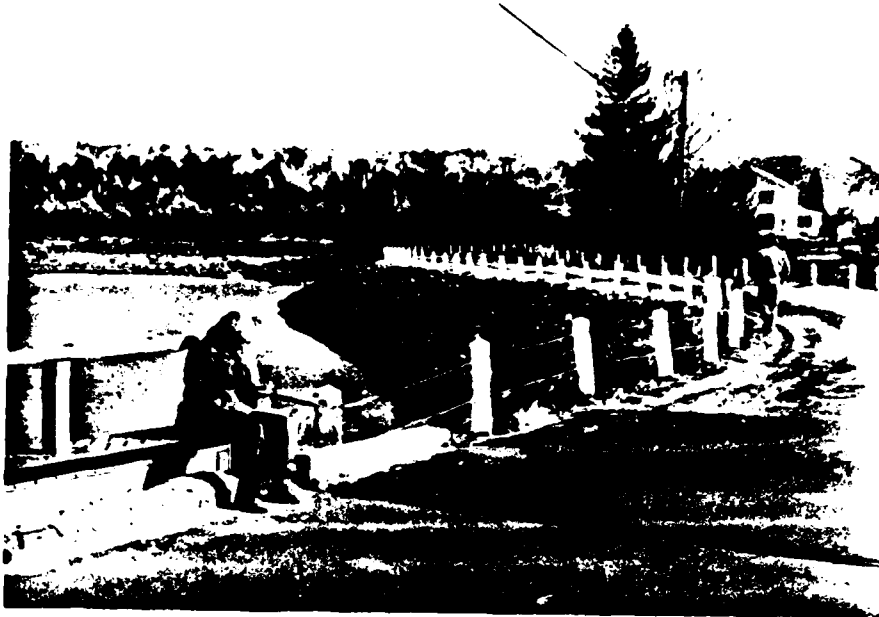
1. Upstream slope left of spillway bridge.

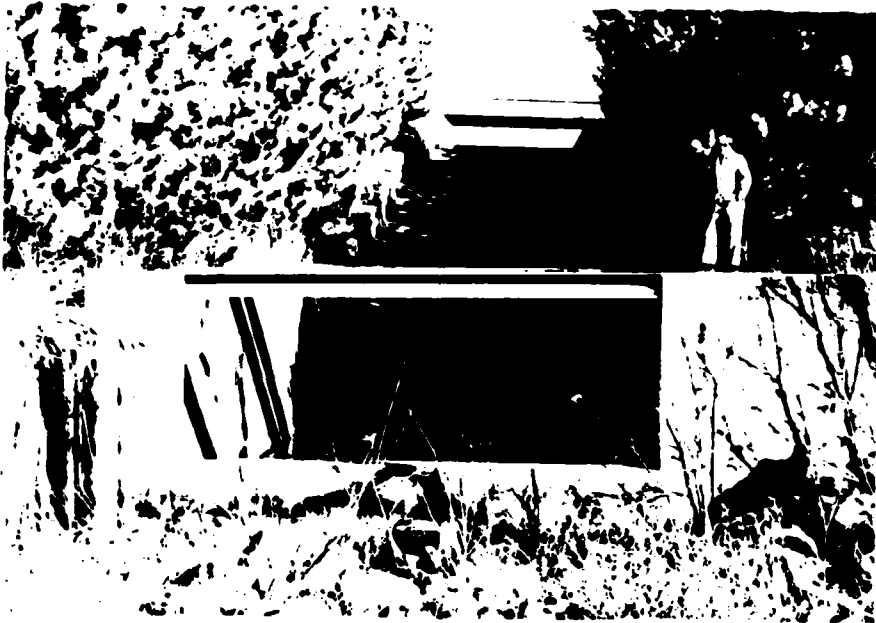
Except as noted below, the spillway alignment appears to be good and concrete surfaces appear to be in good condition. No cracks or spillings of consequence were detected (Appendix C, Photo No. 6).

6. Spillway channel and stilling basin.

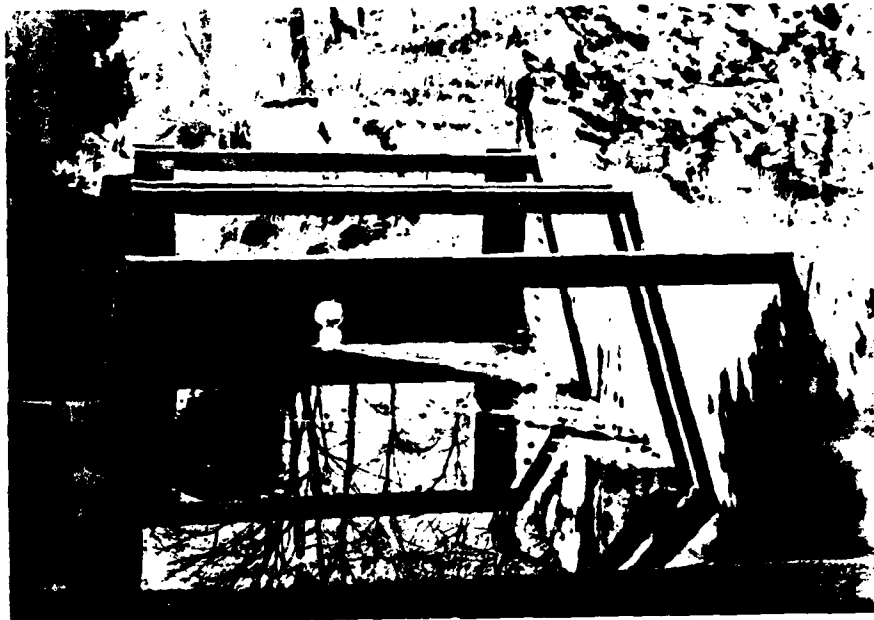
An apparent leaning in of the spillway stilling basin walls led to the installation, in 1968, of four steel beam struts between the tops of the walls. Since the plans show these walls to be of cantilever design, whereas the adjacent chute walls are of gravity design, it is believed that some differential deflection can be expected and that these walls are in no danger of failing, either with or without the struts.

7. Spillway stilling basin.

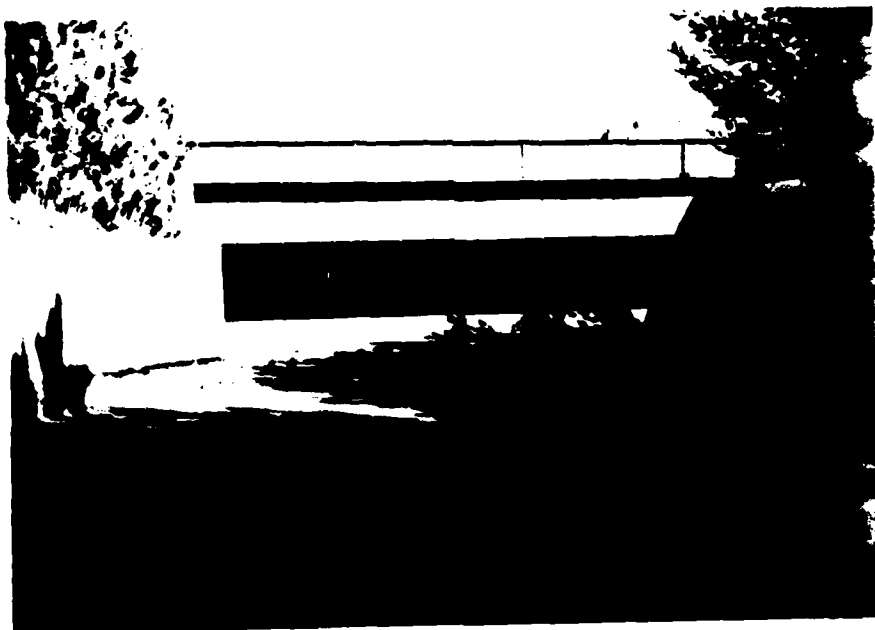
8. Spillway channel with retarding sill.
