BRISTOL FISH AND GAME CLUB DAM
CT-00299
1981

NATIONAL DAM INSPECTION PROGRAM
CORPS OF ENGINEERS

4. TITLE (and Subtitle) Bristol Fish and Game Club Dam NATIONAL PROGRAM FOR INSPECTION OF NON-FEDERAL DAMS		5. TYPE OF REPORT & PERIOD COVERED INSPECTION REPORT

PHASE I INSPECTION REPORT
NATIONAL PROGRAM OF INSPECTION OF DAMS

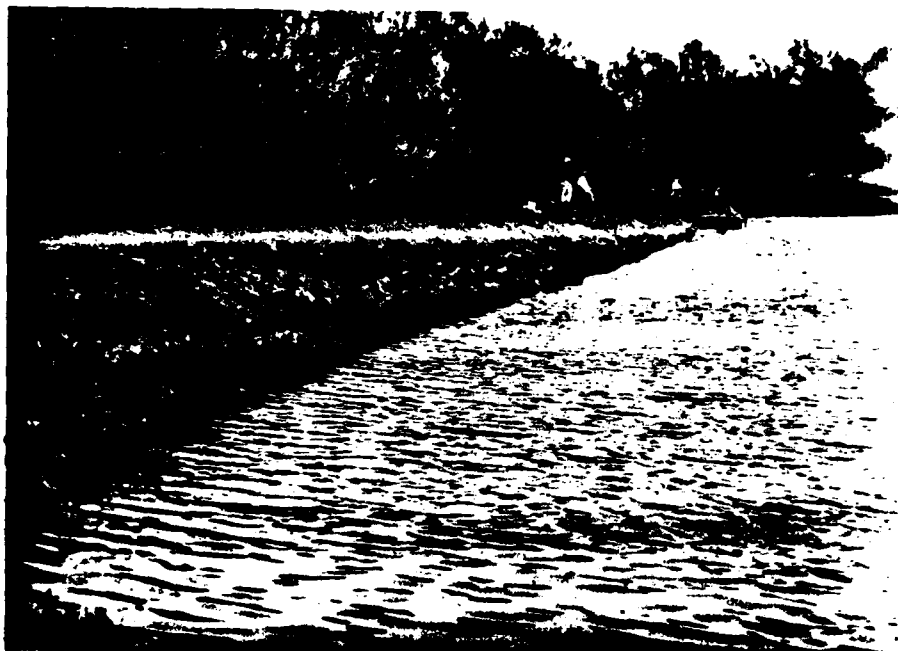
Photo 1 - Upstream slope from left abutment. Minor sloughing of the upstream slope is occurring at the water-line. Drop inlet can be seen at center of dam (April, 1981).

2. Regrading of the upstream slope and placement of sufficient riprap to protect against erosion and sloughing of this slope by wave action. This riprap should be placed between expected high and low water elevations, and should extend around the right end of the embankment to protect against erosion should the emergency spillway be activated.
3. Repairing spalled concrete at the sides of the riser structure hood, along the waterline where water enters the drop inlet.
4. Removing trees to a distance of 10 feet from the toe of the dam with proper backfilling and replacement of protective cover.
5. Elimination of burrowing animals in the embankment, backfilling the burrows and replacement of protective cover.

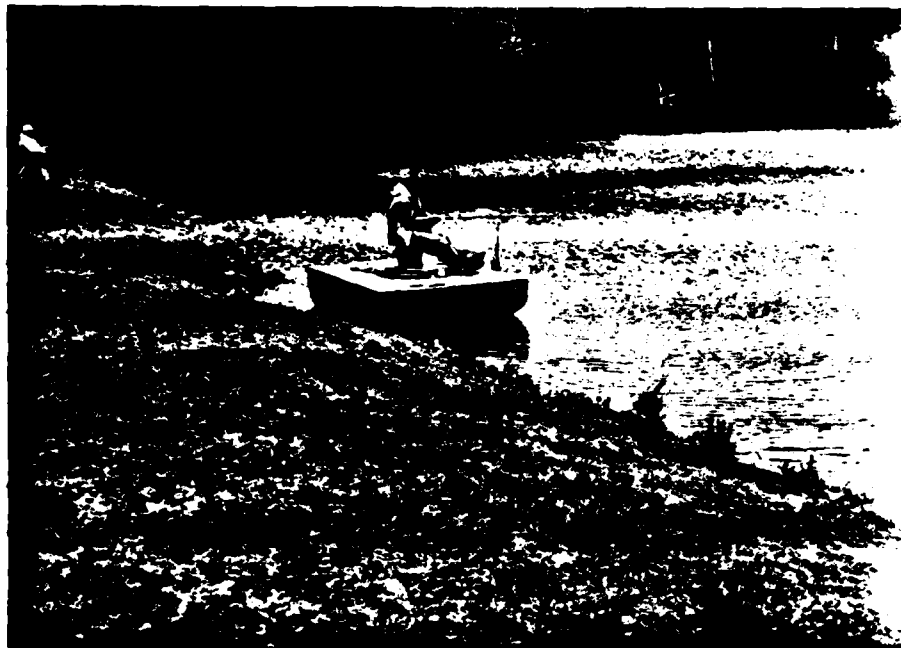
Photo 3 - Top of concrete riser structure. Casing for low-level outlet valve stem is located on upstream side of riser (April, 1981).

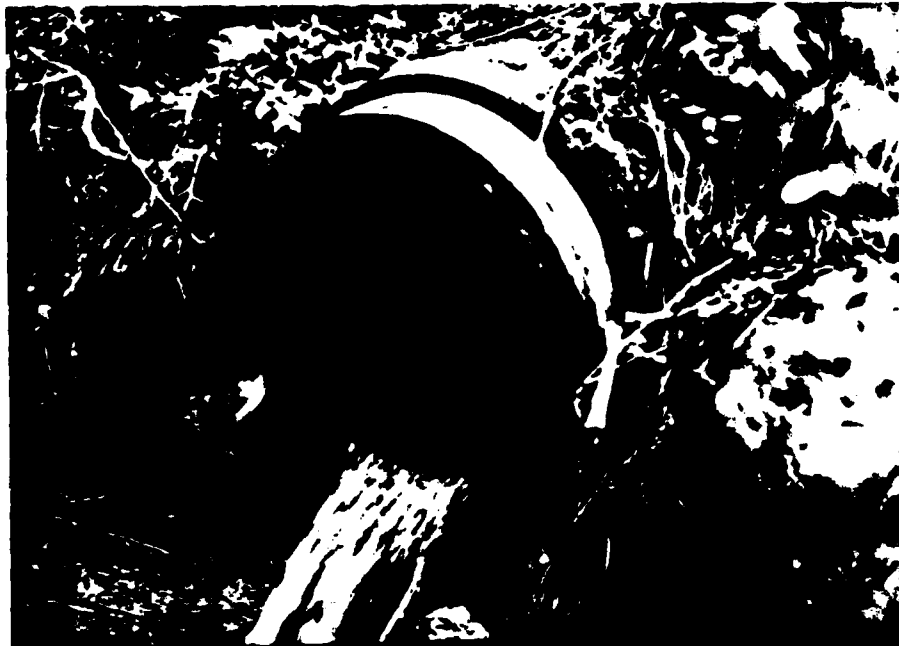
Photo 5 - 16 inch RCP which discharges flows from the concrete riser chamber. These flows may be from the drop inlet or from the low-level intake (April, 1981).

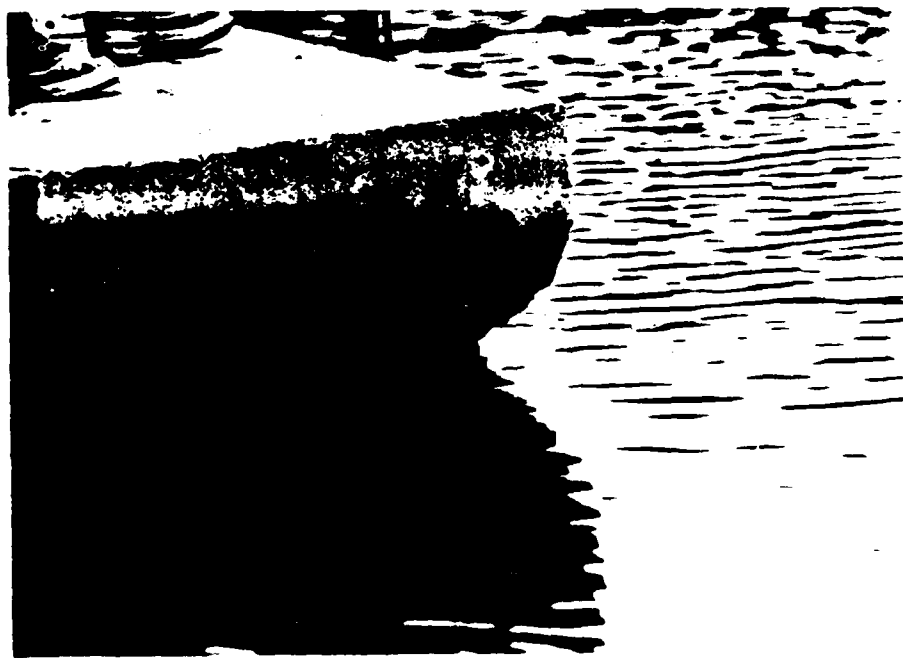
Photo 6 - Close-up of riser structure and spalling of concrete at waterline (April, 1981).

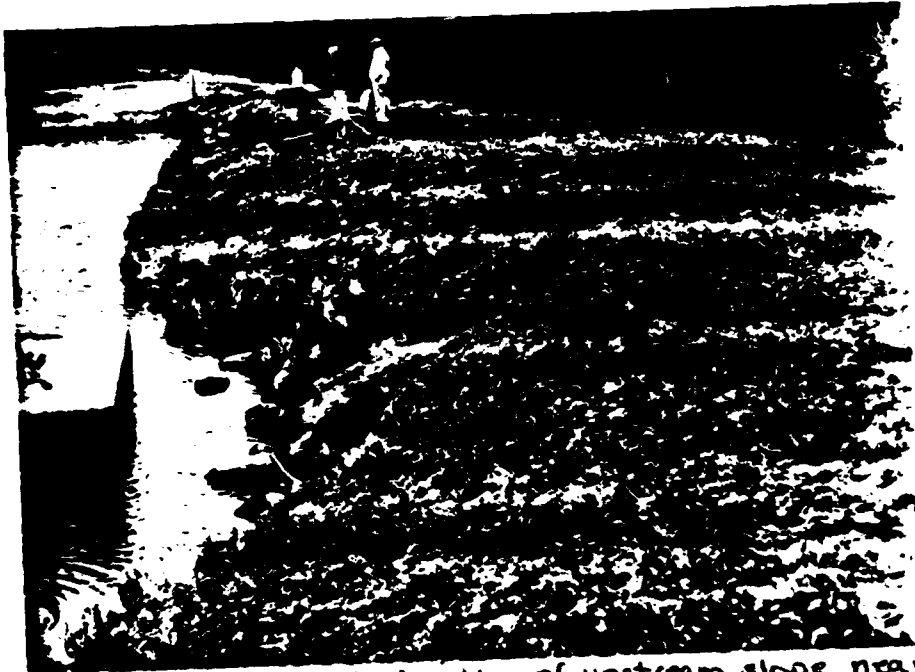
Photo 7 - Erosion and sloughing of upstream slope near drop inlet. Note sparse riprap at waterline (April, 1981).
