| REPORT DOCUMENTATION PAGE | | READ INSTRUCTIONS<br>BEFORE COMPLETING FORM |
|---|---|---|
| 4. TITLE (and Subtitle)<br>Silver Lake Dam | | 5. TYPE OF REPORT & PERIOD COVERED<br>INSPECTION REPORT |
| NATIONAL PROGRAM FOR INSPECTION OF NON-FEDERAL DAMS | | 6. PERFORMING ORG. REPORT NUMBER |
| 11. CONTROLLING OFFICE NAME AND ADDRESS<br>DEPT. OF THE ARMY, CORPS OF ENGINEERS<br>NEW ENGLAND DIVISION, NEDED<br>424 TRAPELO ROAD, WALTHAM, MA. 02254 | | 12. REPORT DATE<br>June 1979 |

### SILVER LAKE DAM

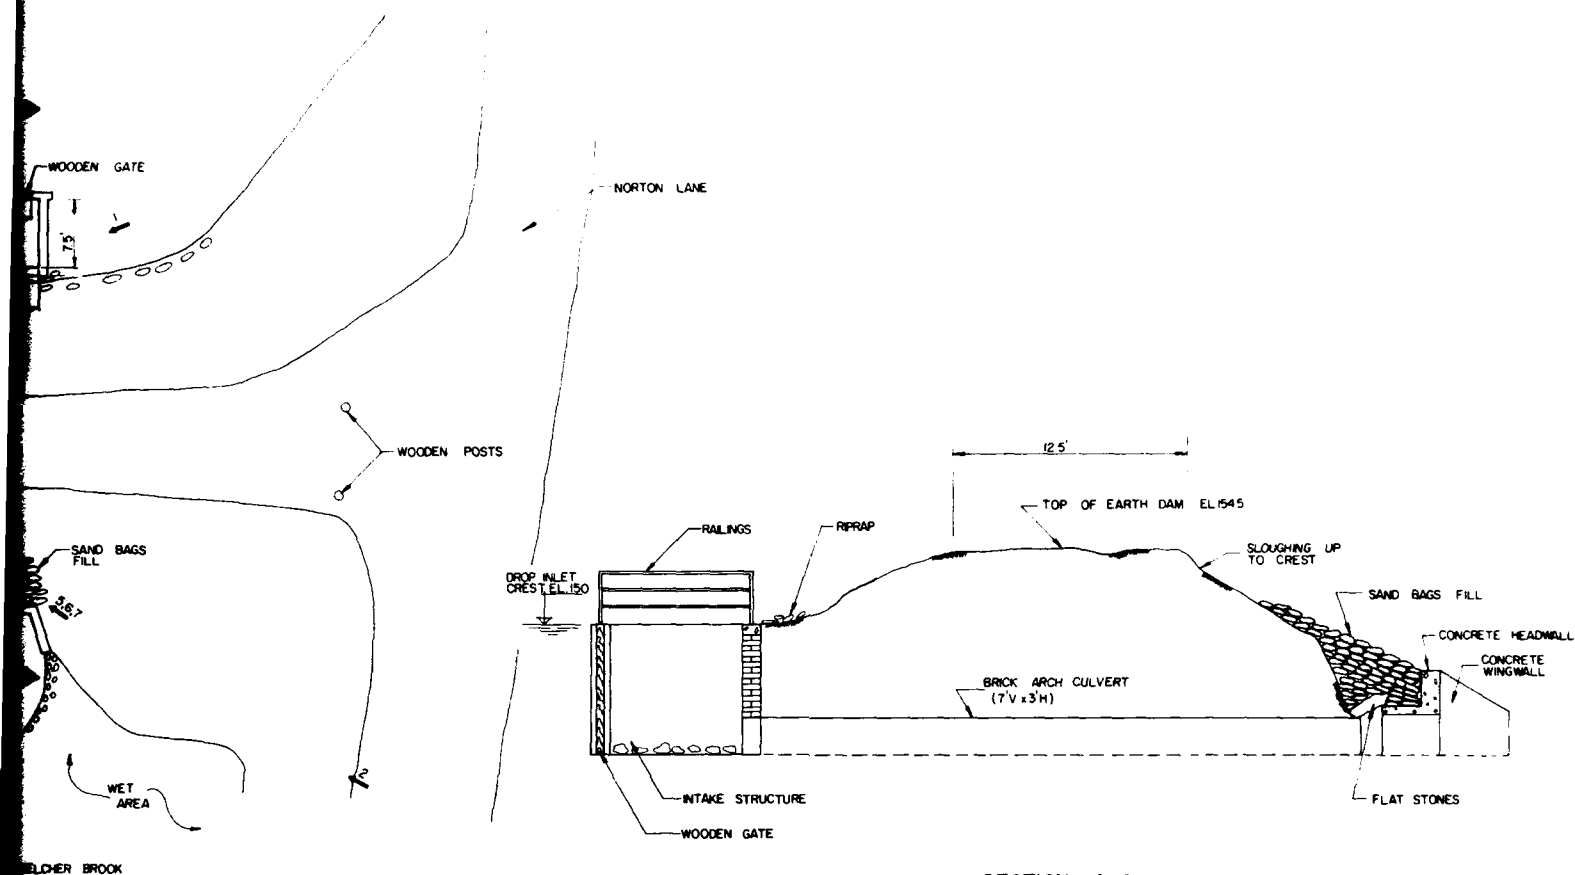
### SECTION A-A

5 0 5 10  
(CROSS-SECTION OF OUTLET WORKS SHOWING  
TEMPORARY REPAIRS)

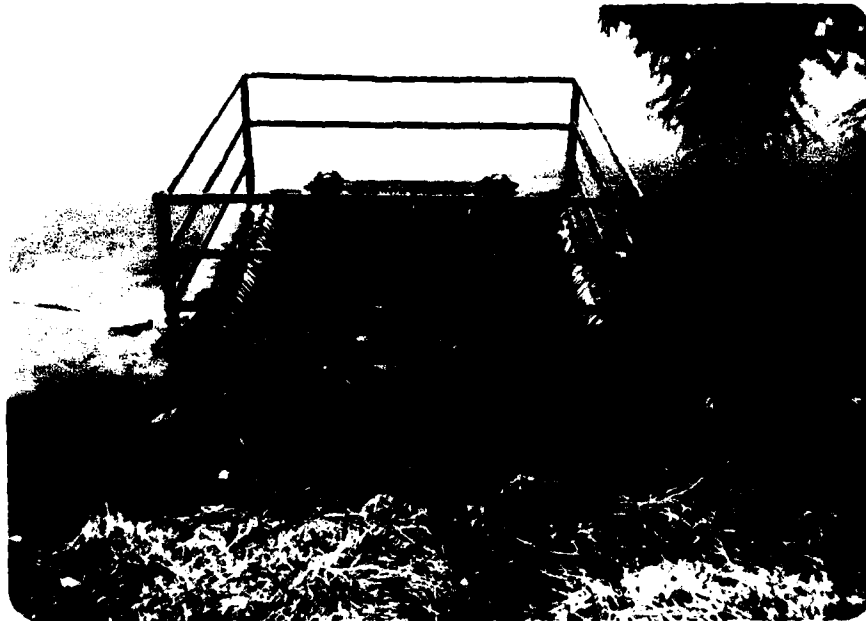
d. Visual Observations - The capacity of the spillway discharge conduit has been reduced due to siltation. Potentially, the already damaged conduit could be totally blocked if the temporary repairs were to fail or if the conduit were to suffer further collapse. In times of severe weather and high water, the drop inlet/conduit would be highly susceptible to partial or total blockage by floating logs or debris.

PHOTO 3 - Drop inlet. Note gate on far side of inlet and log floating toward inlet crest.
