NATIONAL PROGRAM FOR INSPECTION OF NON-FEDERAL DAMS
NEPAUG DAM (CT 00370) (U) CORPS OF ENGINEERS WALTHAM
MA NEW ENGLAND DIV SEP 78

4. TITLE (and Subtitle) Nepaug Dam Phelps Brook Dam NATIONAL PROGRAM FOR INSPECTION OF NON-FEDERAL DAMS	5. TYPE OF REPORT & PERIOD COVERED INSPECTION REPORT

11. CONTROLLING OFFICE NAME AND ADDRESS DEPT. OF THE ARMY, CORPS OF ENGINEERS NEW ENGLAND DIVISION, NEDED 424 TRAPELO ROAD, WALTHAM, MA. 02254	12. REPORT DATE September 1978

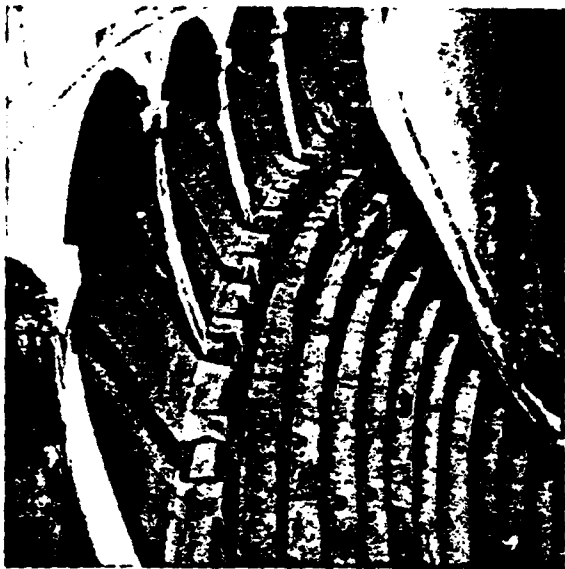
#1 Downstream side of dam and spillway in poor condition.
