**ROGERS LAKE DAM  
CT. 00418**

**PHASE 1 INSPECTION REPORT  
NATIONAL DAM INSPECTION PROGRAM**

**DEPARTMENT OF THE ARMY  
NEW ENGLAND DIVISION, CORPS OF ENGINEERS  
WALTHAM, MASS.**

SEP 20 1980  
**SEPTEMBER, 1980**

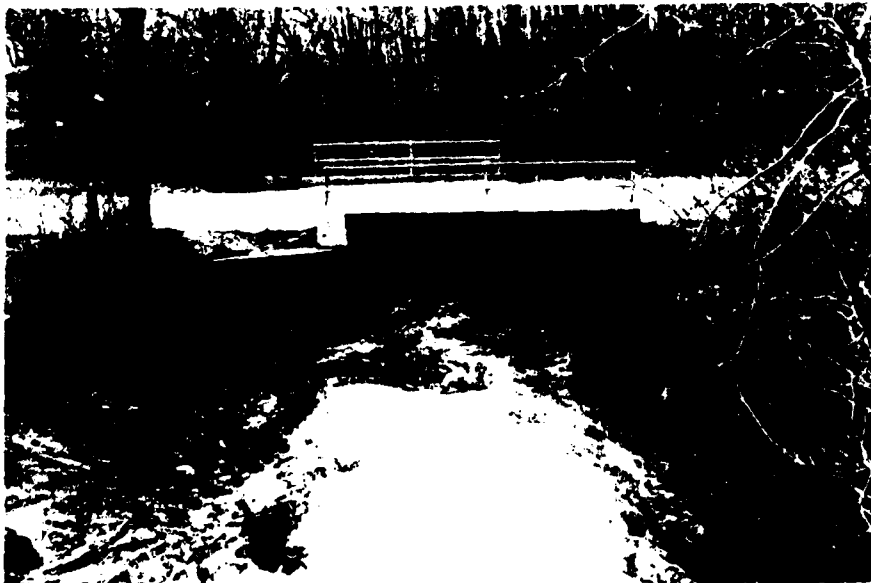
PHOTO C-10 Spillway and outlet works discharge channel.

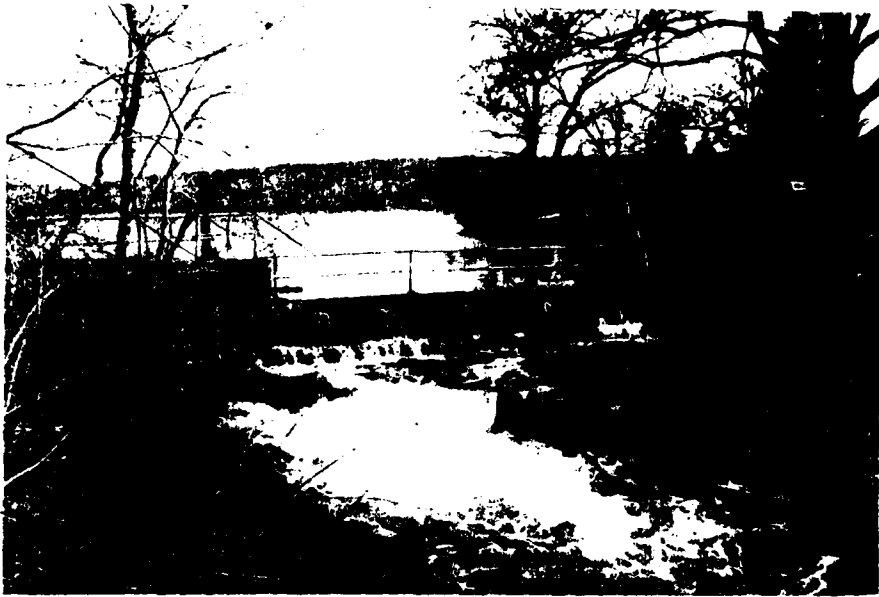
The downstream face consists of a 12-inch-wide concrete wall on each side of the spillway, (Photos C-5 and C-7). To the right of the spillway the concrete wall is about 18 feet long and has spalled and cracked in several locations. Seepage was observed through a spalled area at the base of the wall located about 6 feet from the left end of the wall and about 5.5 feet below the top of the wall (Photo C-11). The spalled area has dimensions of about 15 inches by 6 inches, and a wooden rule could be placed 8 inches into the spalled area. The seepage appeared to be clear and was flowing at a rate of about 3 gallons per minute. The area downstream of the right wall is covered with thick brush and trees. A 12-inch diameter tree is located about 7 feet from the right corner of the wall. To the left of the spillway the concrete wall is about 24 feet long with mortared stone blocks forming the right portion of the wall. A 26-inch diameter tree is located about 10 feet from the wall, and several small tree stumps are located close to the downstream toe of the wall. An extensive root system is located near the downstream toe of the wall and is apparently part of the large tree located 10 feet from the wall. A wet area with dimensions of about 25 feet by 10 feet is located just downstream of the large tree shown in Photo C-7 and is about 6 feet below the top of the dam. It could not be determined if the wet area is seepage through the dam. An area of lush green growth, about 7 feet by 7 feet, is located to the left of the downstream wall, (see Photo C-5). The cause of this growth is unknown.

PHOTO C-7 Spillway and embankments from downstream right side.

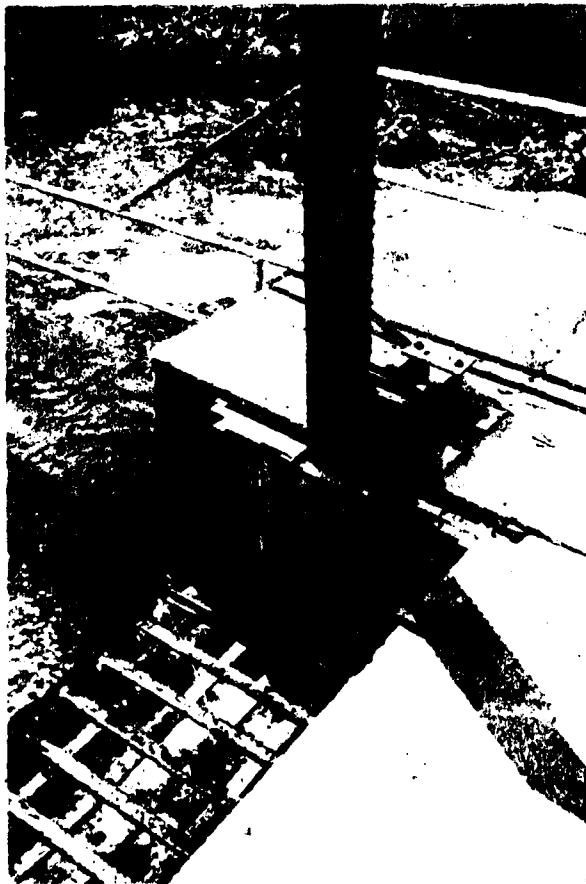
PHOTO C-8 Outlet works intake structure and gate control.

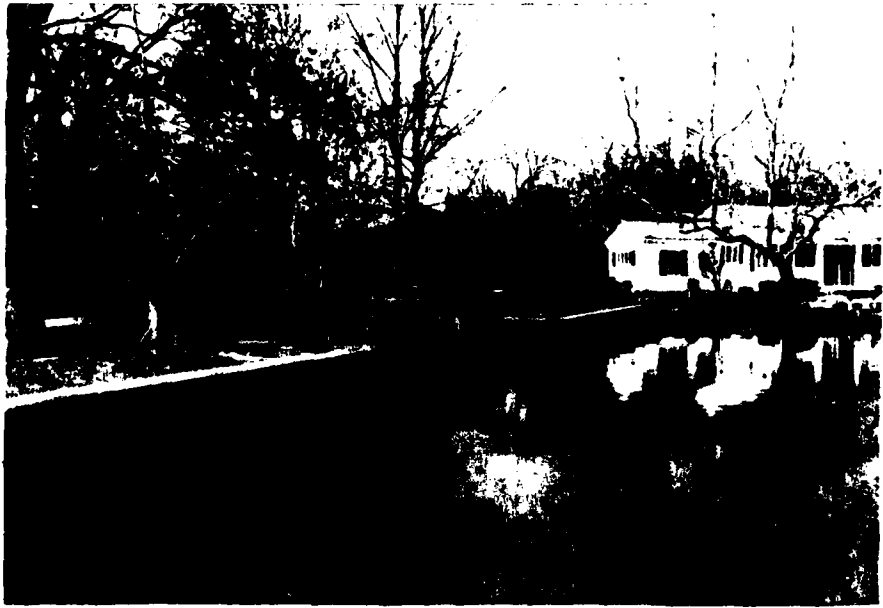
The upstream face of the dam consists of a 24-in.-wide concrete wall on each side of the spillway (Photos C-1, C-2 and C-3). The visible portion of the wall on the right side of the spillway is in generally good condition and shows no sign of misalignment. The grassy area to the right of the wall is at a lower elevation than the top of the wall, (Photo C-13). The low spot of this grassy area is about 17 feet from the right end of the wall and is about 0.5 feet lower than the top of the wall, (Photo C-5). The wall on the left side of the spillway consists of two sections: a 34-ft.-long, 24-in.-wide section and a 19-ft.-long, 10-in. -wide section. Spalling of both sections was observed and a 1/2 inch wide vertical crack with a 1/4 inch offset was observed near the center of the 10-in.-wide wall, (Photo C-12). The ground surface to the left of the wall is lower than the top of the wall. A 25-ft.-long row of sandbags, partially eroded, is located to the left of the wall (Photos C-13 and C-14). Sandbags were needed to prevent high stages in the lake from flowing around the left abutment of the dam at a low area.

PHOTO C-1 Upstream face of dam from left side.
