# SCHWARTZ POND DAM CT 00280

PHASE I INSPECTION REPORT  
NATIONAL DAM INSPECTION PROGRAM

APRIL 1981

IDENTIFICATION NO: CT-00280  
NAME OF DAM: Schwartz Pond Dam  
TOWN: Suffield  
COUNTY AND STATE: Hartford County, Connecticut  
STREAM: Stony Brook, a tributary of Connecticut River  
DATE OF INSPECTION: December 17, 1980

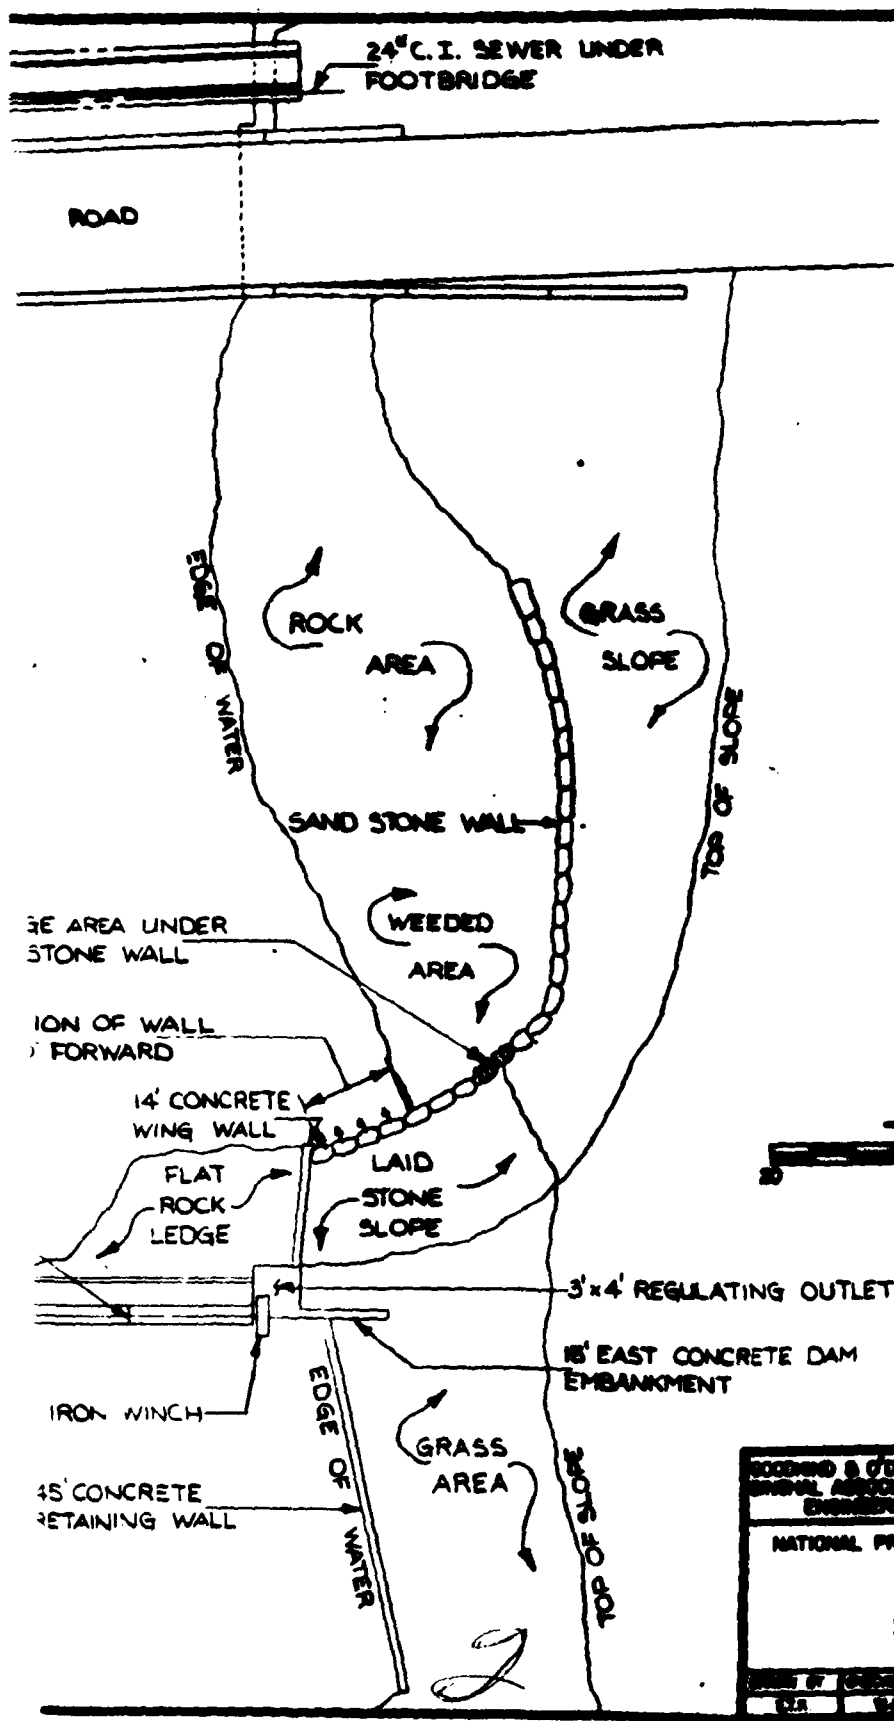
**GENERAL PLAN**

Seepage was observed under the sandstone wall, east of the spillway, as noted on the general dam plan in Appendix B. The seepage flowed steadily, but was small and appeared to be free of any soil particles. A 12 ft. portion of this sandstone wall, which is abutting the stone slope, was also observed to be tilting forward (See general dam plan in Appendix B).

1. Inspect and evaluate the condition of the concrete dam structures and the contact zone between the structures and rock base. The water level in the pond should be lowered so that a thorough inspection can be completed.
2. Determine the origin and significance of seepage under the sandstone wall located on the east side of the dam.
