CONNECTICUT COASTAL BASIN  
CLINTON, CONNECTICUT

**BOULDER LAKE DAM  
CT 00518**

**PHASE I INSPECTION REPORT  
NATIONAL DAM INSPECTION PROGRAM**

**JULY 1981**

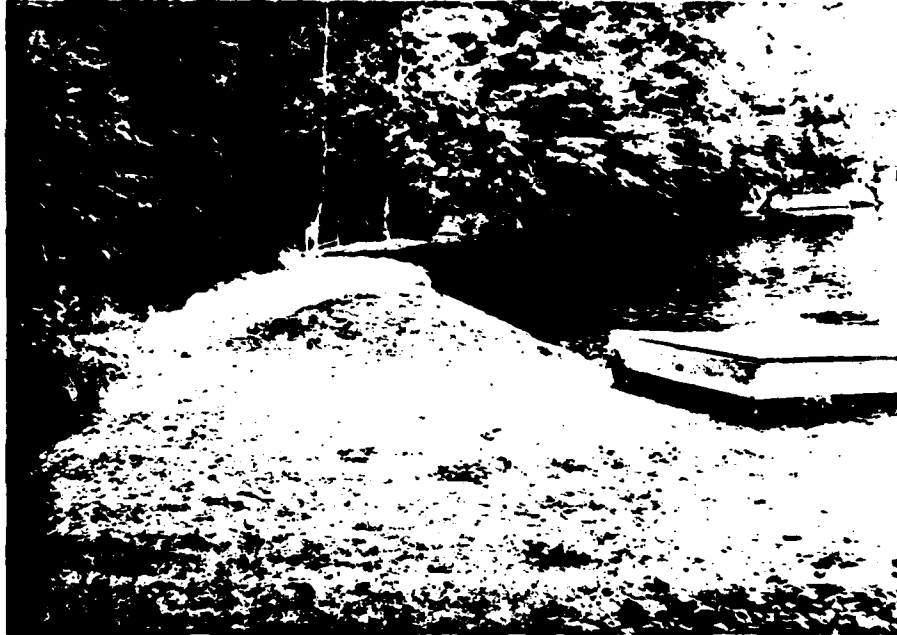
Photo 1 - View along crest of dam looking west.  
Note two trees on the crest of dam in  
background.

1. Surveillance of the dam during periods of heavy precipitation.
2. Monitoring of the seepage areas noted at the dam embankment.
3. Remove trees on crest at west end of dam embankment.
4. Provide adequate protection along crest of dam to prevent erosion and scouring.

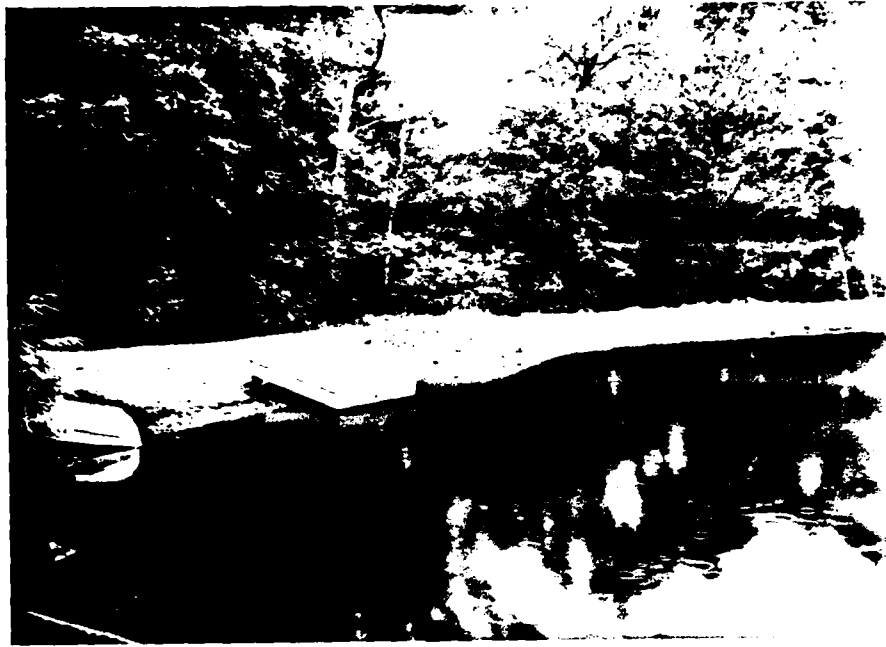
Photo 3 - View of dam embankment looking downstream.

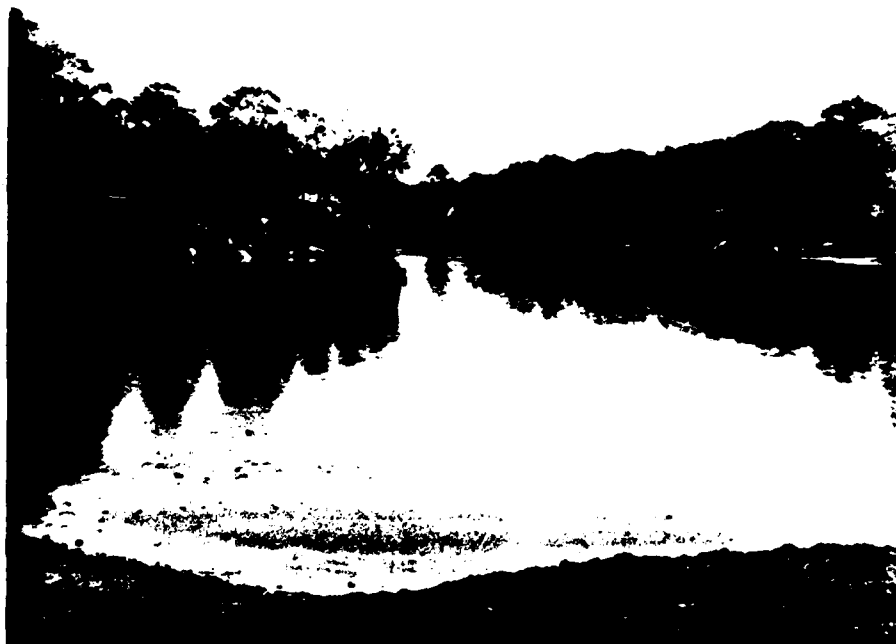
Photo 6 - Upstream reservoir area (Boulder  
Lake).
