SCANTIC RIVER BASIN  
SCITICO, CONNECTICUT

SCITICO DAM  
CT 00529

PHASE I INSPECTION REPORT  
NATIONAL DAM INSPECTION PROGRAM

APRIL 1980

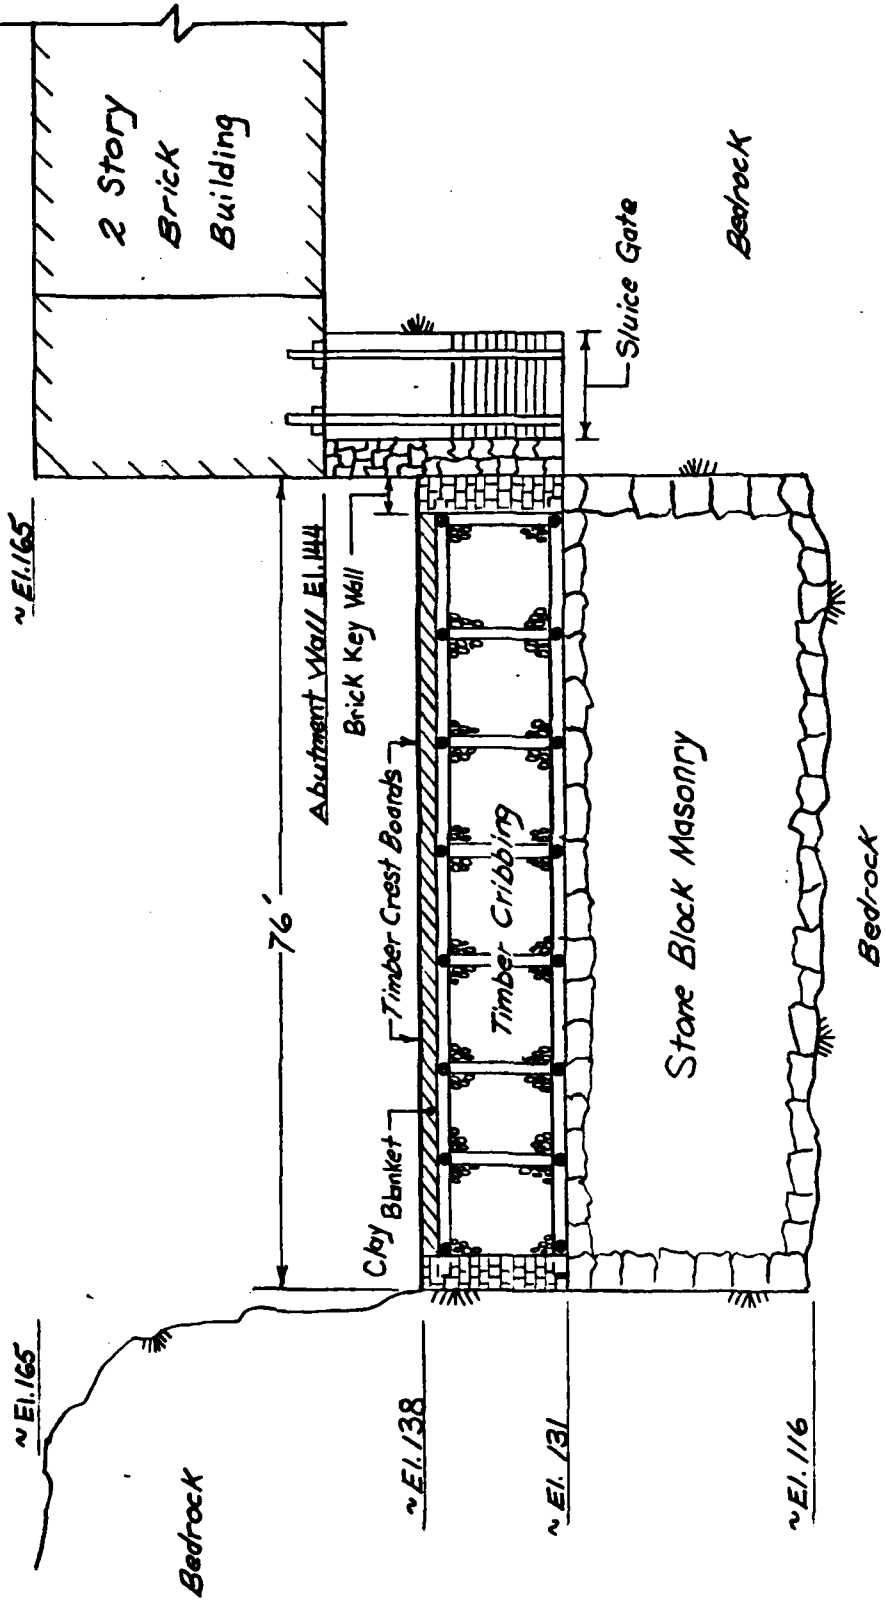
UPSTREAM PROFILE  
SCITICO DAM

Note: Sketch prepared from visual inspection and recorded observations made during remedial repairs in 1955.
