CONNECTICUT RIVER BASIN  
VERNON , CONNECTICUT

HOCKANUM RIVER DAM  
CT 00620

PHASE I INSPECTION REPORT  
NATIONAL DAM INSPECTION PROGRAM

MAY 1980

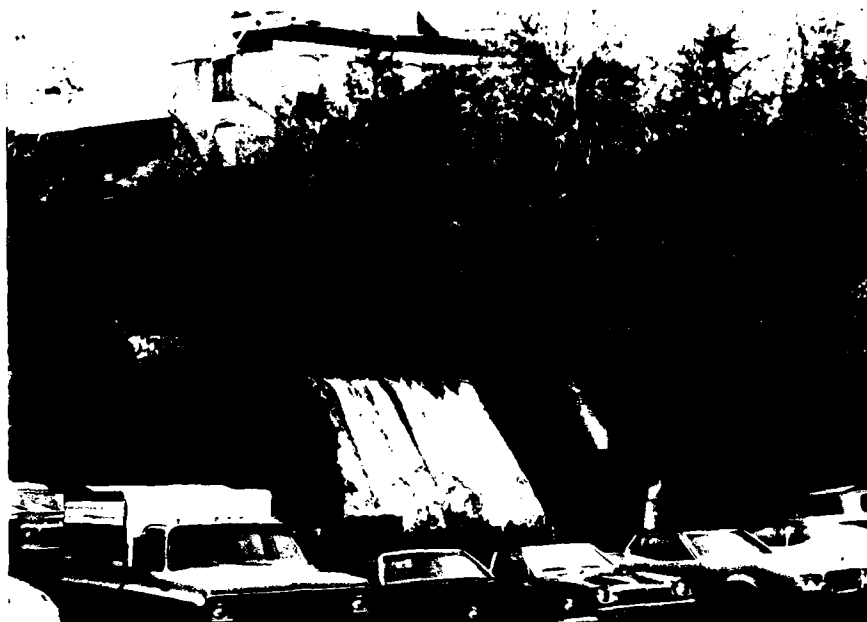
PHOTO #1: Downstream face of the dam
