NATIONAL PROGRAM FOR INSPECTION OF NON-FEDERAL DAMS  
MILL POND DAM (CT 004) (U) CORPS OF ENGINEERS WALTHAM  
MA NEW ENGLAND DIV APR 80

MILL POND DAM  
CT 00423

PHASE I INSPECTION REPORT  
NATIONAL DAM INSPECTION PROGRAM

Identification No.: CT 00423  
Name of Dam: Mill Pond Dam  
Town: Essex  
County and State: Middlesex, Connecticut  
Stream: Falls River  
Date of Inspection: 1 November, 1979

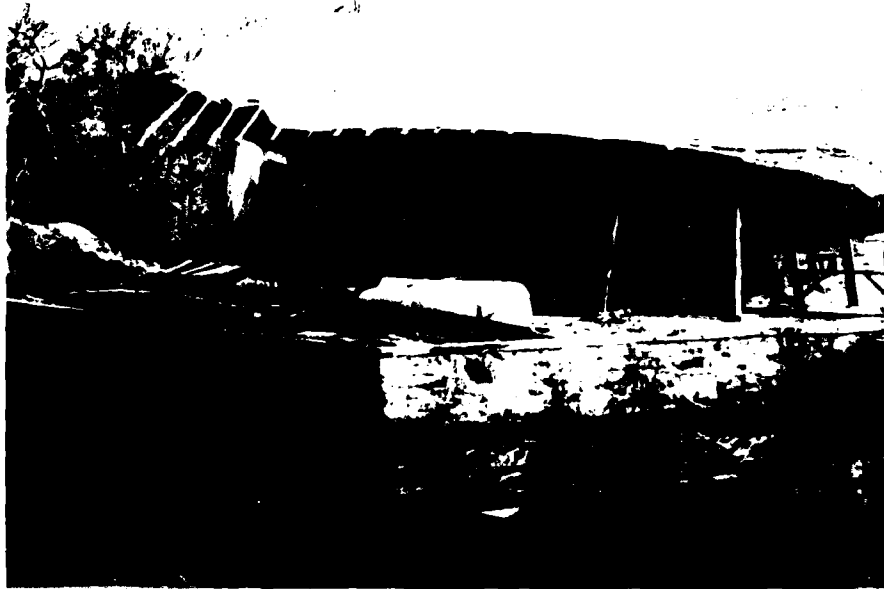
1) Upstream Face - The upstream face of the dam is comprised of mortared stone masonry (see Photo No. 13). The stone pointing is in fair condition. Several voids in the upstream face indicate that material has been lost by erosion.

PHOTO #13: Upstream face and crest of dam, from left side.
