HALLS POND DAM

CT 00388

PHASE I INSPECTION REPORT

Identification No.:	CT 00388 CT 00598
Name of Dam:	Halls Pond Dam
Town:	Eastford
County and State:	Windham, Connecticut
Stream:	Slovik Brook
Date of Inspection:	27 February, 1981

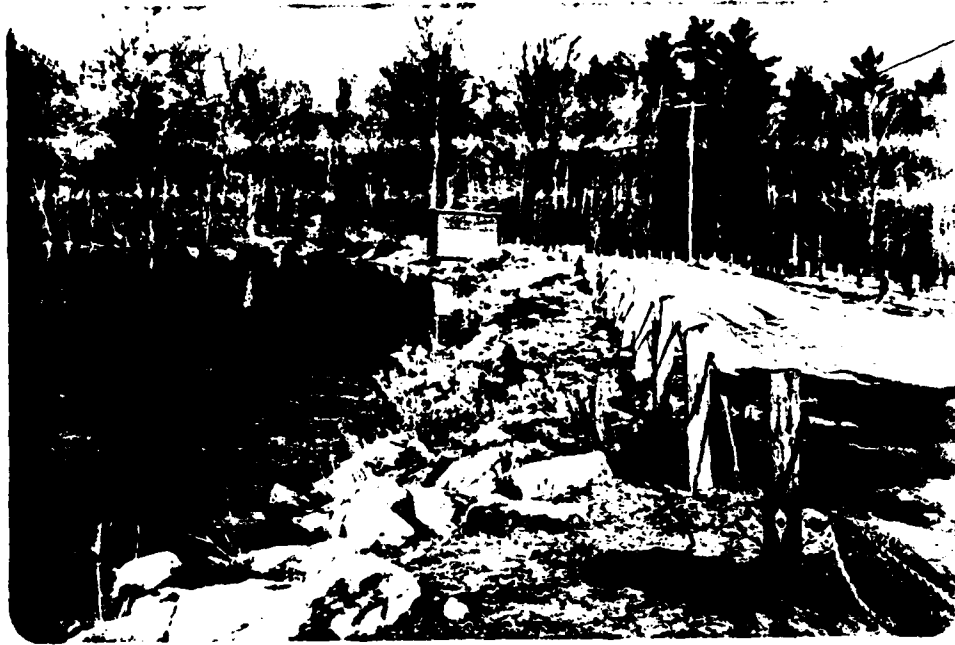
C1-1 UPSTREAM SLOPE

1. Upstream Face - The dumped rock fill is missing in some areas. There is minor brush growth, most of which has been trimmed as shown in Photos C1-1 and C1-6. There has been some erosion just south of the spillway, caused by storm runoff from the roadway.
2. Crest - The crest consists of Kennerson Reservoir Road which is an oiled gravel Town road. The road is in good condition, but the wire rope guide rail on the west side has been partially removed at the south end as shown in Photo C1-1.
3. Downstream Face - The downstream face is grass covered with some brush growth as shown in Photos C1-2 and C1-3. No seepage was observed.

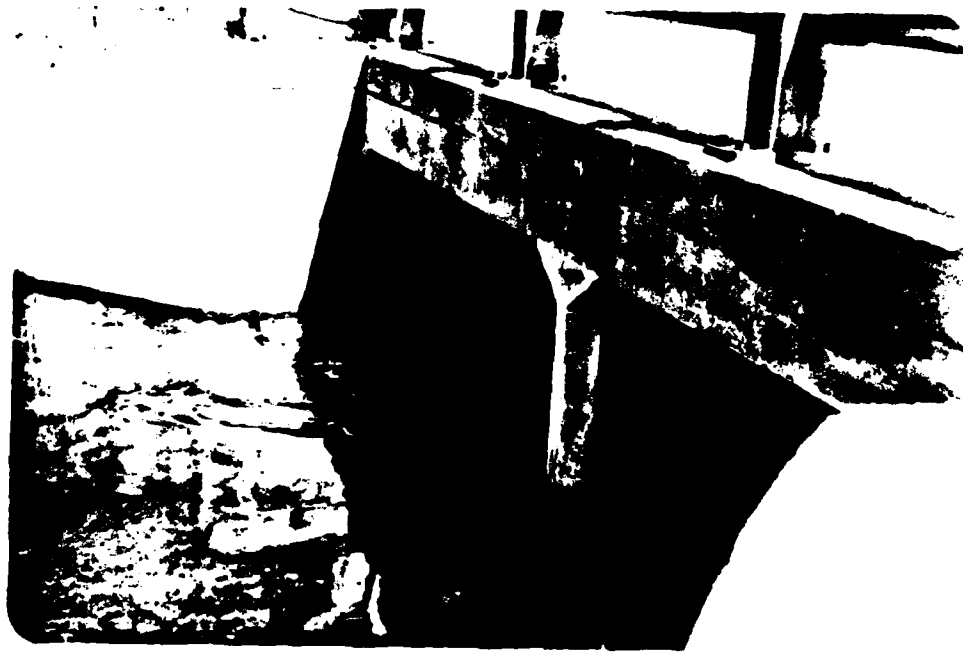
C1-4 UPSTREAM END OF SPILLWAY

1. Spillway - Twin 9'x3.3' cast-in-place concrete box culverts constructed in 1968 form the spillway with a concrete channel on a 2H:1V slope for an outlet channel. Photos C1-4 and C1-5 show the spillway and channel. The spillway is in good condition except for a crack at the wingwall at the northwest corner as shown in Photo C1-4. This crack should be investigated further.

- a. Investigate areas of seepage in the downstream face of the south dam to determine if repairs are warranted.
- b. Investigate the crack in the box culvert spillway at the northwest corner to determine if repairs are warranted.

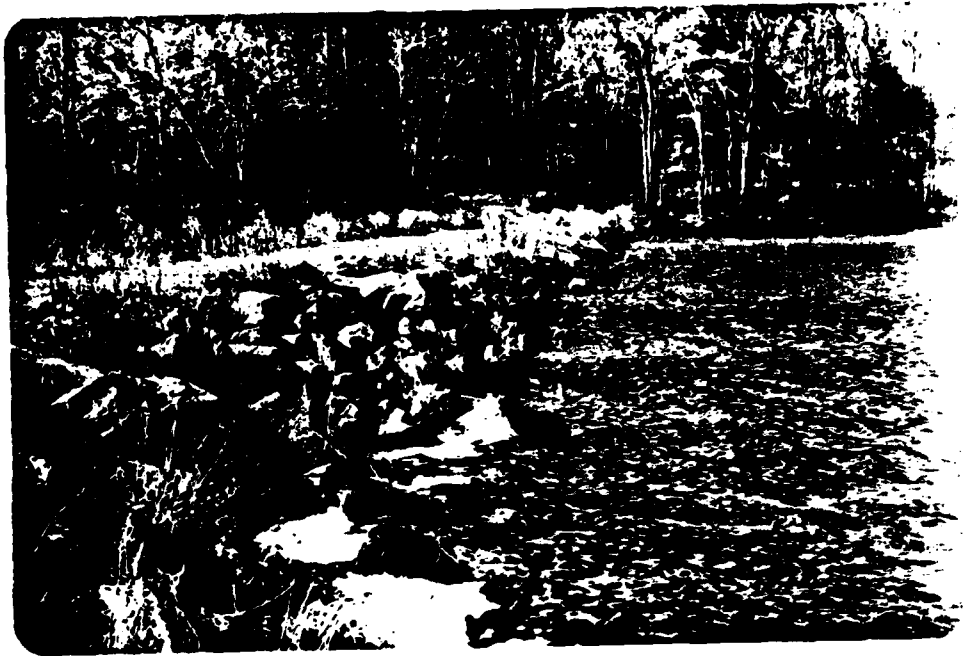
C2-3 UPSTREAM FACE

1. Upstream Face - The upstream face has dumped rock fill which is missing in some areas as shown in Photos C2-3 and C2-4. There is minor erosion from wave action.

1. Repair guide rail at south end of north dam.
2. Construct paved ditch to carry road water at spillway.
3. Paint all steel in gate house and repair lock on door.
4. Repair riprap at both dams.
5. Check operation of gate on a regular basis.
