**CONNECTICUT COASTAL BASIN**  
**GUILFORD, CONNECTICUT**

**GUILFORD LAKES UPPER DAM**  
**CT. 00412**

**PHASE I INSPECTION REPORT**  
**NATIONAL DAM INSPECTION PROGRAM**

**JUNE 1981**

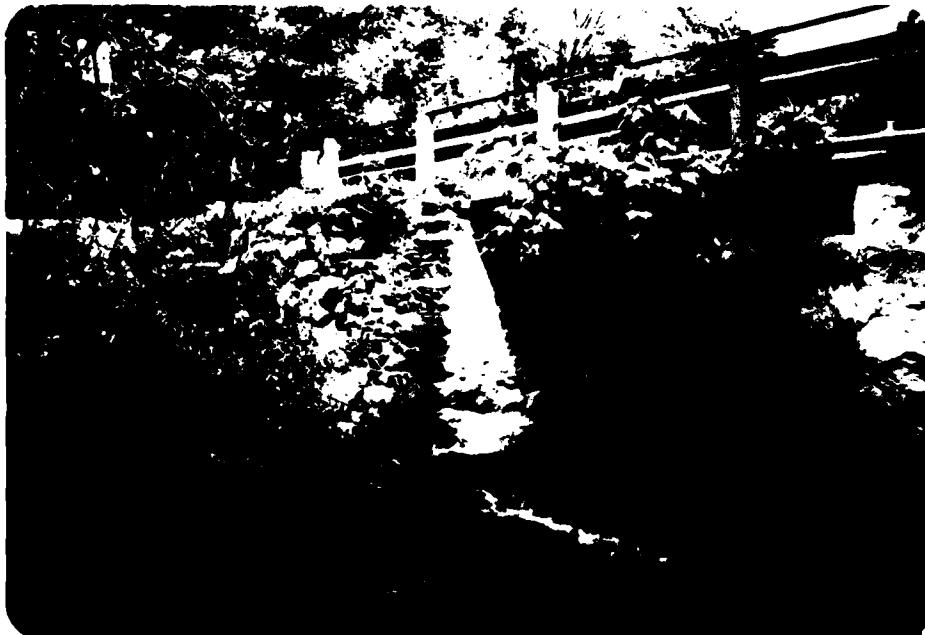
3. Downstream Face and Toe. The downstream face and toe are shown on Photos C-3 and C-4. The downstream face is a dry stone masonry wall in fair to good condition. Brush and trees to 24 inches in diameter are growing immediately downstream from the downstream face. The brush, trees and their roots systems should be removed to a distance of 15 feet downstream to prevent future damage to the wall and to facilitate proper inspection by the downstream area.

PHOTO C-3. Downstream face to right of the right spillway.

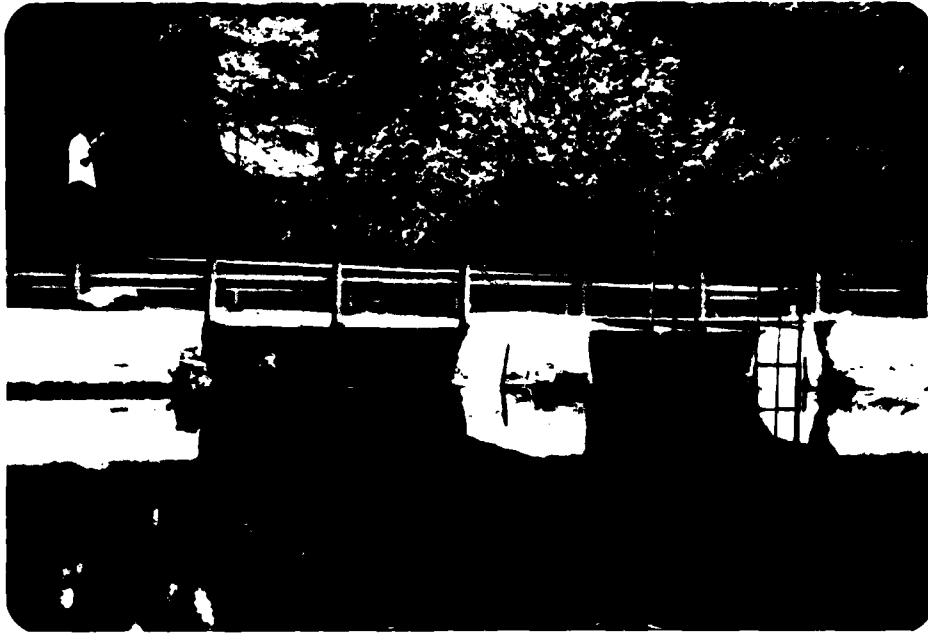
PHOTO C-5. Left and right spillways and outlet gates lifting mechanisms.

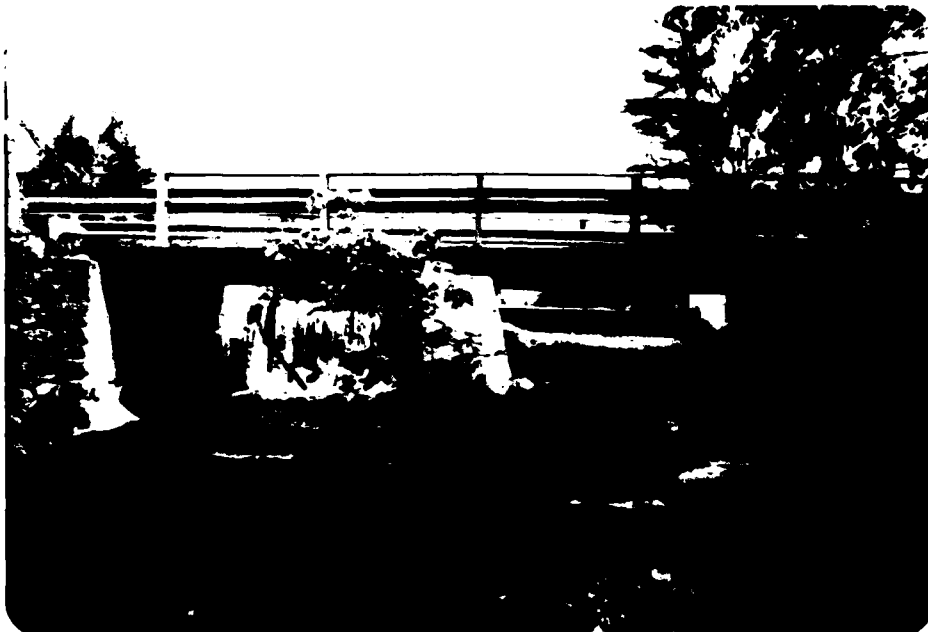
PHOTO C-6. Left and right spillways and spillway discharge channels.

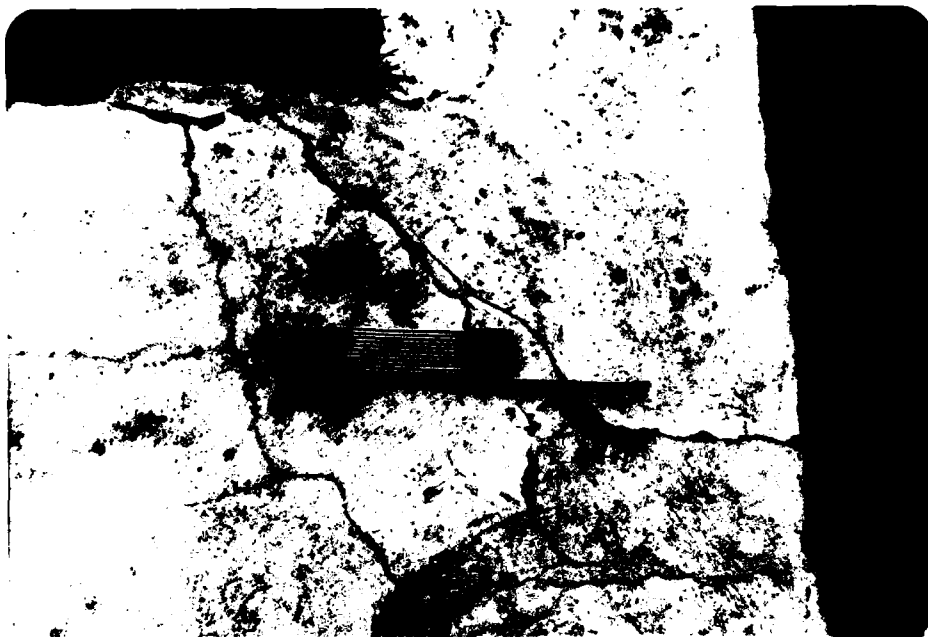
Frost action will continue to open such cracks. The right training wall of the right spillway appears to have moved laterally to the left about 1 inch (into the spillway opening), probably due to frost action. This movement is likely to increase with time. The floor of the left spillway discharge channel is approximately 4 feet higher than the right spillway discharge channel. A floating log was trapped upstream of the right spillway at the low level outlet gate. There are several steel pins set in the crests of the two spillways which were apparently used for stoplogs at one time. These pins should be removed to prevent debris accumulation.

PHOTO C-9. Crack through training wall which divides the spillway discharge channels.

2. Observe movement of right training wall of right spillway and cracks and leaks in center training wall between spillways at least annually. Note condition and take action as needed.

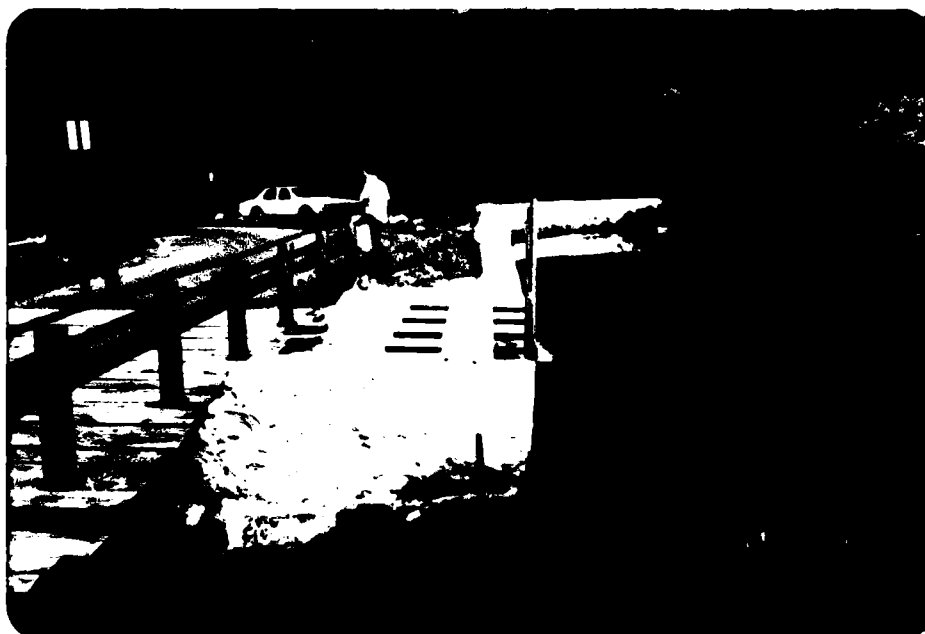
1. Upstream Face. The upstream face is a vertical grouted stone masonry wall which has a slight downstream curvature to the right of the spillways as shown in Photo C-12. It is possible that this curvature is due to ice pressure. The curvature is of no immediate concern, however, it should be observed at least annually to determine if any changes are occurring. The mortared stone masonry has numerous hairline cracks throughout its length.

PHOTO C-12. View along crest from the left of the spillways showing bend in the upstream face.
