**HOUSATONIC RIVER BASIN  
SEYMOUR, CONNECTICUT**

**MIDDLE RESERVOIR DAM  
CT 00590**

**PHASE 1 INSPECTION REPORT  
NATIONAL DAM INSPECTION PROGRAM**

APRIL, 1980

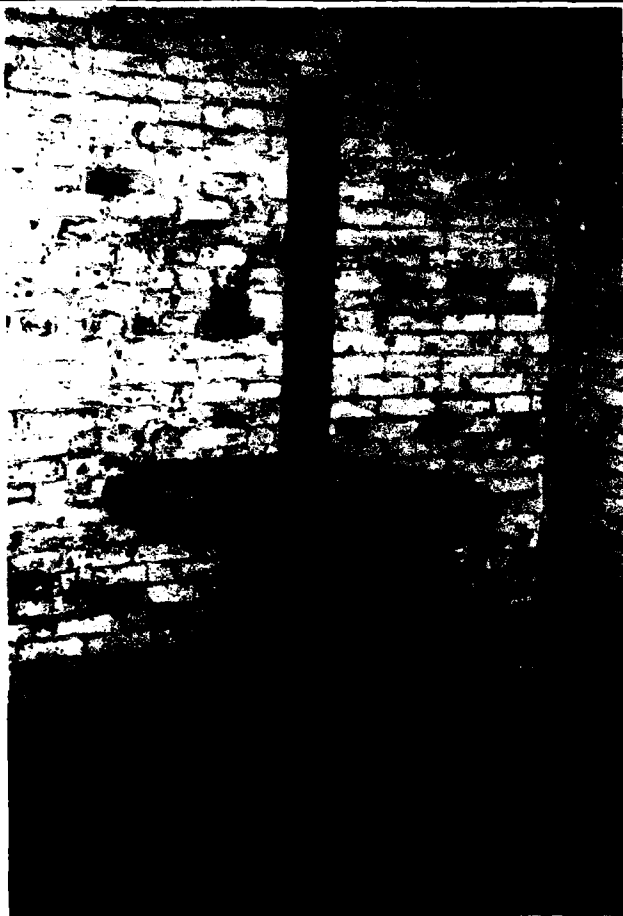
C-11 LIFT MECHANISM FOR  
30 INCH GATE VALVE --  
INSIDE GATE HOUSE
