NAUGATUCK RIVER BASIN
WATERBURY, CONNECTICUT

**BELLEVUE LAKE DAM
CT 00642**

**PHASE I INSPECTION REPORT
NATIONAL DAM INSPECTION PROGRAM**

MAY 1979

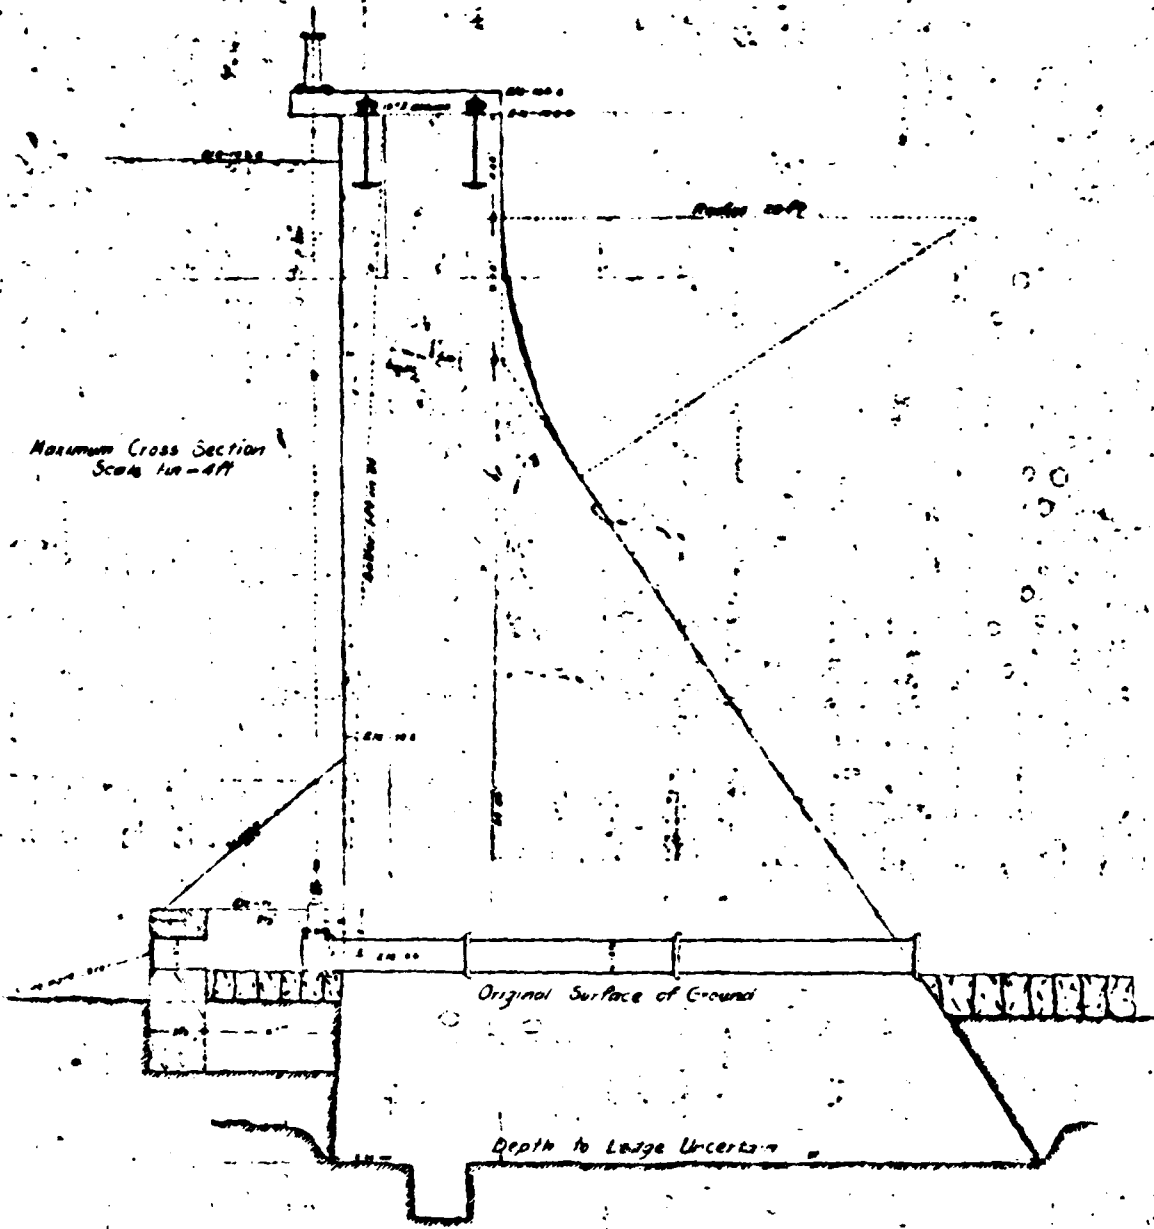
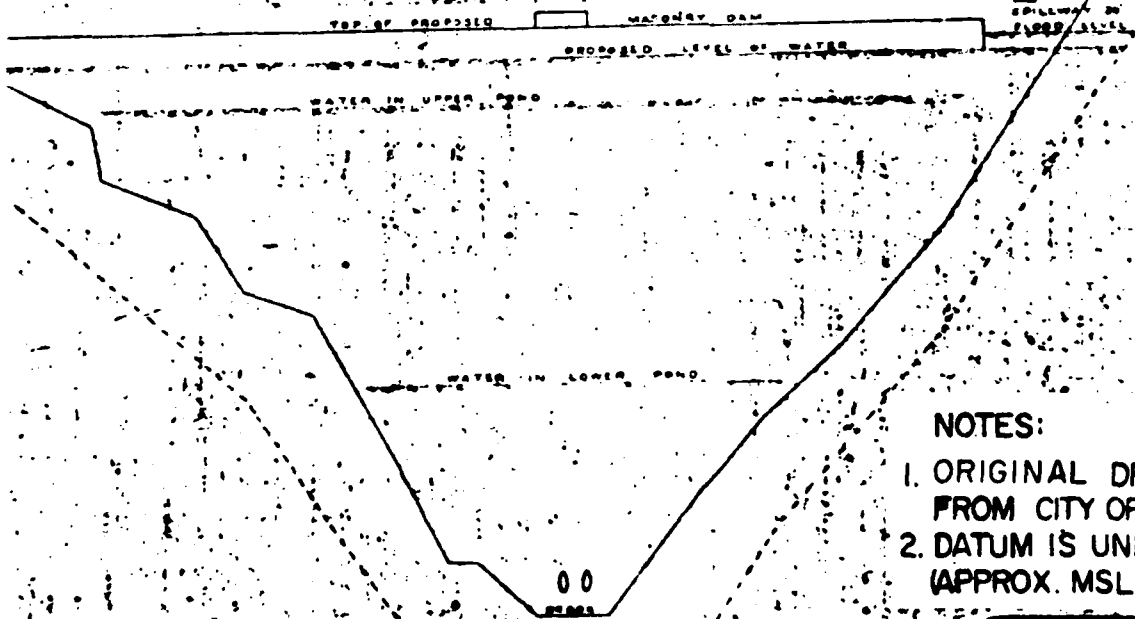
PROPOSED MASONRY DAM

SPILLWAY IS INCORRECT AS SHOWN,
SEE SKETCH IN APPENDIX D FOR
ACTUAL CONDITIONS
