NAUGATUCK RIVER BASIN

MORRIS, CONNECTICUT

# PITCH RESERVOIR DAM CT 00474

PHASE I INSPECTION REPORT  
NATIONAL DAM INSPECTION PROGRAM

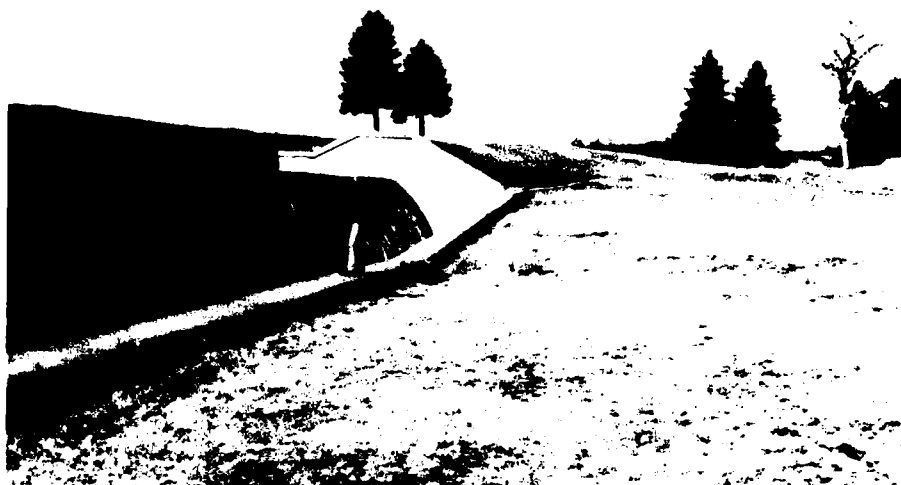
The spillway structure, shown in Photo 11 consists of an ogee-shaped concrete weir 150 feet long and two training walls. The concrete spillway surface is in good condition.

PHOTO NO. 11 - Looking upstream along spillway channel  
from left (east) side of spillway training wall.
